ENGINE - REWORK THE BIFURCATION DISCONNECT PANEL ASSEMBLY TO EXTEND SEALING FEATURES -  
CATEGORY CODE 4 - MOD.ENG-72-0062

V2500-ENG-72-0062

## SERVICE BULLETIN

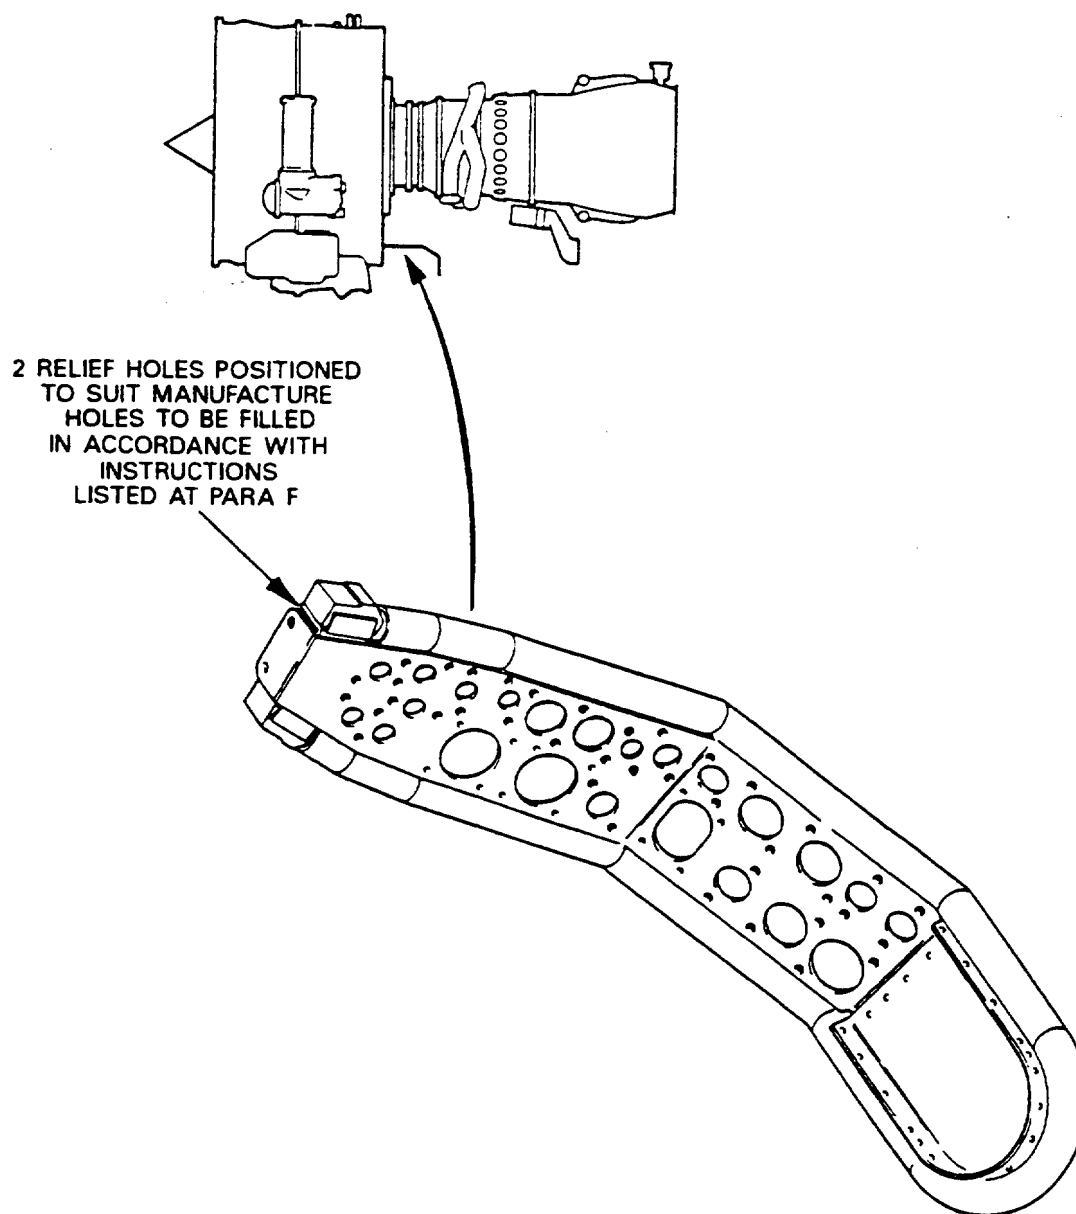
Bifurcation Panel  
Fig.1

Bifurcation disconnect panels on existing engines have two relief holes for manufacturing purposes only. These holes are required to be filled with cold curing silicone rubber compound.

- (3) Place warning notice on cockpit panel SUBTASK 78-32-00-869-401.
- (4) Open the cowl panel SUBTASK 78-32-00-010-404.
- (5) De-activate hydraulic control unit SUBTASK 78-32-00-040-403.
- (6) Open thrust reverser half SUBTASK 78-32-00-010-407.
- (7) Locate Bifurcated disconnect panel 6A3361 (See fig.1).
- (8) Apply cold curing Silicone compound CoMat 08-013 to the two manufacturing holes in accordance with:
