ENGINE - LP COMPRESSOR - PROVIDE MARKING INSTRUCTION FOR VARIOUS MAJOR ASSEMBLIES -
CATEGORY CODE 6 - MOD.ENG-72-0066

V2500-ENG-72-0066

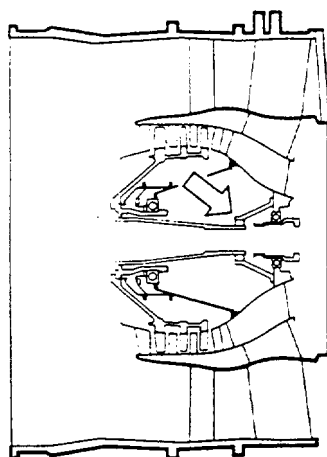
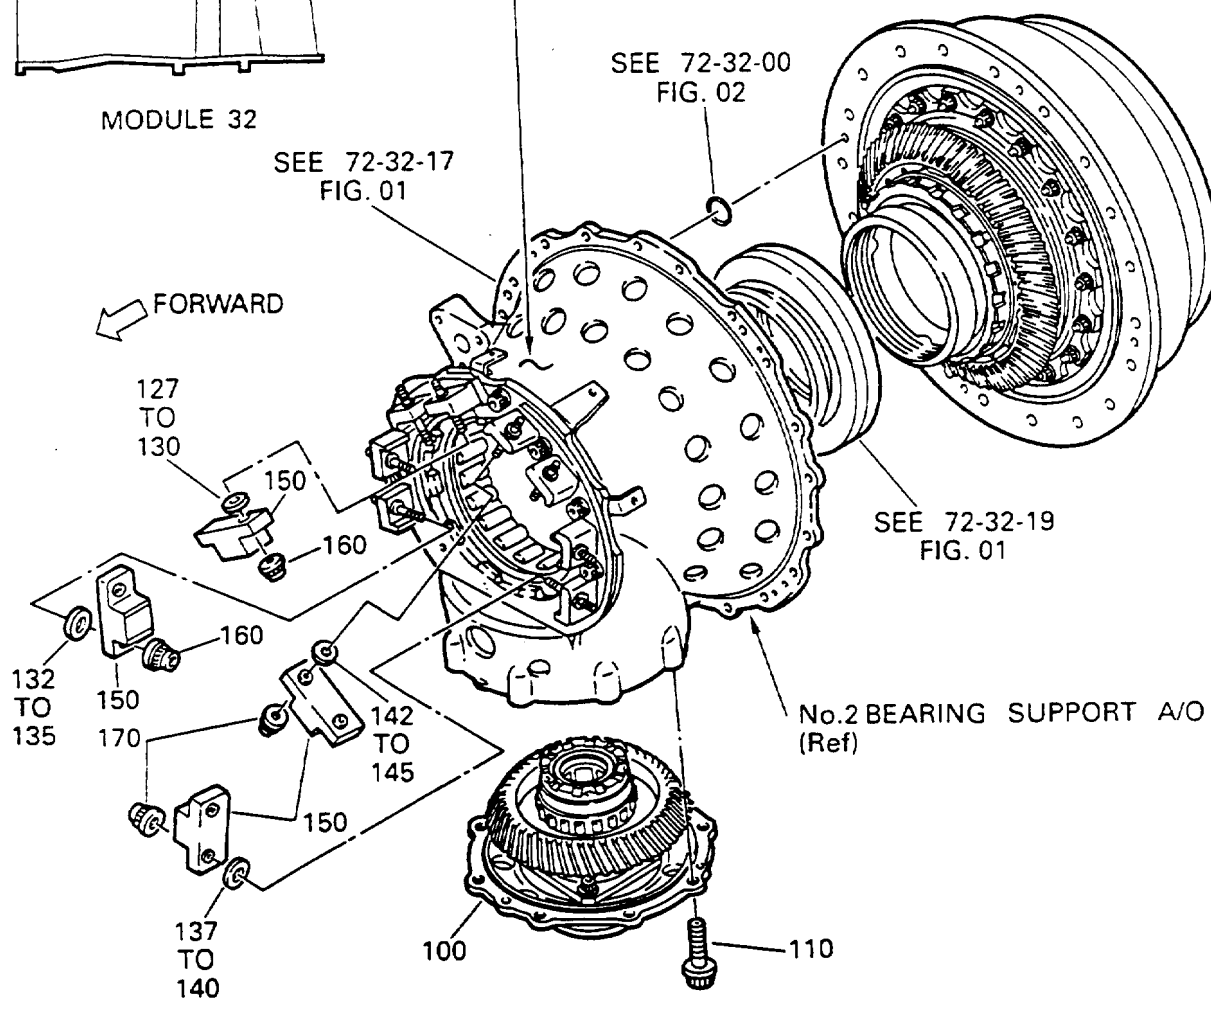
Fig.1

Some major assemblies in the LP Compressor/Intermediate Case Module do not have the Identification Number and the Serial Number marked on them.

Marking of the Part Number and the Serial Number on No.3 Bearing, Internal Gearbox and Support Assembly

- (a) Mark a new Part Number 5W0099 which is followed by the letters "SUB-MODULE" (i.e. SUB-MODULE 5W0099) with Vibro-peen near the existing Part Number of No.2 Bearing support A/0. (Refer to Figure 1, and 1.K.(3)).
- (b) Mark the Serial Number with Vibro-peen adjacent to the new Part Number 5W0099 marked on the No.2 Bearing support A/0. (Refer to Figure 1, 1.K. (3), and 2.A. Note).

MARK NEW PN 5W0099 WHICH IS FOLLOWED BY LETTERS "SUB-MODULE" WITH VIBRO-PEEN NEAR THE EXISTING PN OF No.2 BEARING SUPPORT A/O IDENTIFIED HERE.

MARK THE SERIAL NUMBER SPECIFIED IN SECTION 2.A.NOTE, WITH VIBRO-PEEN ADJACENT TO NEW PN 5W0099.

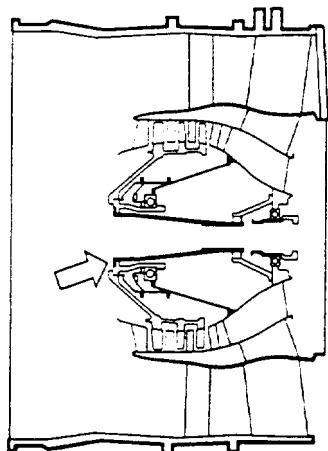
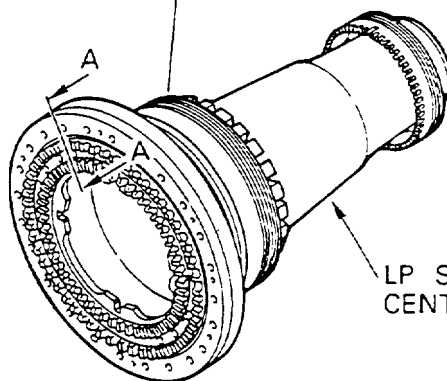
Marking of the Part Number and the Serial Number on LP Shaft, No.1 and No.2 Bearing
Assembly
Fig.2

MARKING IS NOT PERMITTED
ON THIS AREA.

- (a) Mark a new Part Number 5W0098 which is followed by the letters "SUB-MODULE" (i.e. SUB-MODULE 5W0098) with Vibro-peen near the existing Part Number of LPc Stub Shaft Rotor Center A/0 marked on its front surface. (Refer to Figure 2, and 1.K.(3)).
- (b) Mark the Serial Number with Vibro-peen adjacent to the new Part Number 5W0098 marked on the front surface of LP Stub Shaft Rotor Center A/0. (Refer to Figure 2, 1.K.(3), and 2.A. Note).

MARK NEW PN 5W0098 WHICH IS FOLLOWED
BY LETTERS "SUB-MODULE" WITH VIBRO-
PEEN NEAR THE EXISTING PN OF LP STUB
SHAFT ROTOR CENTER A/O IDENTIFIED
HERE. (See 2.A. (2). (a).)
MARK THE SERIAL NUMBER SPECIFIED IN
SECTION 2.A. NOTE, WITH VIBRO-PEEN
ADJACENT TO NEW PN 5W0098.
(See 2.A. (2). (b).)
