## SERVICE BULLETIN

ENGINE - LP TURBINE - DELETE THE MARKING REQUIREMENTS FOR THE STAGE 6 TURBINE DISK AND  
LP TURBINE SHAFT - CATEGORY CODE 6 - MOD.ENG-72-0067

V2500-ENG-72-0067

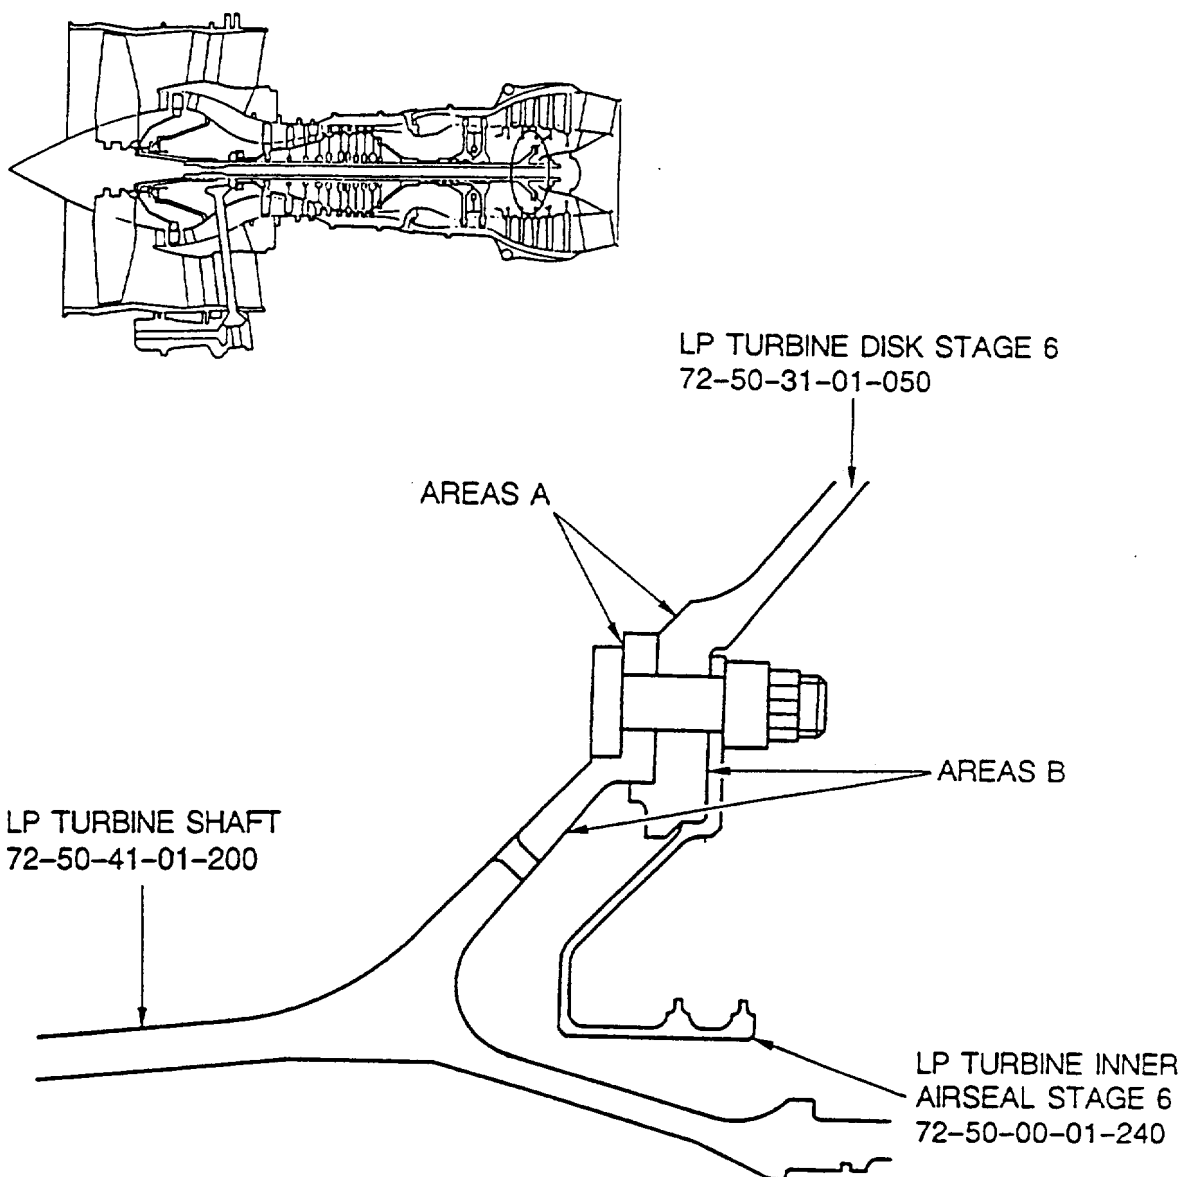
LP turbine shaft and LP turbine stage 6 disk - Position of correlation markings  
Fig.1

(1) The engine S/N's listed above have a correlation marking between the LP Turbine disk stage 6 and the LP Turbine shaft.

- (1) Identify the correlation marking on the LP Turbine disk stage 6. Refer to Figure 1.

NOTE: The correlation marking may be located on the front or rear side of the LP Turbine shaft connection flange.

- (1) Identify the correlation marking on the LP turbine shaft. Refer to figure 1.

NOTE: The correlation marking may be located on the front or rear side of the stage 6 LP Turbine disk connection flange.

- (3) Remove the correlation marking from the stage 6 LP Turbine disk. Refer to Engine Manual, Chapter 72-50-31, Repair 004 (VRS4157).

- (a) Polish out to remove correlation marking

Use hand held pneumatic grinder and abrasive stones or CoMat 05-020 abrasive paper or CoMat 05-021 abrasive paper.  
The surface finish of the repair must be same as the adjacent area. Polish until all correlation marking is removed.
