ENGINE - HPC SHAFT - INCREASED LIFE REAR SHAFT - CATEGORY CODE 6 - MOD.ENG-72-0068

V2500-ENG-72-0068

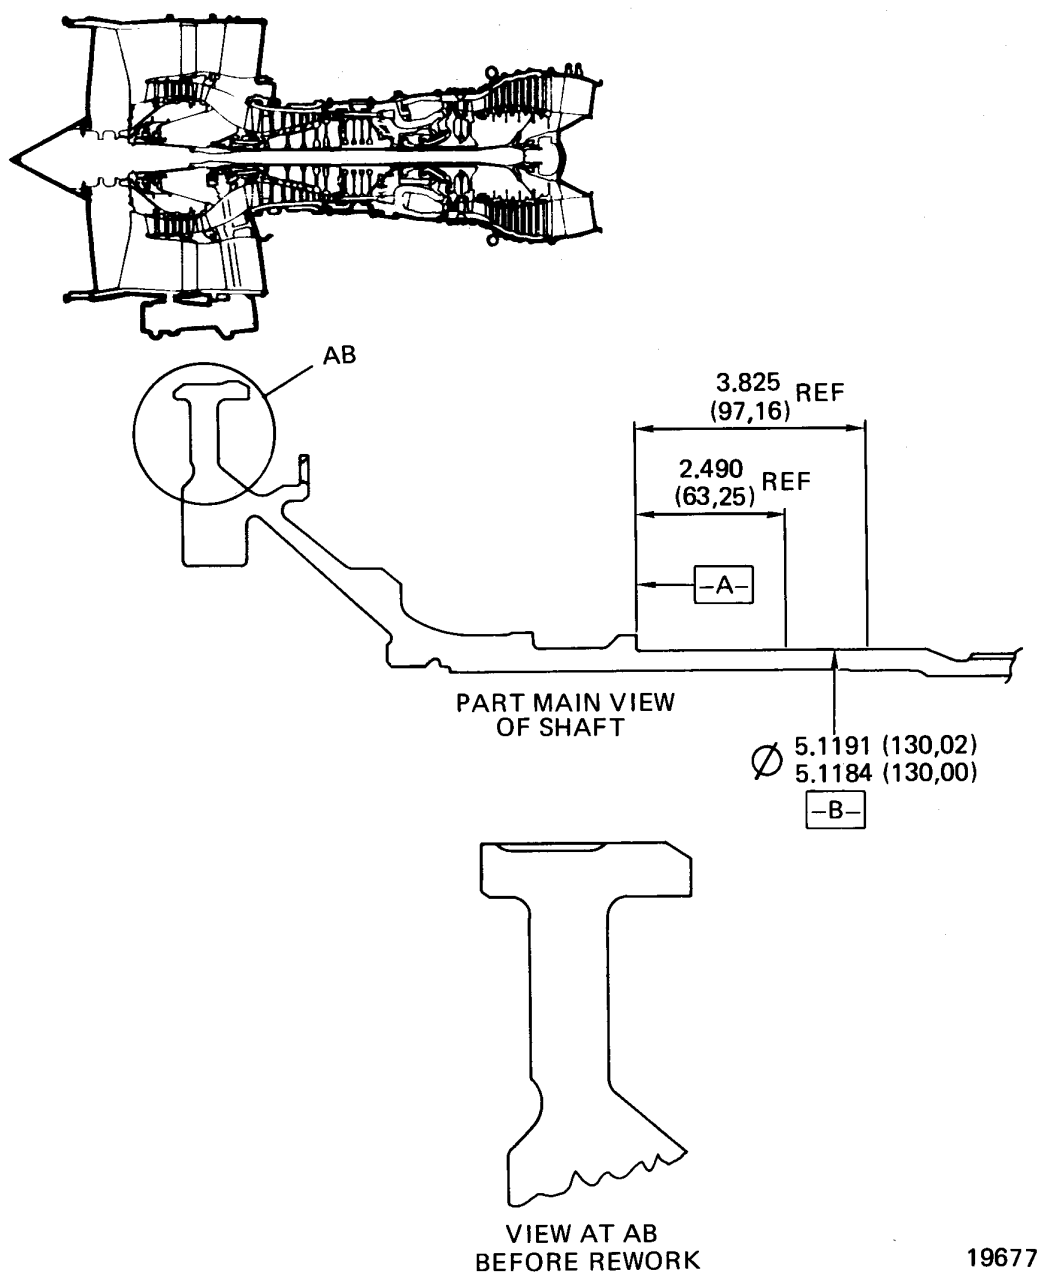
Modification of rear HP compressor shaft assembly
Fig.2 Sheet 1 of 2

(1) The cycle life limit for the HPC shaft is less than it could be, because of an overweight condition which can cause stress around the bolt holes in the mini-disk flange.

- (1) The axial length of the hammerhead on the mini-disk is reduced from the front face.
- (2) The hard coating on the mini-disk outside diameter is deleted.
- (3) A 40 degree chamfer is added to the front of the mini-disk.
- (4) The outside diameter of the mini-disk is decreased for a part of its length and the remainder has relaxed tolerances.

Procedure	Supplementary Information	
(a) Set-up and machine the outside diameter and the front axial face of the mini-disk at the locations specified	Refer to Figure 2, Sheets 1 and 2, requirements.	
(b) Make a mark adjacent to the old part number to show the new part number. Use the vibro peen method.	Old Part Number 2A1386	New Part Number 2A1990
	Refer to Reference (4), Control No./Task No. 70-09-00-400-501, Marking of Parts.
