## SERVICE BULLETIN

ENGINE - DIFFUSER AND COMBUSTION GROUP - REPLACE A NO.4 BEARING COMPARTMENT TUBE  
BRACKET (CP 5756) - CATEGORY CODE 4 - MOD.ENG-72-0072

V2500-ENG-72-0072

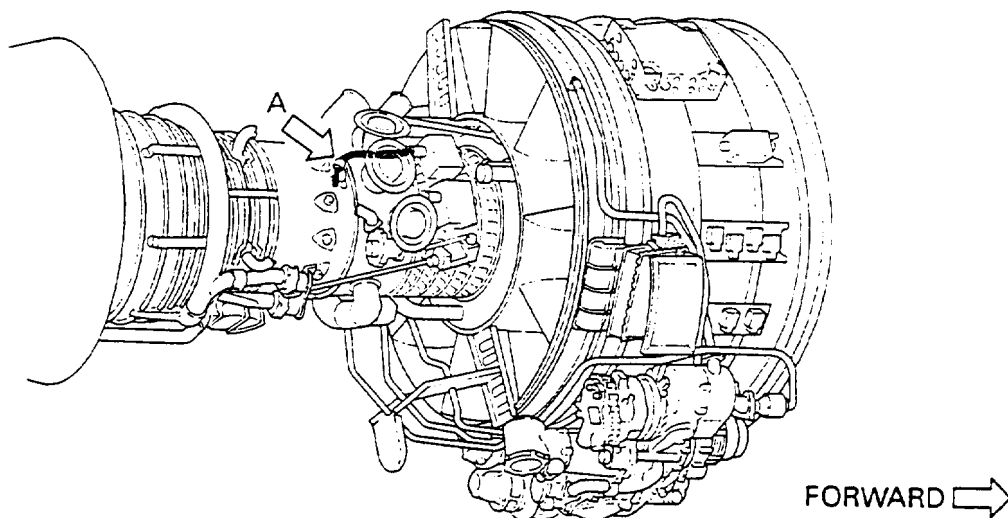
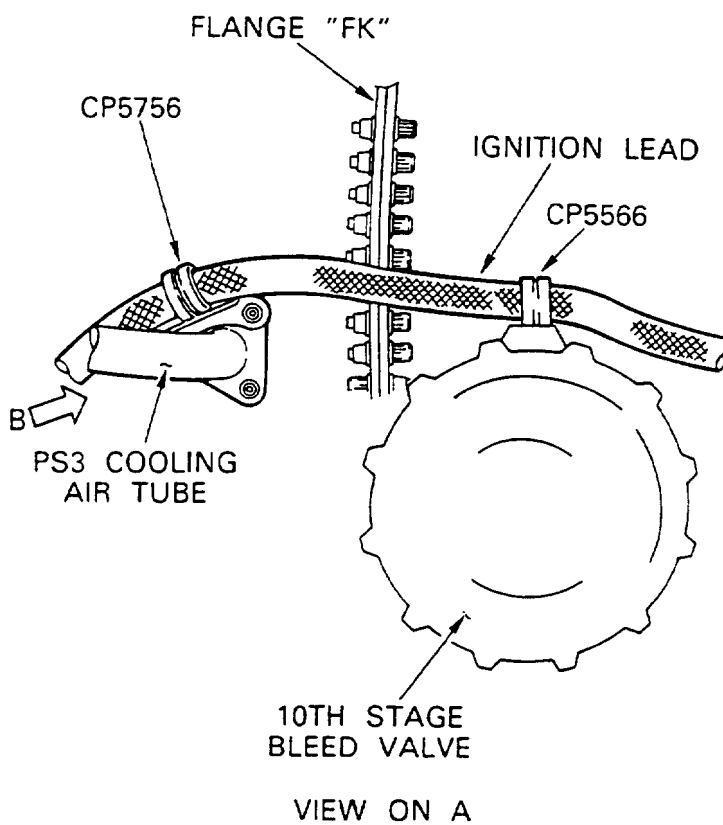
CLIPPING POINT 5756  
Fig.1 Sheet 1 of 2

Insufficient clearance may exist between the bolt at the clipping point 5756 and PS3 cooling air tube.

- (a) Find the clipping point 5756.

- (1) Remove 5W8368, Bracket (72-42-20, 06-255), refer to Figures 1 and 2.

- (1) Install 5W0103 Bracket (72-42-20, 06-255), refer to Figures 1 and 2.

- (b) Install the new bracket to the adapter on the diffuser case with two bolts (72-42-20, 06-250).
- (c) Torque the bolts to 65 to 85 lbfin (7,3 to 9,6 Nm).
- (d) Safety the three bolts with CoMat 02-141 lockwire.
- (2) Install the clip (74-21-43, 01-144) to the bracket.
  - (a) Install the clip, on the ignition lead at the clipping point 5756, to the bracket with the bolt (74-21-43, 01-141) and the washer (01-142).
  - (b) Torque the bolt to 36 to 45 lbfin (4 to 5 Nm).
