SERVICE BULLETIN

ENGINE - HP TURBINE - INCORPORATE AN IMPROVED TURBINE LOCK - CATEGORY CODE 5 -
MOD.ENG-72-0076

V2500-ENG-72-0076

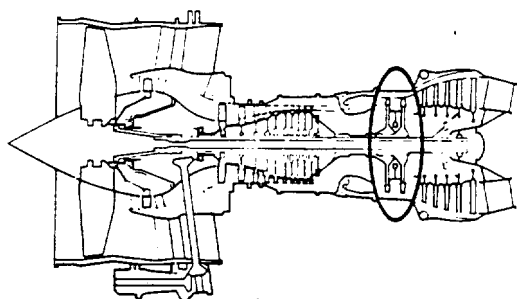
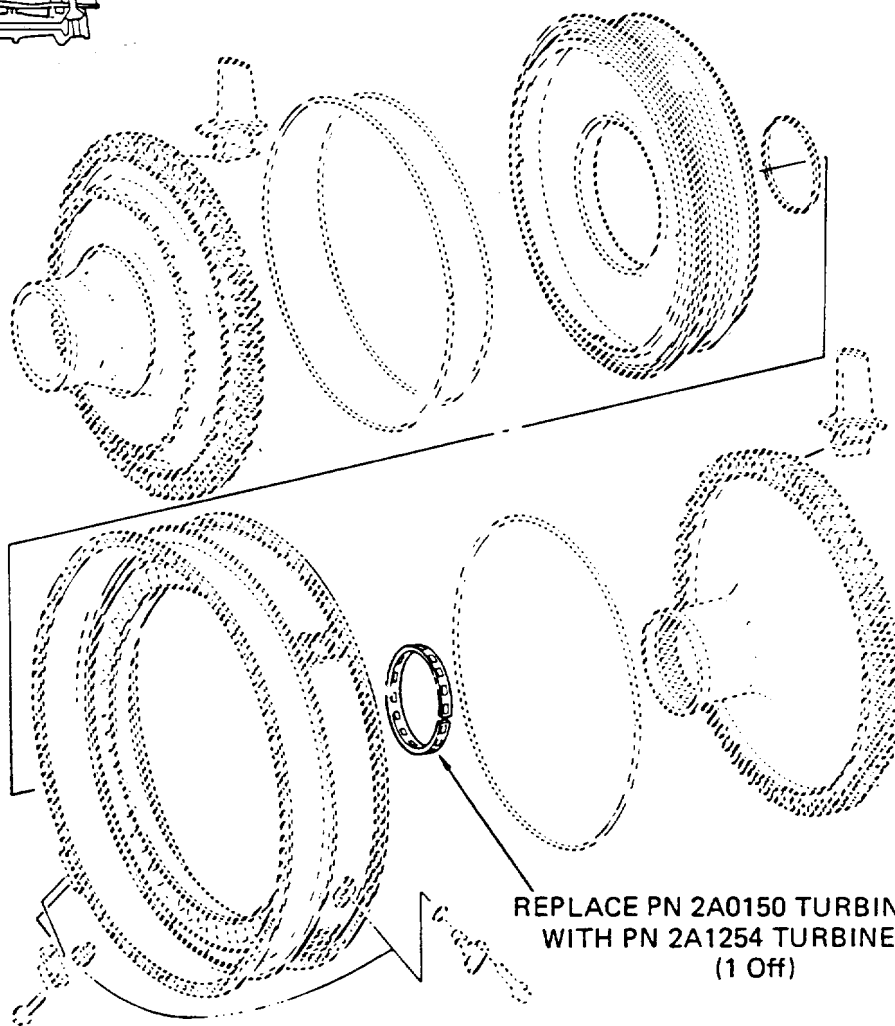
Location of HP Turbine Hub Lock
Fig.1

The stage 2 Turbine Hub may not adequately align with the HPC Shaft circumferentially. In such a case, pressure, used during the assembly of the HPC Shaft, could cause damage to the mating spline areas.

The present Hub Lock used to retain the Stage 1 and 2 Turbine Disks allows circumferential movement of the Stage 2 Turbine Hub. This movement, in some instances, can cause spline misalignment.

- (1) Remove 2A0150 Turbine Hub Lock by the approved procedures in Reference (1), Chapter/Section 72-45-00 Disassembly. See Figure 1.

- (1) Install 2A1254 Turbine Hub Lock (1 off) by the approved procedures in Reference (1), Chapter/Section 72-45-00 Assembly. See Figure 1.
