Subject: Transmittal of Revision 1 to Service Bulletin No. V2500-ENG-72-0079

ENGINE - HP COMPRESSOR - INTRODUCE A STRENGTHENED NO.4
BEARING BUFFER AIR TUBE BRACKET ASSEMBLY

V2500-ENG-72-0079

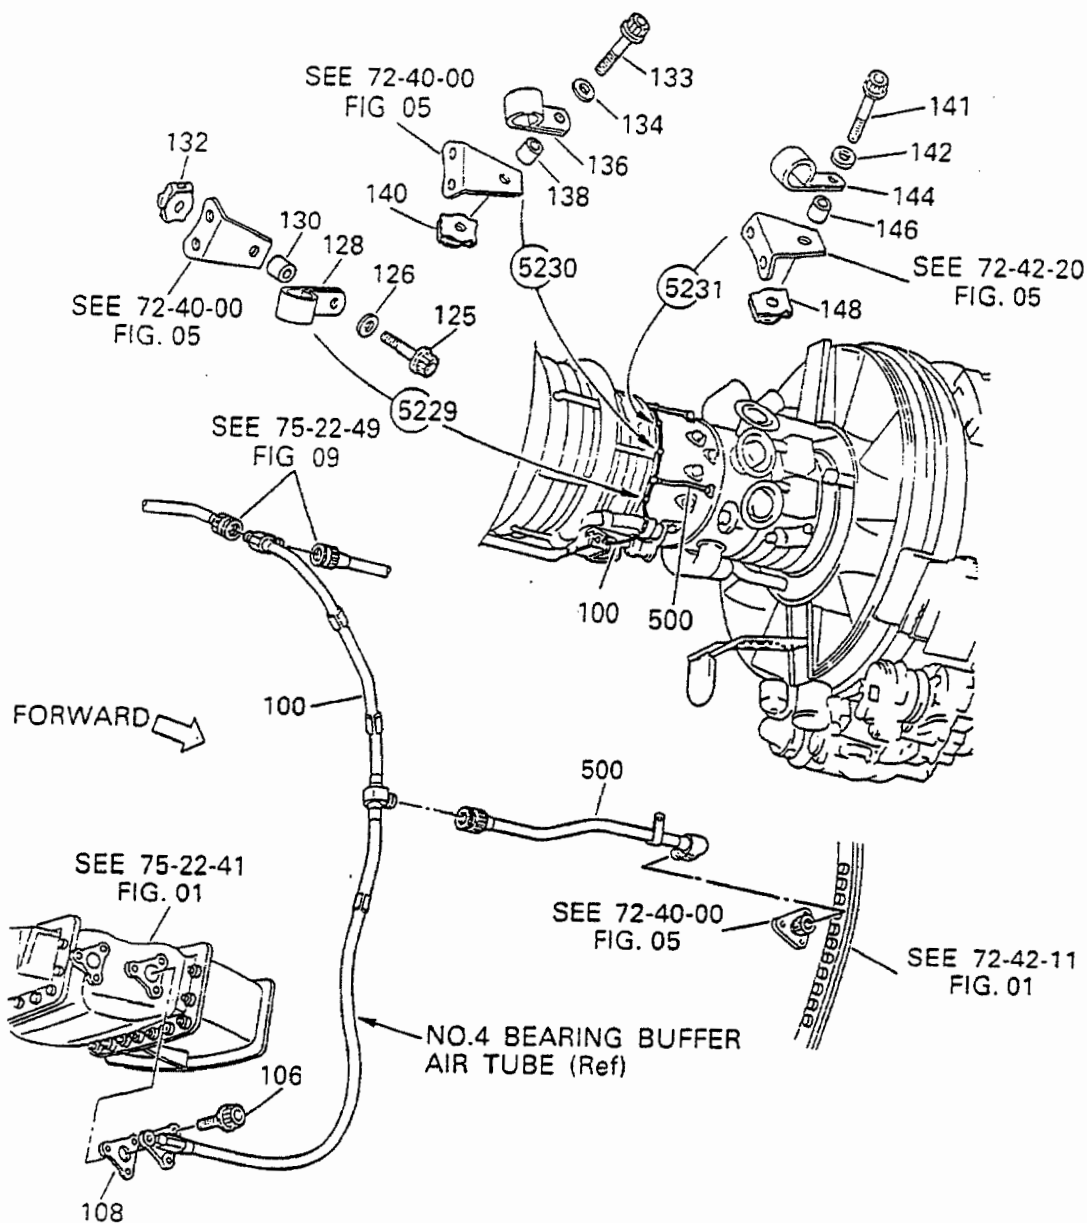
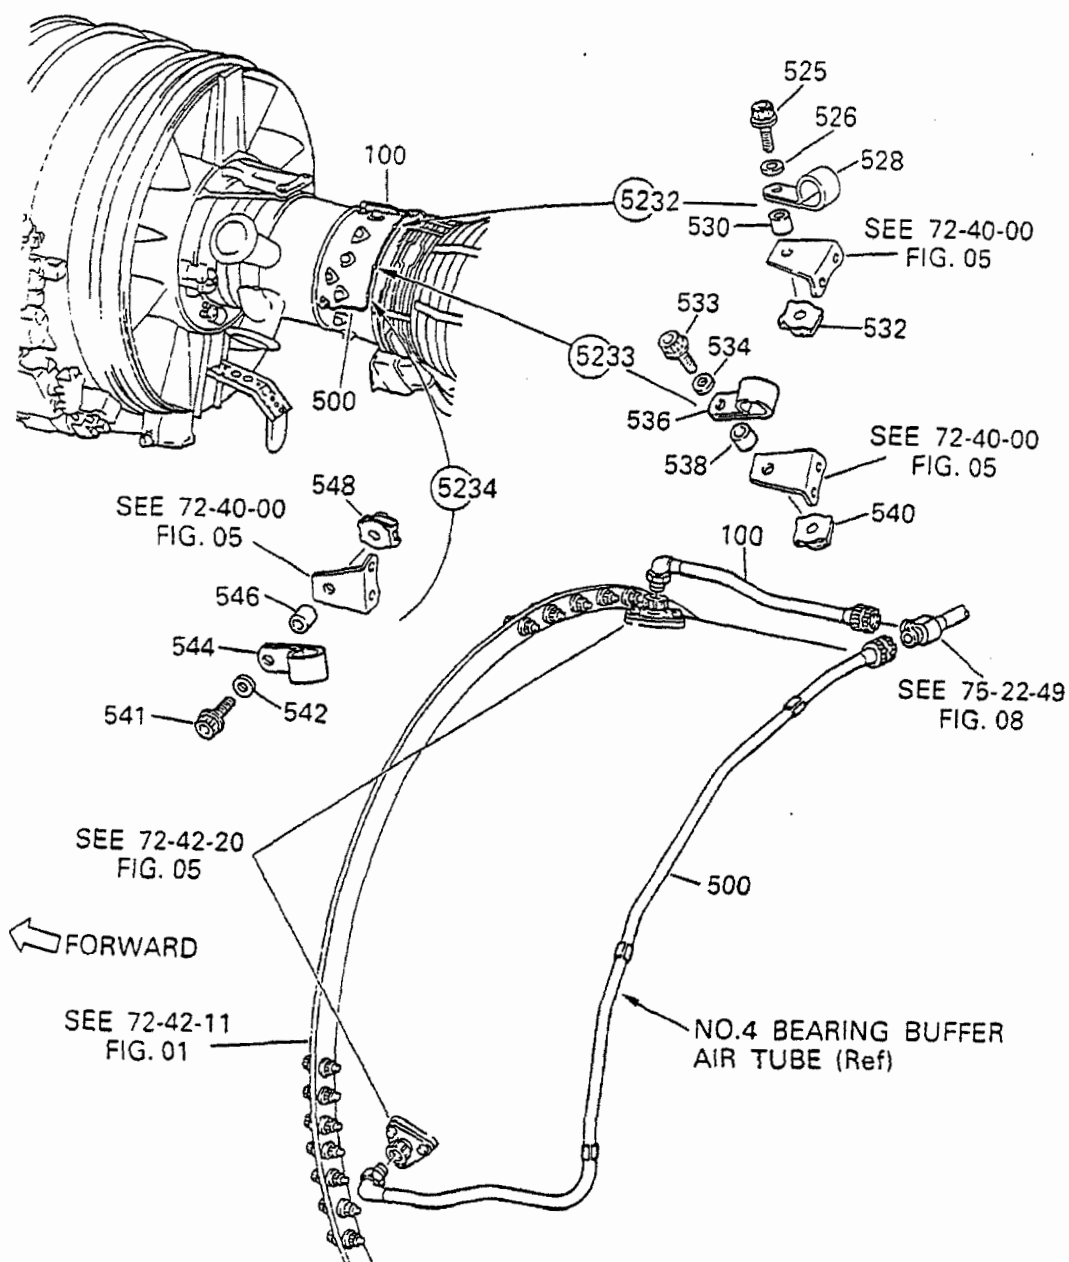
Figure 1, Sheet 2 of 2

Resonance could occur on No.4 Bearing Buffer Air Tubes which are held by the clipping Brackets at CP5229, CP5230, CP5231, CP5232, CP5233 and CP5234 and this could cause the wear of tubes at clipping points.

Location of No.4 Bearing Buffer Air Tubes and Clipping Positions
CP5229, CP5230, CP5231, CP5232, CP5233 and CP5234
Figure 1, Sheet 1 of 2

- (2) Install the No.4 Bearing Buffer Air Tubes to the HPC System Module as follows (Refer to Figures 1, 2 and I.K.(3)):
 - (a) Connect the No.4 Bearing Buffer Air Tubes and torque the tube Nuts by the approved procedures in the Engine Manual, 72-00-40, Installation, TASK 72-00-40-420-007.

- (b) At each of Clipping Positions CP5229, CP5230, CP5231, CP5232, CP5233 and CP5234, install the new 4W0103, Bolt, 5W1086, Washer, 5W1114, Clip 4W0043, Clip Nut to the Tube and the Bracket. Torque each Bolt to 36 to 45 lbfin (4,00 to 5,00 Nm).

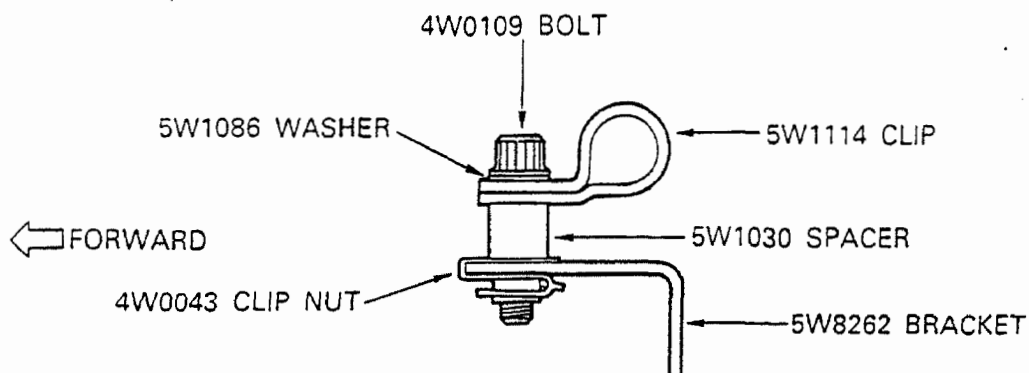
CLIPPING DETAIL AT CP5229, CP5230, CP5231, CP5232,
CP5233 AND CP5234 - BEFORE ALTERATION

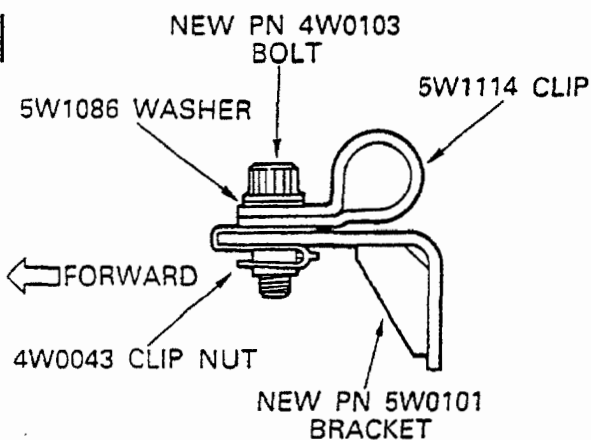
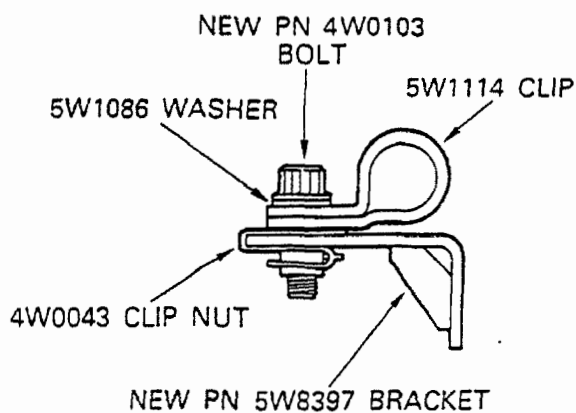
Clipping Detail at CP5229, CP5230, CP5231, CP5232, CP5233 and CP5234 -
Before and After Alteration
Figure 2

CLIPPING DETAIL AT CP5229, CP5230,
AND CP5231 - AFTER ALTERATION

CLIPPING DETAIL AT CP5232, CP5233,
AND CP5234 - AFTER ALTERATION

- (a) The existing six 5W8262, Brackets at the Flange FM are replaced with the three new 5W0101, Brackets with gussets and the three new 5W8397, Brackets with gussets to increase the strength of clipping Brackets (See Figure 3).
- (b) At each of clipping positions CP5229, CP5230, CP5231, CP5232, CP5233 and CP5234, the existing 5W1030, Spacer is deleted and also clipping Bolt is changed from 4W0109 to 4W0103 to decrease the length of Bolt (See Figure 2).

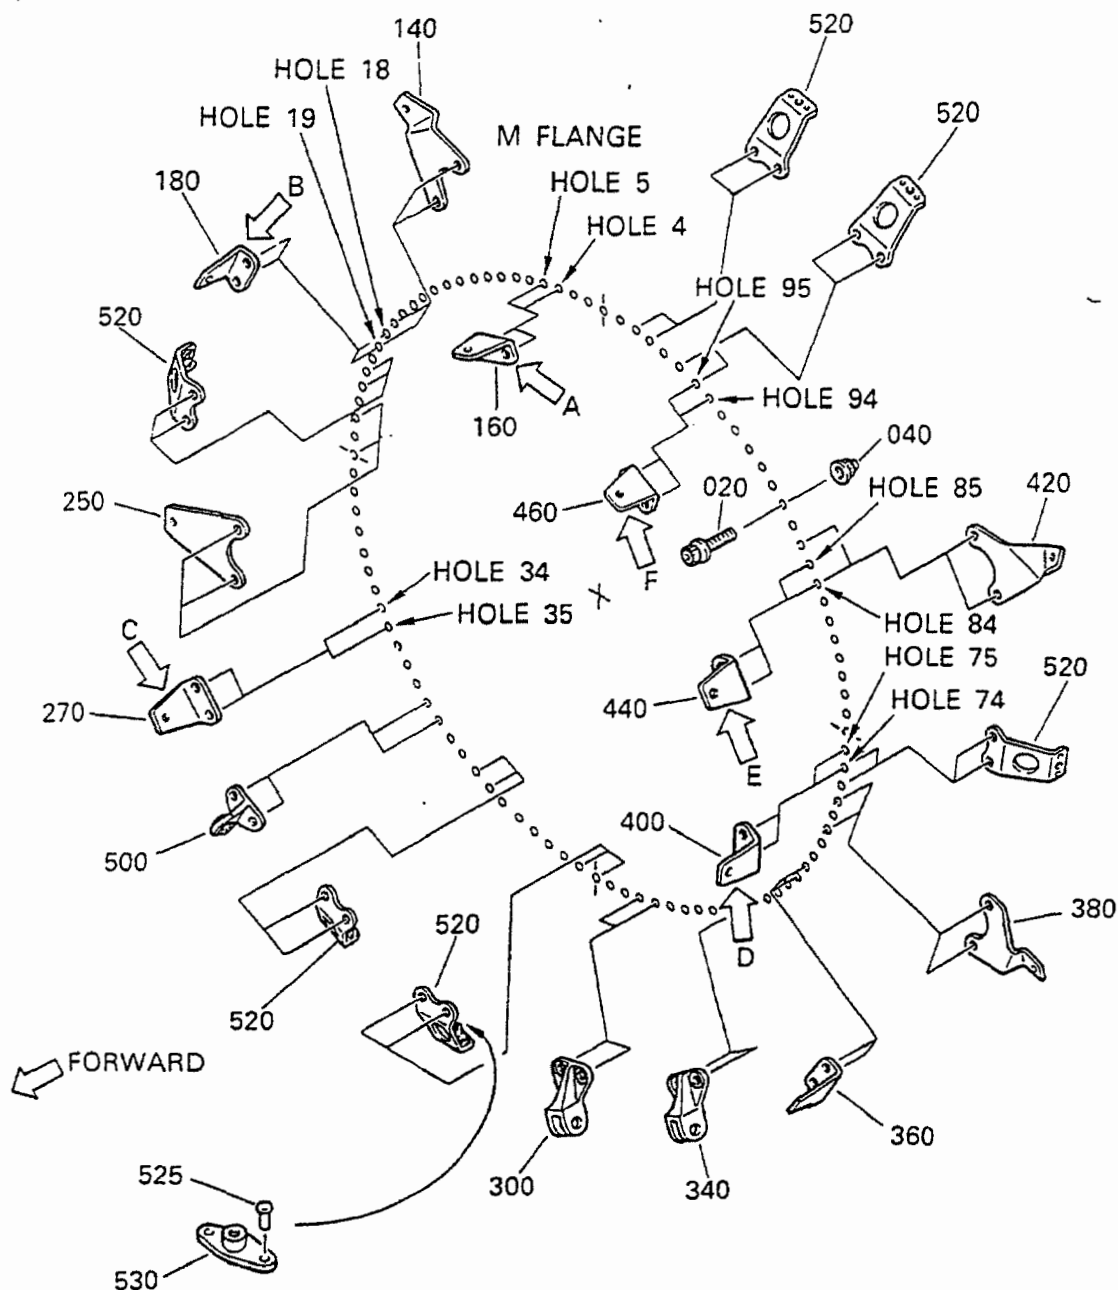
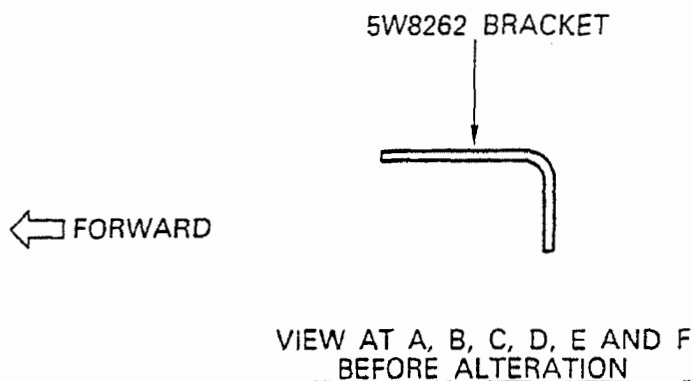
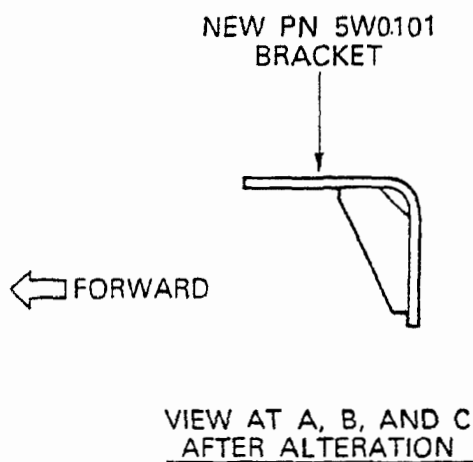
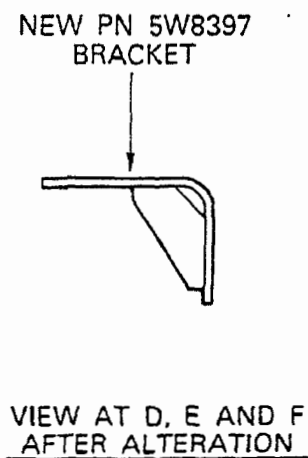
Clipping Brackets at Flange FM — Before and After Alteration
Figure 3 Sheet 1 of 2

- (1) Install the clipping Brackets to the Flange FM as follows (Refer to Figure 3 and I.K.(3)):
 - (a) At Flange hole No.4 and 5, attach the new 5W0101, Bracket with the two 4W0471, Bolts and 4W0003, Nuts.

- (b) At Flange hole No.18 and 19, attach the new 5W0101, Bracket with the two 4W0471, Bolts and 4W0003, Nuts.
 - (c) At Flange hole No.34 and 35, attach the new 5W0101, Bracket with the two 4W0471, Bolts and 4W0003, Nuts.

- (d) At Flange hole No.74 and 75, attach the new 5W8397, Bracket with the two 4W0471, Bolts and 4W0003, Nuts.
 - (e) At Flange hole No.84 and 85, attach the new 5W8397, Bracket with the two 4W0471, Bolts and 4W0003, Nuts.

- (f) At Flange hole No.94 and 95, attach the new 5W8397, Bracket with the two 4W0471, Bolts and 4W0003, Nuts.
 - (g) At Flange hole No.4, 5, 18, 19, 34, 35, 74, 75, 84, 85, 94 and 95, torque each Bolt to 180 to 220 lbfin (20,00 to 25,00 Nm).
