# SERVICE BULLETIN

ENGINE - HP COMPRESSOR - REPLACE A BRACKET AT FLANGE FJ - CATEGORY CODE 5 -  
MOD.ENG-72-0080

- (1) Aircraft: Airbus A320
- (2) Engine: V2500-A1 Engine, prior to Serial Number V0122

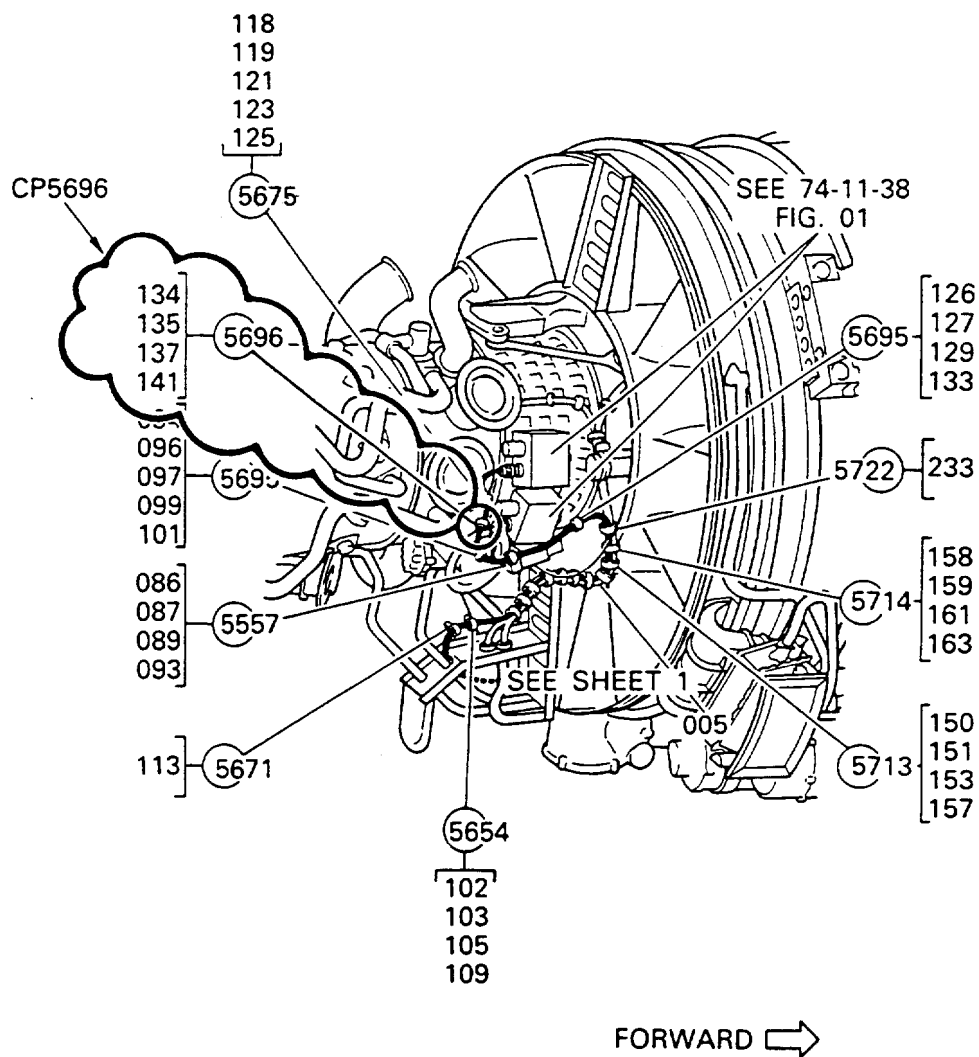
Location of Clipping Point CP5696  
Fig.1

There may be insufficient clearances between the EEC Core Harness Clamp at CP5696 and the 7th Stage Bleed Valve Duct, and also between the clipping Bracket at CP5696/CP5643 and the Stage 7 HPC Bleed Valve Air Tube because of inadequate Bracket location at Flange FJ.

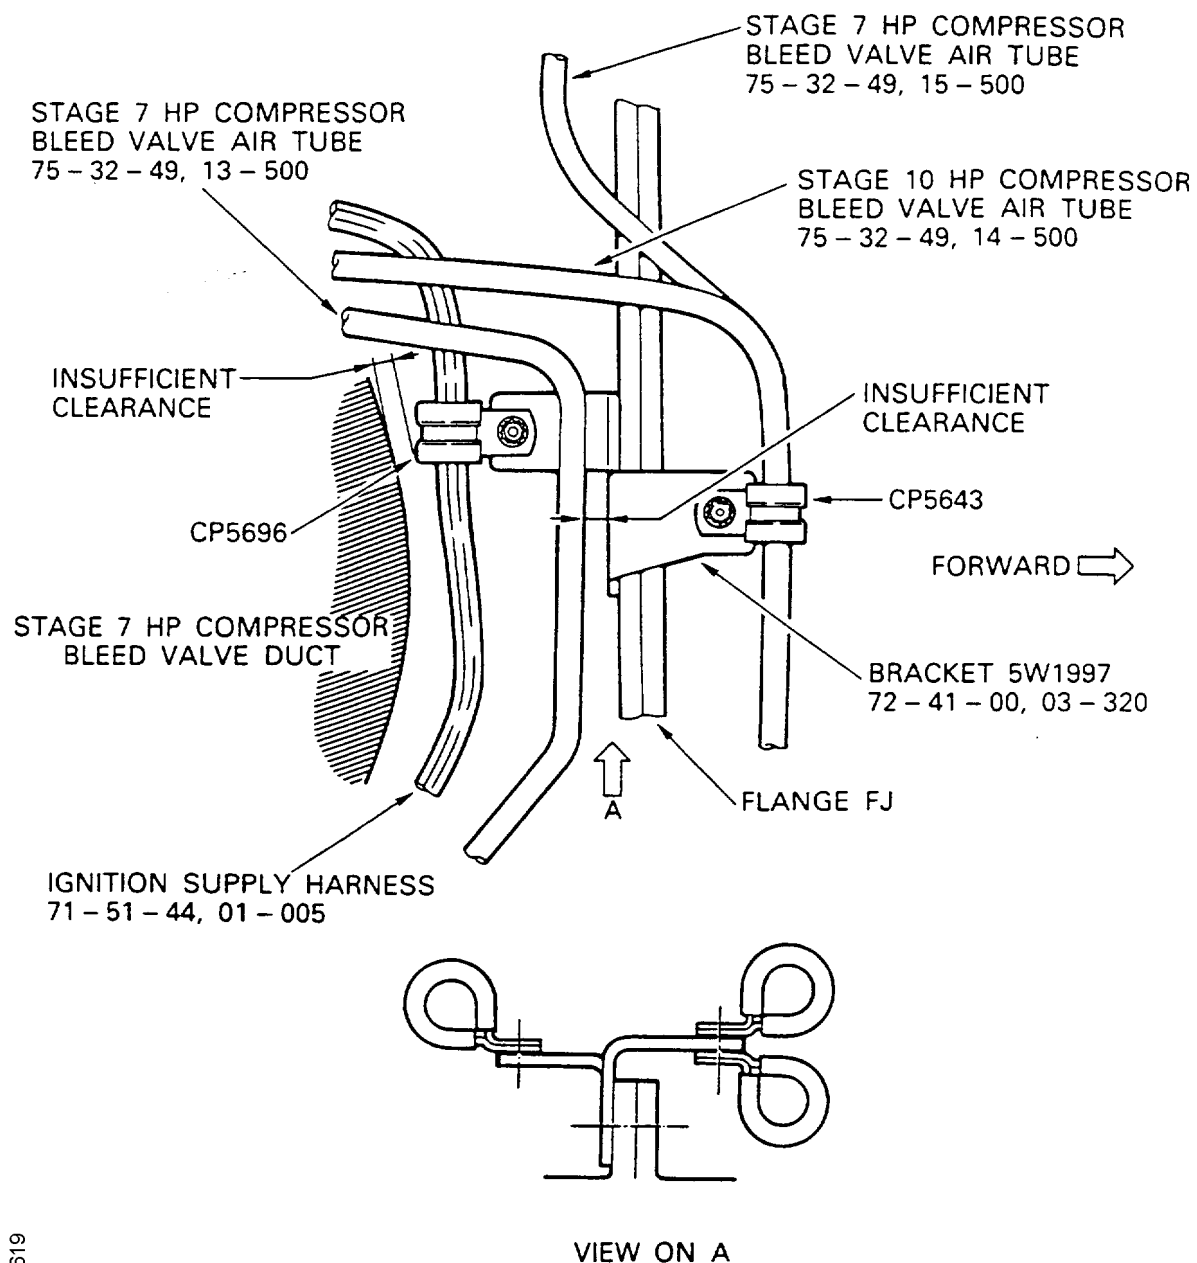
Details of the Bracket at Flange FJ - Before alteration  
Fig.2

This condition was noted during assembly of production engines. A review for the existing clipping Bracket at CP5696/CP5643 has shown the need for design change and relocation of the Bracket at Flange FJ.
