ENGINE - REPLACE AN960 SERIES WASHERS - CATEGORY CODE 6 - MOD.ENG-72-0081

V2500-ENG-72-0081

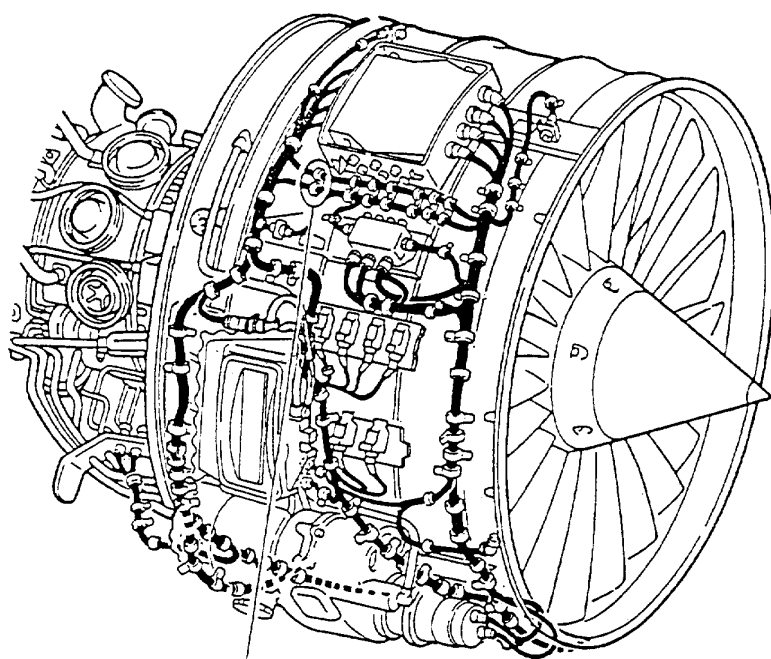
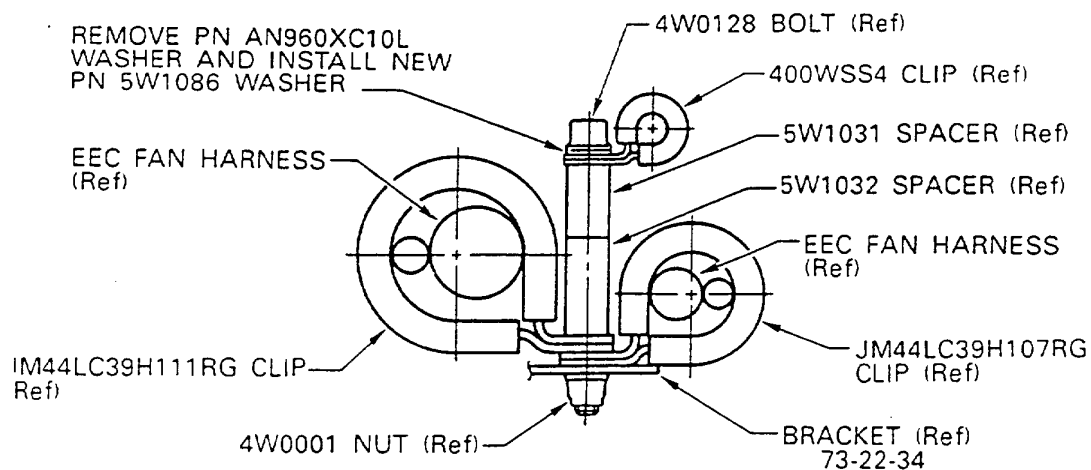
Replacement of Washer - EEC Fan Harness
Fig.1

- (a) At CP0796, AN960XC10L, EEC Fan Harness clipping Washer is replaced by 5W1086, Washer (see Fig.1).
 - (b) AN960C8, Washers which attach the EEC Core Harness to the NF Electrical Harness terminal are replaced by MS9321-08, Washers (see Fig.2).

- (1) At CP0796, install the new 5W1086, Washer, to the EEC Fan Harness by the approved procedures in the Engine Manual, 72-00-32, Installation, TASK 72-00-32-420-004. (Refer to Fig.1, and 1.K. References (1) and (2)).

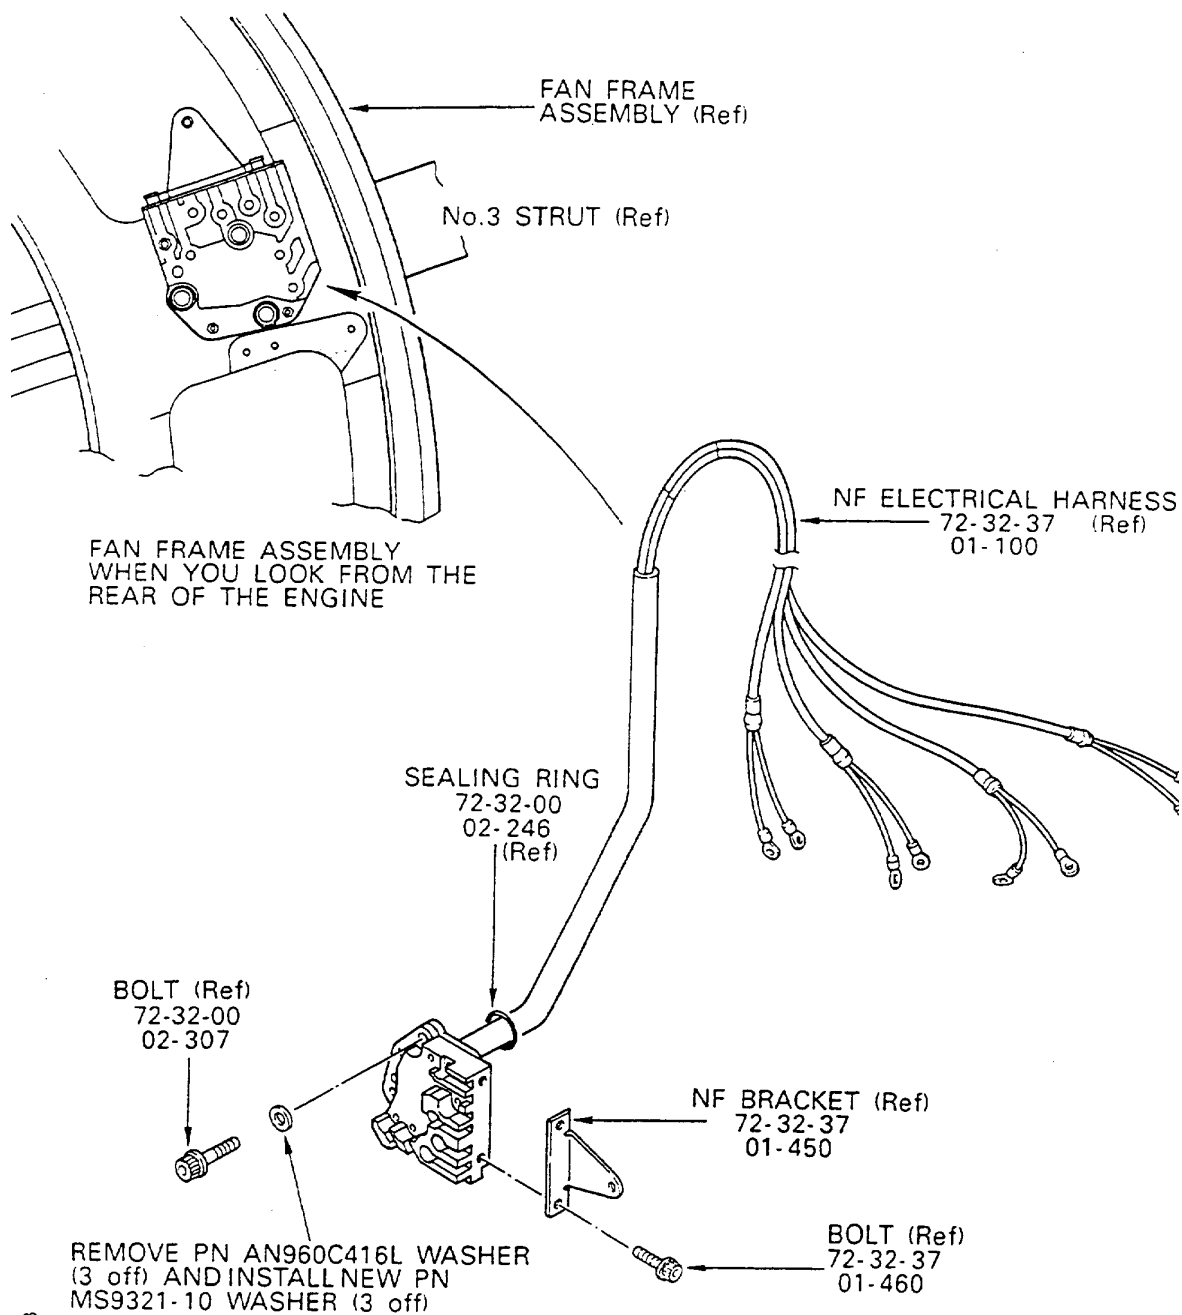
Replacement of Washers - LP Compressor/Intermediate Case Module
Fig.3

- (c) AN960C416L, Washers which attach the NF Electrical Harness to the Fan Frame Assembly are replaced by MS9321-10, Washers (see Fig.3).
 - (d) AN960C416, Washers which attach the No.1 and No.6 Struts Fairing Panels are replaced by MS9321-10, Washers (see Fig.4).

- (3) Install the three new MS9321-10, Washers, to attach the NF Electrical Harness to the Fan Frame Assembly by the approved procedures in the Engine Manual, 72-32-00, Assembly, TASK 72-32-00-430-004. (Refer to Fig.3, and 1.K. References (1) and (2)).

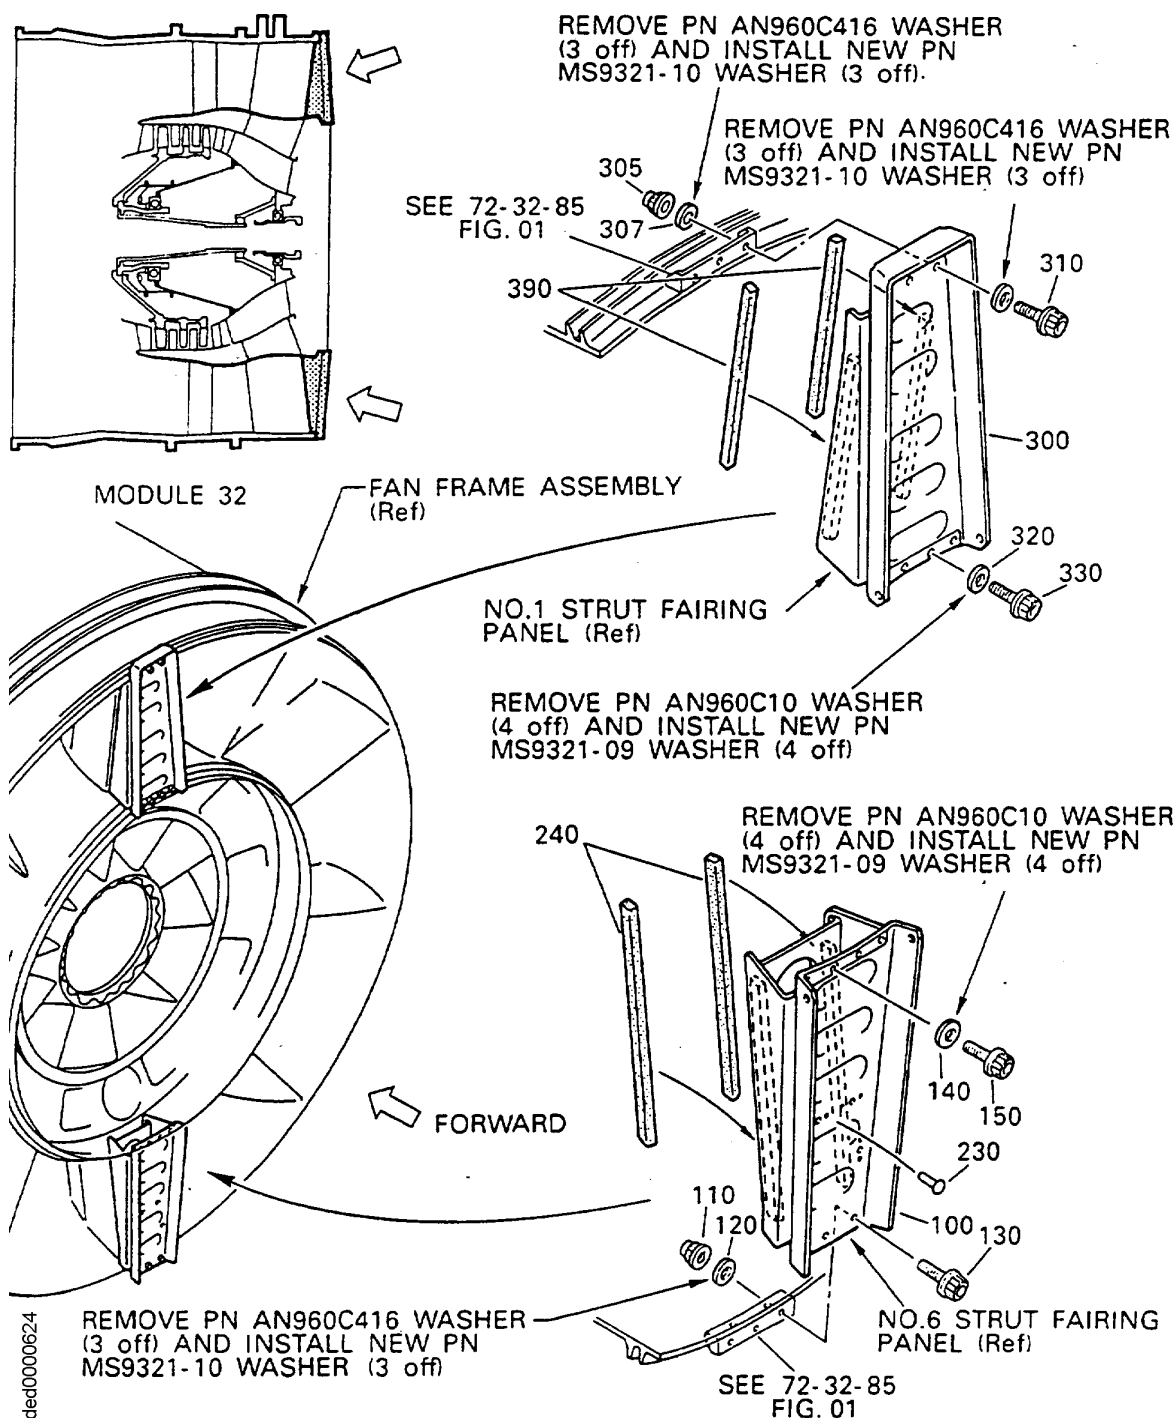
Replacement of Washers - Fan Frame Assembly
Fig.4

- (e) AN960C10, Washers which attach the No.1 and No.6 Struts Fairing Panels are replaced by MS9321-09, Washers (see Fig.4).
 - (f) AN960C416, Washers which attach the Oil Jet and Oil Supply Tube are replaced by MS9321-10, Washers (see Fig.5).

- (4) Install the four new MS9321-09, Washers and the three new MS9321-10, Washers to attach the No.6 Strut Fairing Panel to the Fan Frame Assembly, and install the four new MS9321-09, Washers, and each three new MS9321-10, Washers, to attach the No.1 Strut Fairing Panel to the Fan Frame Assembly, by the approved procedures in the Engine Manual, 72-32-00, Assembly, TASK 72-32-00-430-014. (Refer to Fig.4, and 1.K. References (1) and (2)).

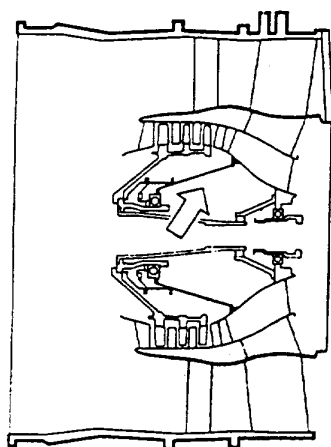
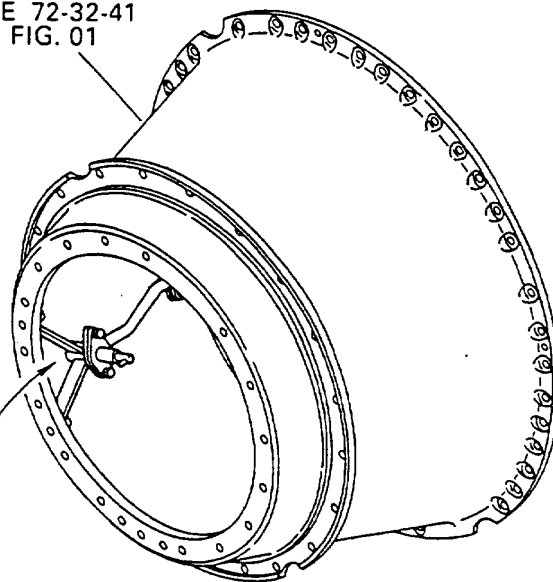
Replacement of Washers - Oil Jet and Oil Supply Tube
Fig.6

- (g) AN960C416, Washers which attach the No.1 Bearing Oil Jet are replaced by MS9321-10, Washers (see Fig.6).
 - (h) AN960C416, Washers which attach the Seal and the Seal Retainer are replaced by MS9321-10, Washers (see Fig.7).

- (6) Install the two new MS9321-10, Washer, to attach the No.1 Bearing Oil Jet to the Strainer Housing by the approved procedures in the Engine Manual, 72-32-40, Assembly, TASK 72-32-40-440-001. (Refer to Fig.6 and 1.K. References (1) and (2)).

REMOVE PN AN960C416 WASHER
(2 off) AND INSTALL NEW PN
MS9321-10 WASHER (2 off)

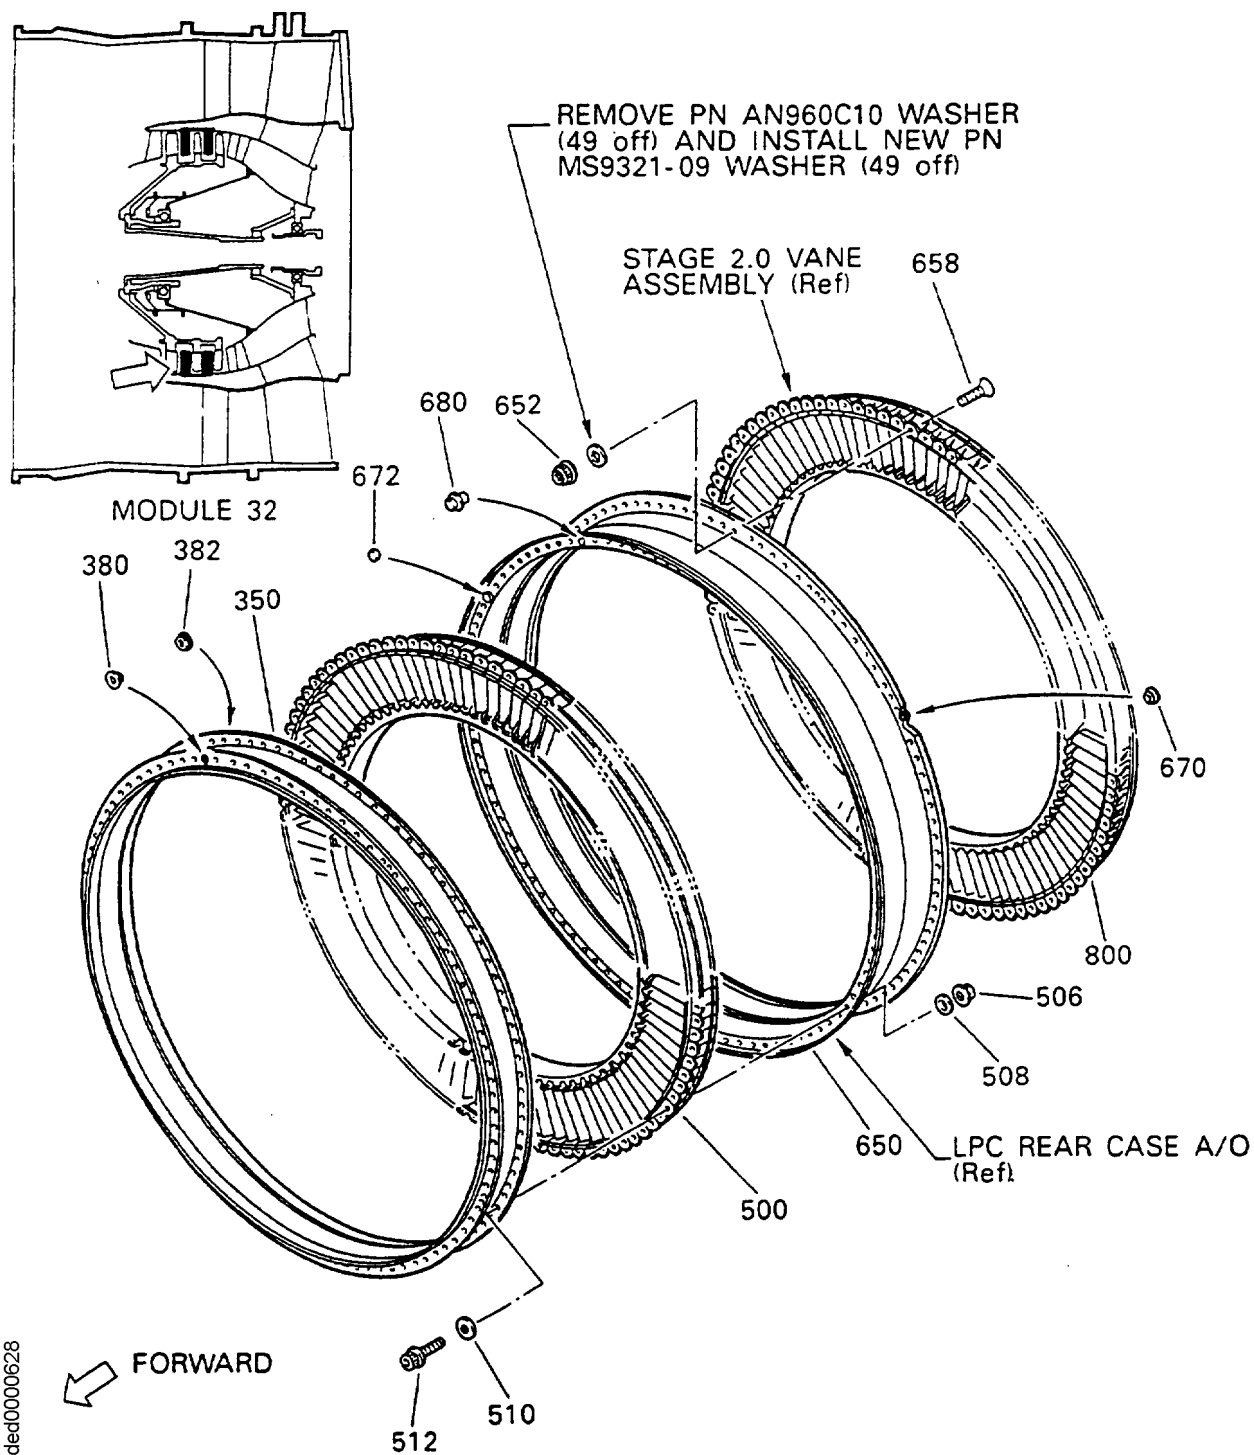
Replacement of Washers - LP Compressor Stage 1.5 and 2 Vanes
Fig.8

- (i) AN960C10, Washers which attach the LPC Rear Case A/O are replaced by MS9321-9, Washers (see Fig.8).
 - (j) AN960C416, Washers which attach the Fairing Panels supporting Brackets are replaced by MS9321-10, Washers (see Fig.9).

- (8) Install the forty nine new MS9321-09, Washers, to attach the LPC Rear Case to the LPC Stage 2.0 Vane Assembly the the approved procedures in the Engine Manual, 72-32-80, Assembly, TASK 72-32-80-040-001. (Refer to Fig.8, and 1.K. References (1) and (2)).

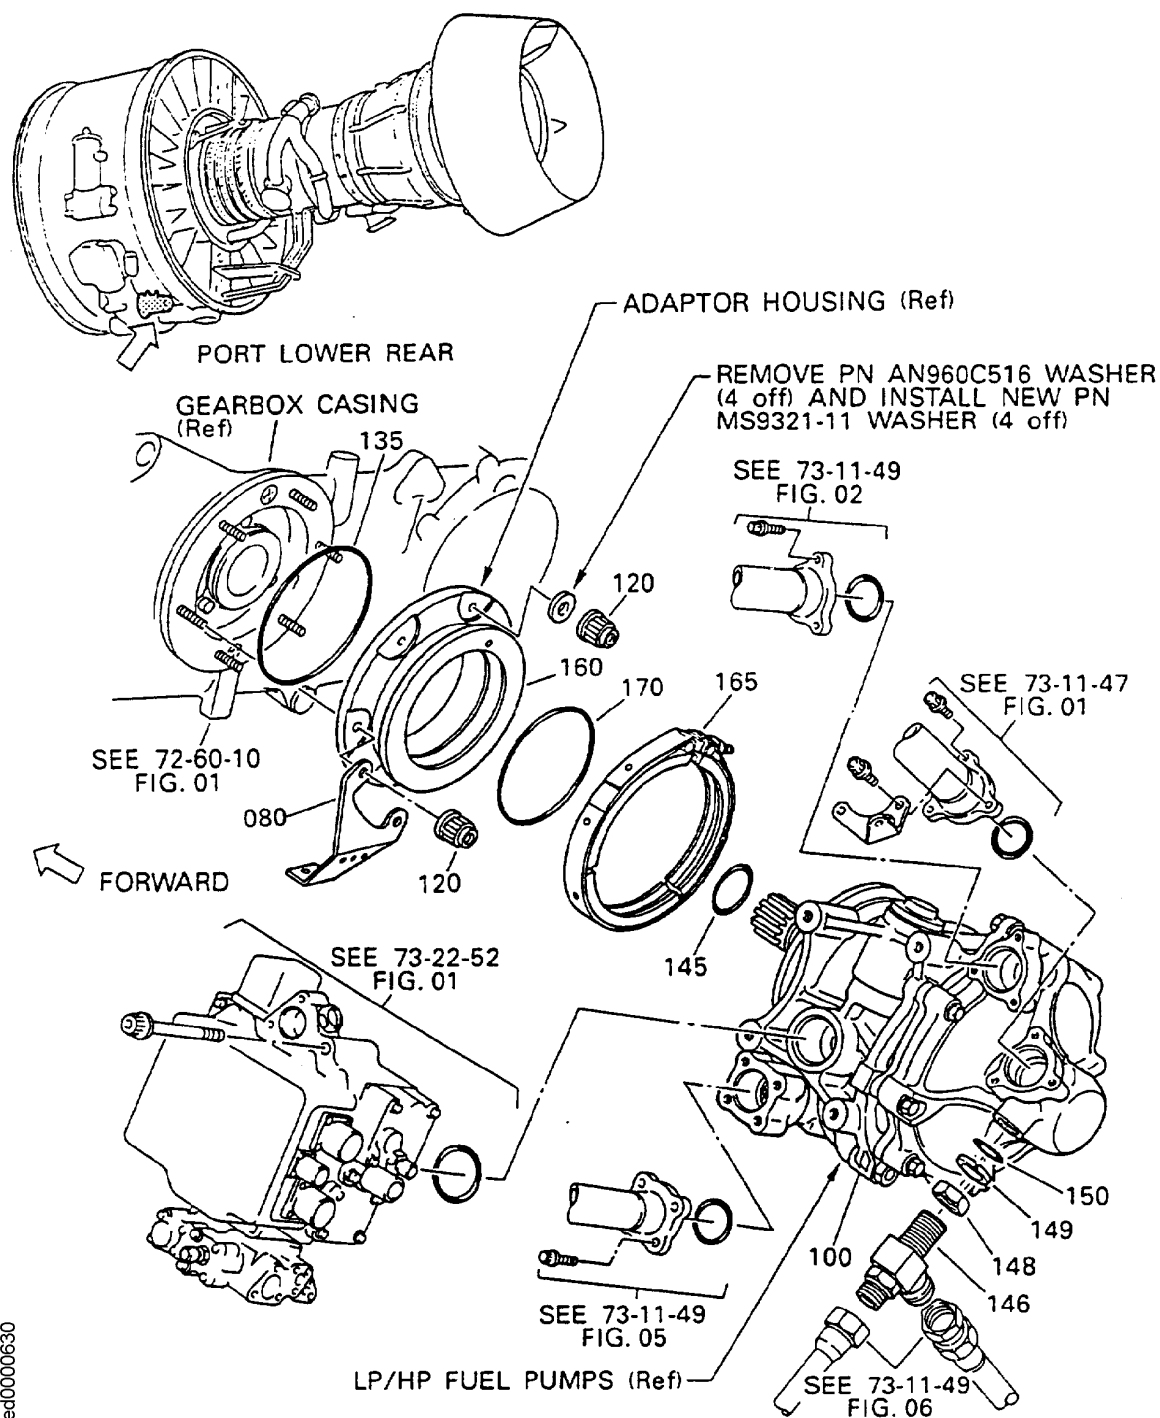
Replacement of Washers - LP/HP Fuel Pumps
Fig.10

- (k) AN960C516, Washers which attach the Adaptor Housing are replaced by MS9321-11, Washers (see Fig.10).

- (10) Install the four new MS9321-11, Washers, to attach the Adaptor Housing to the Gearbox Casing by the approved procedures in the Engine Manual, 72-00-60, Installation, TASK 72-00-60-420-001-002. (Refer to Fig.10, and 1.K. References (1) and (2)).

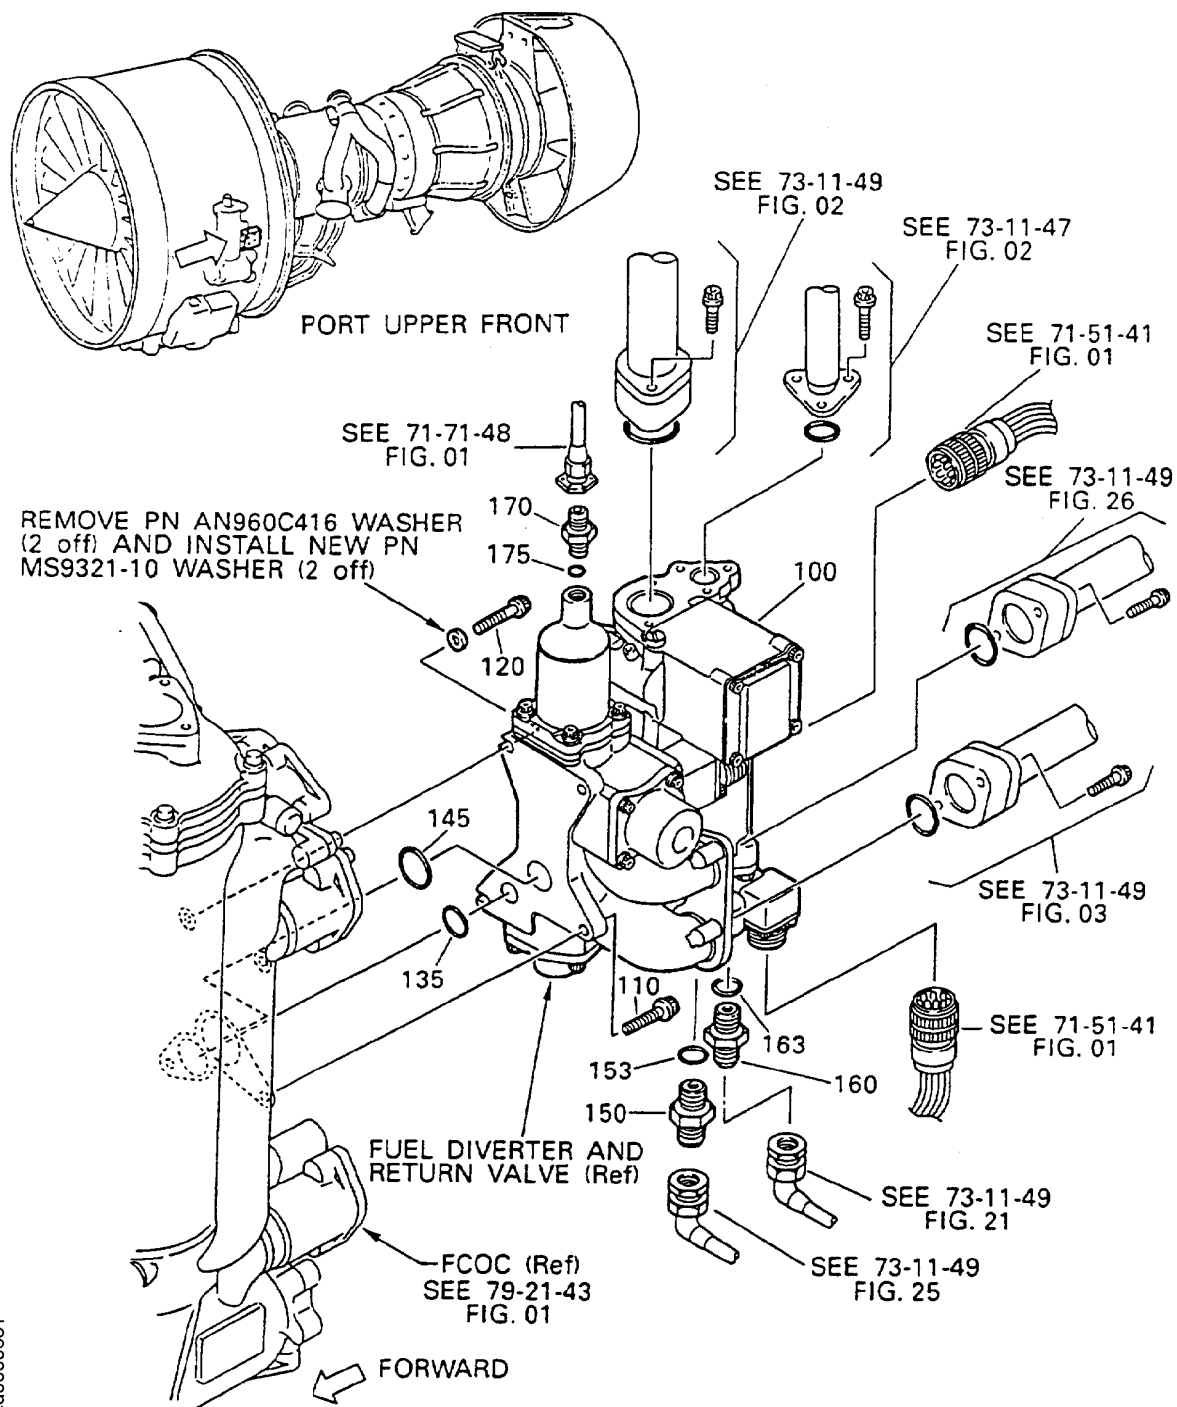
Replacement of Washers - Fuel Diverter and Return Valve
Fig.11

- (l) AN960C416, Washers which attach the Fuel Diverter and Return Valve are replaced by MS9321-10, Washers (see Fig.11).
- (m) At CP1026, AN960XC10, Fuel System Air Tube clipping Washer is replaced by 5W1086, Washers (see Fig.12).
- (n) AN960C416, Washers which attach the Brackets on Air Cooled Oil Cooler (ACOC) are replaced by MS9321-10, Washers (see Fig.13).
- (o) AN960C416, Washers which attach the Bracket on ACOC and Inlet duct are replaced by MS9321-10, Washers (see Fig.13).
- (p) AN960C416, Washers which attach the Fuel Cooled Oil Cooler (FCOC) Cap are replaced by MS9321-11, Washers (see Fig.14).

- (11) Install the two new MS9321-10, Washers, to attach the Fuel Diverter and Return Valve to the Fuel Cooled Oil Cooler (FCOC) by the approved procedures in the Engine Manual, 72-00-32, Installation, TASK 72-00-32-420-002. (Refer to Fig. 11, and see 1.K. References (1) and (2)).
