ENGINE - LP COMPRESSOR - REWORK THE NO.1 BEARING SEAL ASSEMBLY TO INCORPORATE A REVISED SLEEVE SPACER AND RETAINING COLLAR - CATEGORY CODE 6 - MOD.ENG-72-0082

V2500-ENG-72-0082

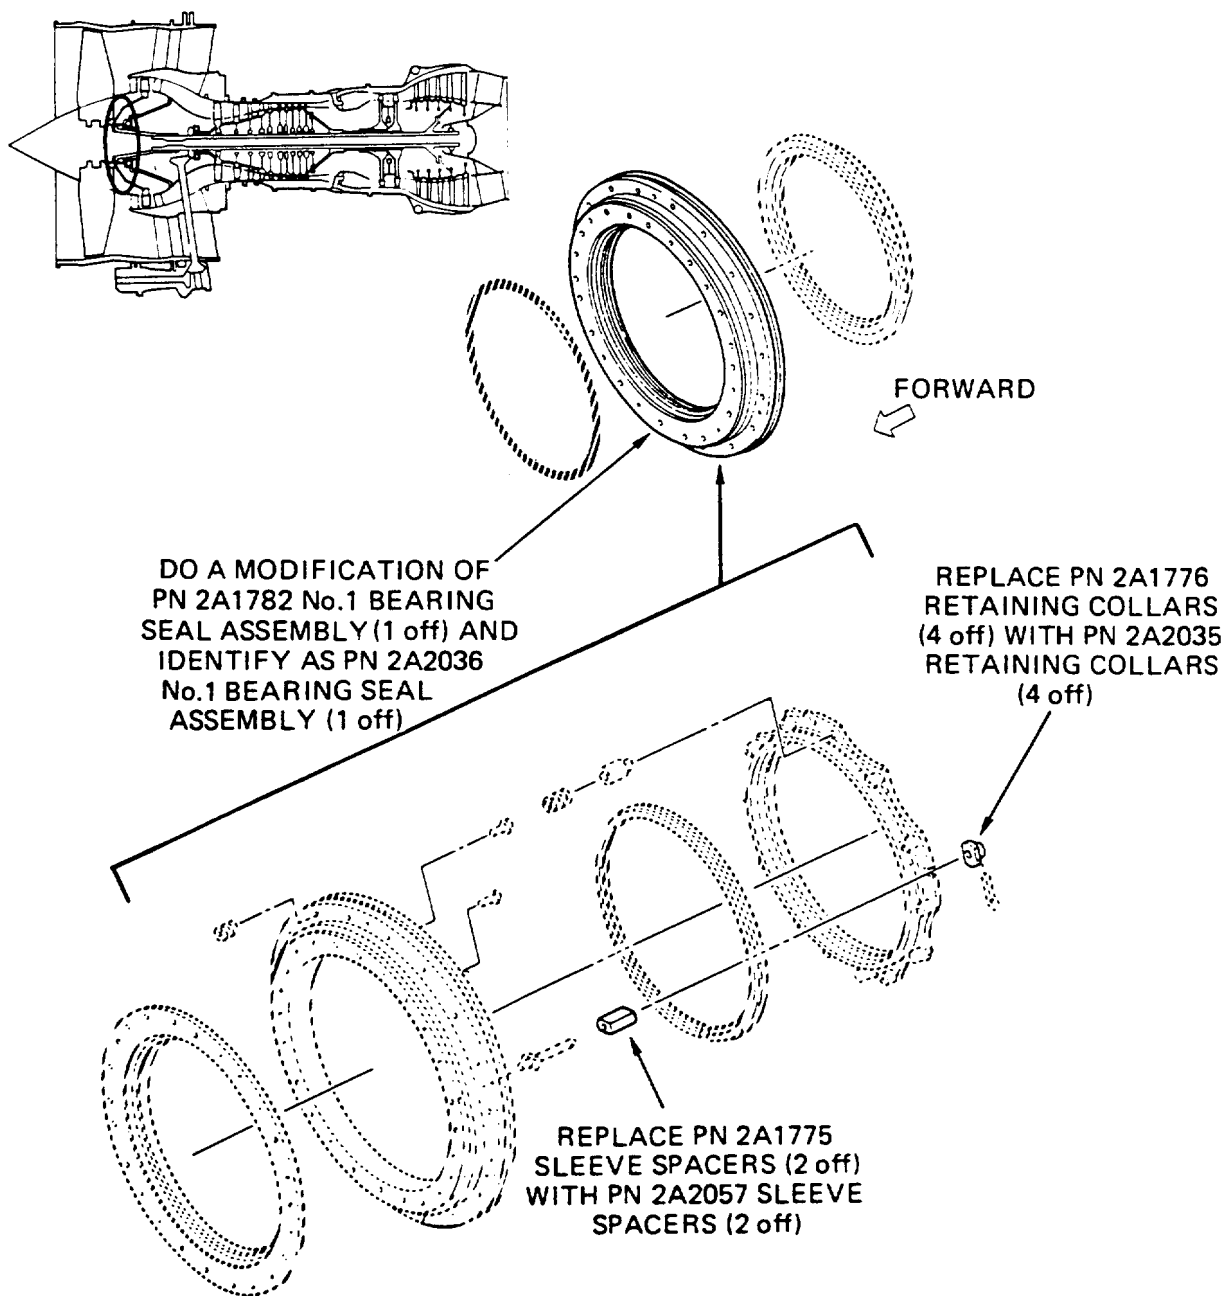
Location of No.1 Bearing Seal Assembly
Fig.1

When the parts are in a free state, the No.1 Carbon Seal Assembly Piston Ring is riding in the carbon carrier chamfer, instead of the sealing land. This can cause chipping of the Carbon Nose or an improperly seated carbon seal at assembly.

The original Retaining Collar for the No.1 Bearing Carbon Seal Carrier Retaining Pin was not long enough. Collar length could only be increased 0.040 inch (1.016 mm.) because of design requirements. At extreme conditions, when the parts were assembled, the No.1 Bearing Carbon Seal Assembly was found to be improperly seated.

- (1) A new longer Retaining Collar and a new Sleeve Spacer are provided to decrease the possibility that the No.1 Bearing Carbon Seal will seat improperly.

- (1) Assemble the No.1 Bearing Seal Assembly by Figure 1 and approved procedure in Reference (1), Chapter/Section 72-32-53, except:
 - (a) Install 2A2057 Sleeve Spacers (2 off) on the two pins that are almost 90 degrees from both sides of the offset pin.
 - (b) Install 2A2035 Retaining Collars (4 off) on the pins.
- (2) Identify 2A1782 No.1 Bearing Seal Assembly as 2A2036. Refer to Reference (2), Chapter/Section 70-09-00, Marketing of Parts. Use the vibration peen method.
