SERVICE BULLETIN

ENGINE - LP COMPRESSOR - BIFURCATION PANEL - INCORPORATION OF NEW SEALING PROCESS -
CATEGORY CODE 6 - MOD.ENG-72-0083

V2500-ENG-72-0083

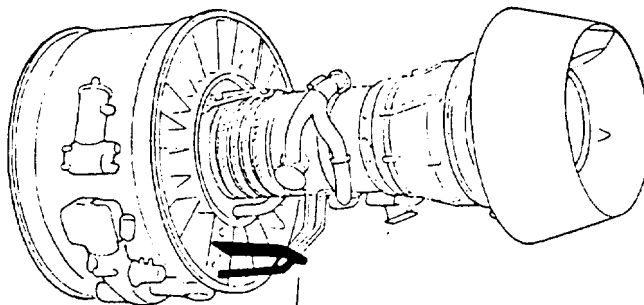
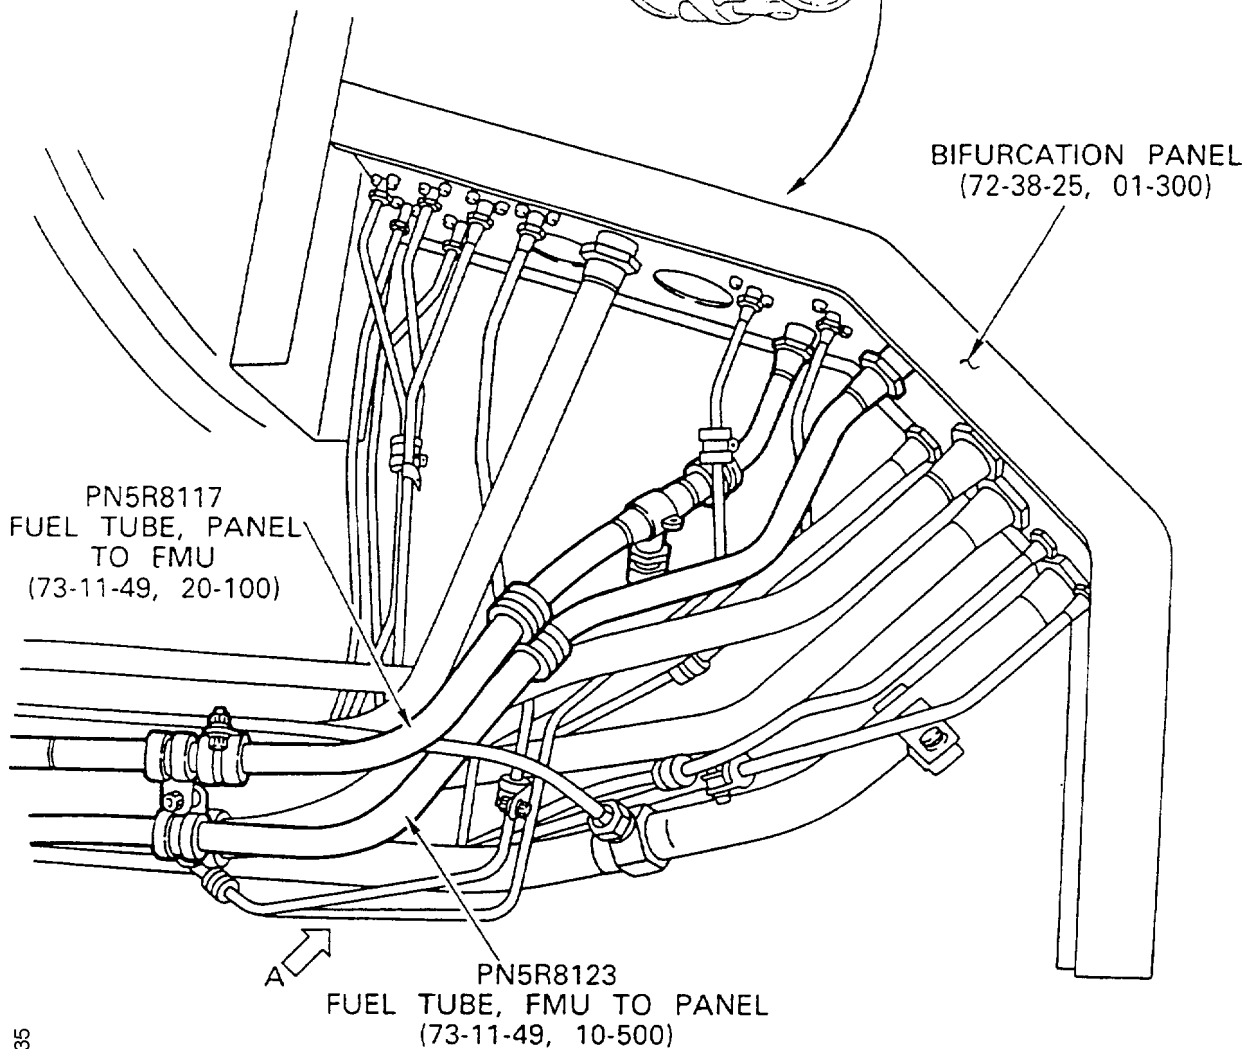
Incorporation of new sealing process
Fig.1(Sheet 1 of 4)

Unnecessary clearances may exist between the bifurcation panel and the fuel supply and return tube connectors.

Procedure	Supplementary Information
(1) Find the fuel supply and return tube connectors	Refer to fig.1 Sheets 1 and 2
(2) Clean the surface of areas A, B, C and D on the bifurcation panel	Refer to fig. 1 Sheet 3. Use clean cloth or soft brush made moist with CoMat 01-076 methylethylketone CH ₃ COC ₂ H ₅
