### SERVICE BULLETIN

# <u>ENGINE - H.P. COMPRESSOR VARIABLE STATOR VANES - REDUCED NUMBER OF RIGGING PIN BRACKETS</u> - CATEGORY CODE 7 - MOD.ENG-72-0084

(1) Aircraft: Airbus A320

(2) Engine: V2500-A1 Engines prior to Serial No.V0242

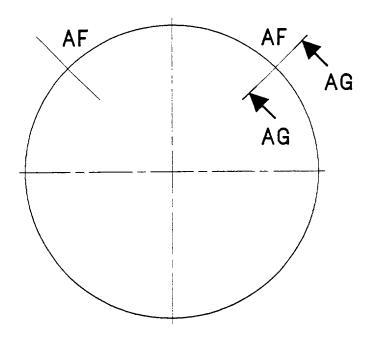
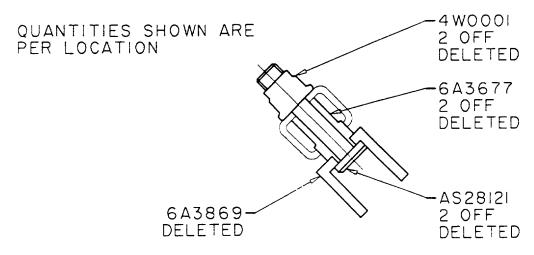
Section AG at 2 positions AF showing VIGG rig pin brackets before and after alteration Fig.3

The two rigging pin brackets located on the upper half unison rings at the V.I.G.V. stage and at stages 4 and 5 are deleted. At stage 3, one bracket is deleted from each of the half rings. The associated hollow dowels and bolts for securing the brackets are no longer required.

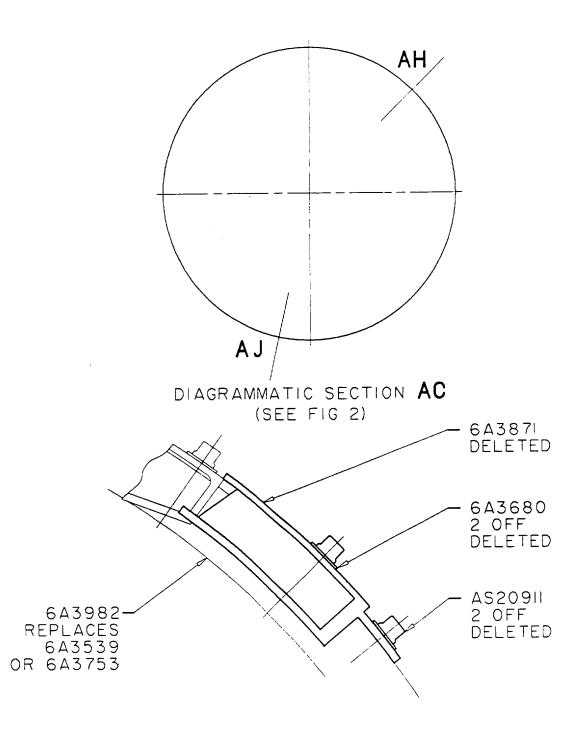
View at AH showing rig pin bracket before and after alteration Fig.4  $\,$

The bracket assemblies within the stages 3 and 4 unison rings which were required to retain the rigging pin bracket bolts are deleted. On the stage 5 ring the two existing brackets are replaced by shorter brackets.
