ENGINE - HP TURBINE ROTOR AND STATOR ASSEMBLY - PROVIDE NEW STAGE 2 DUCT SEGMENTS INCORPORATING REVISED COATING REQUIREMENTS - CATEGORY CODE 7 - MOD.ENG-72-0085

V2500-ENG-72-0085

SERVICE BULLETIN

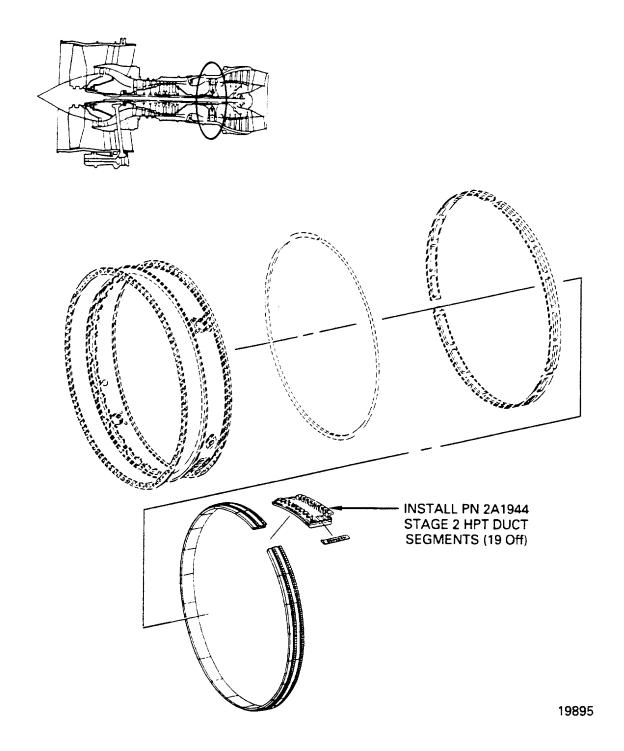
Location of stage 2 HPT duct segments Fig.1

Erosion and Spalling of the current Stage 2 HPT Duct Segments can cause blade tip gap unacceptable measurements.

It has been determined that erosion and spalling can occur on the duct segments when the coating becomes worn.

- A. Rework Instructions
- (1) There are no rework instructions necessary for this Service Bulletin.
- B. Assembly Instructions
 - (1) Replace the 2A0108 Stage 2 HPT Duct Segments with 2A1944 Stage 2 HPT Duct Segments (19 off) by the approved procedure in Reference (2), Chapter/Section 72-45-20, Assembly-02.

NOTE: The new Stage 2 HPT Duct Segments must be replaced in complete sets only. Do not mix the new segments with the old segments.
