ENGINE - NO.4 BEARING COMPARTMENT - INTRODUCE A NEW HEATSHIELDED NO.4 BEARING SCAVENGE  
TUBE ASSEMBLY - CATEGORY CODE 5 - MOD.ENG-72-0087

**V2500–ENG–72–0087**

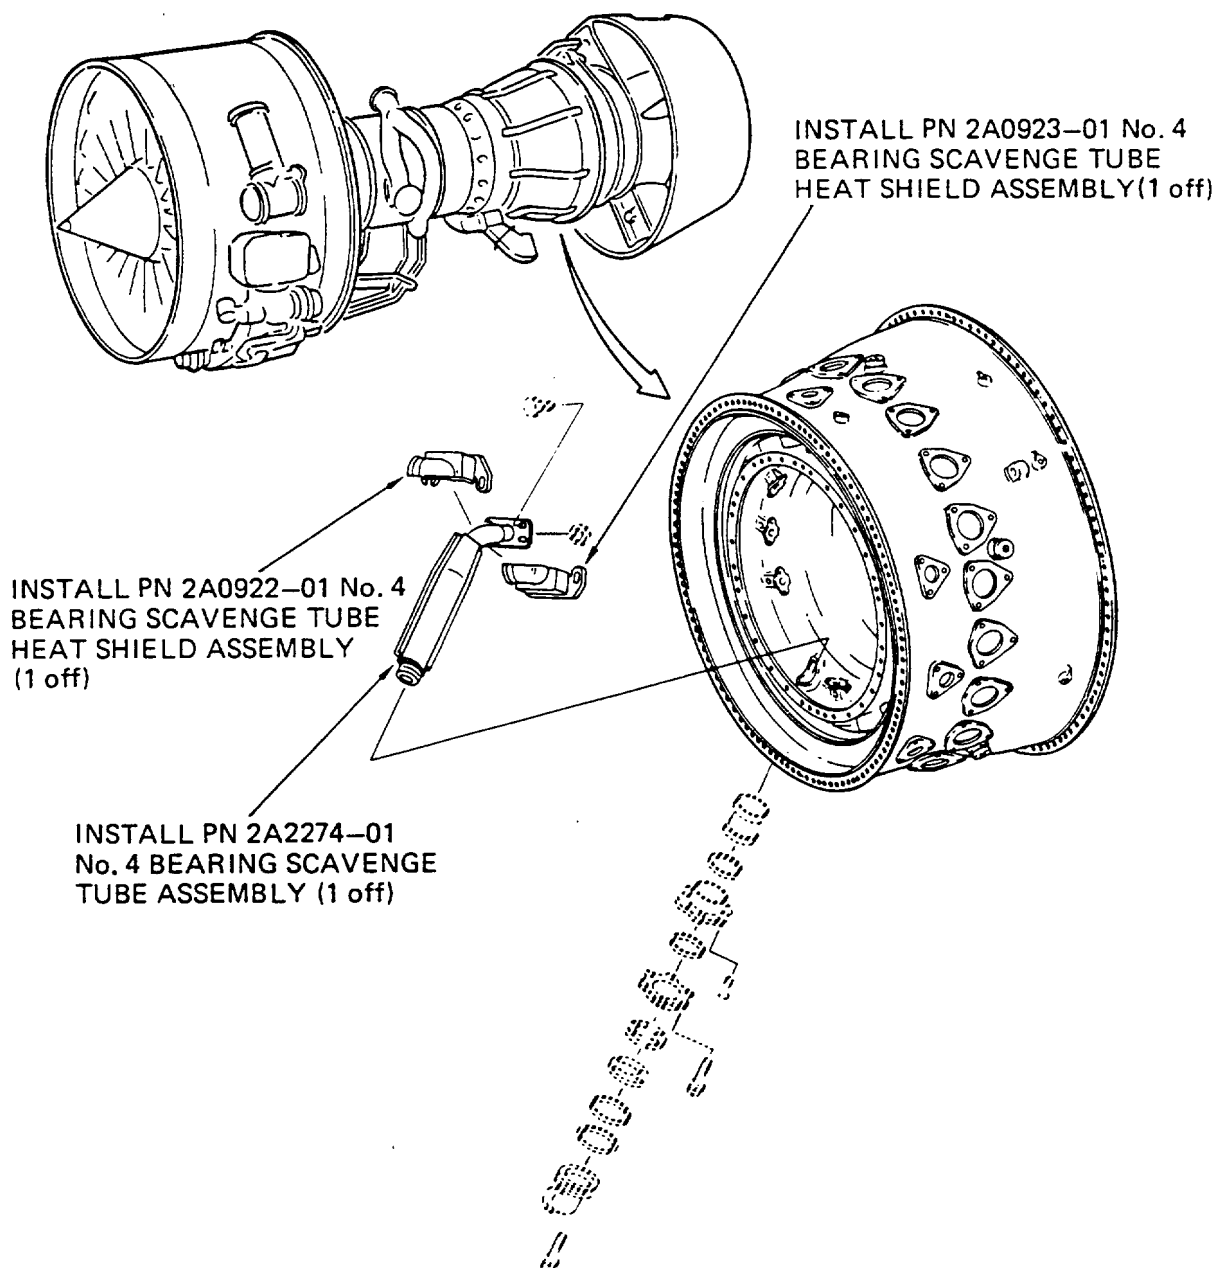
Location of No.4 Bearing Scavenge Tube Assembly  
Fig.1

Rubbing of the Heatshield against the Diffuser Case Strut could cause the Heatshield to fragment.

Heatshield fragmentation occurred on some experimental engines. This happened because the original Tube Assembly had thin Heatshields and interference with the Diffuser Case Strut was possible under adverse tolerance conditions.

- (2) Install the 2A2274-01 No.4 Bearing Scavenge Tube Assembly (1 off) by the approved procedure in Reference (2) Chapter/Section 72-42-00, Assembly. See Figure 1.
- (3) When the No.4 Bearing Housing is installed (by the approved procedure in Reference (2) Chapter/Section 72-42-00 Assembly) the Heat shields 2A0922-01 (1 off) and 2A0923-01 (1 off) will be installed.
