ENGINE - BIFURCATION PANEL - ADDITION OF STIFFENER PLATES AT RIVETED JOINT BETWEEN
UPPER AND LOWER PANELS - CATEGORY CODE 6 - MOD.ENG-72-0088

V2500-ENG-72-0088

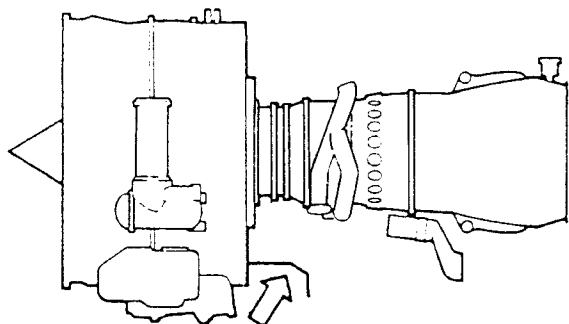
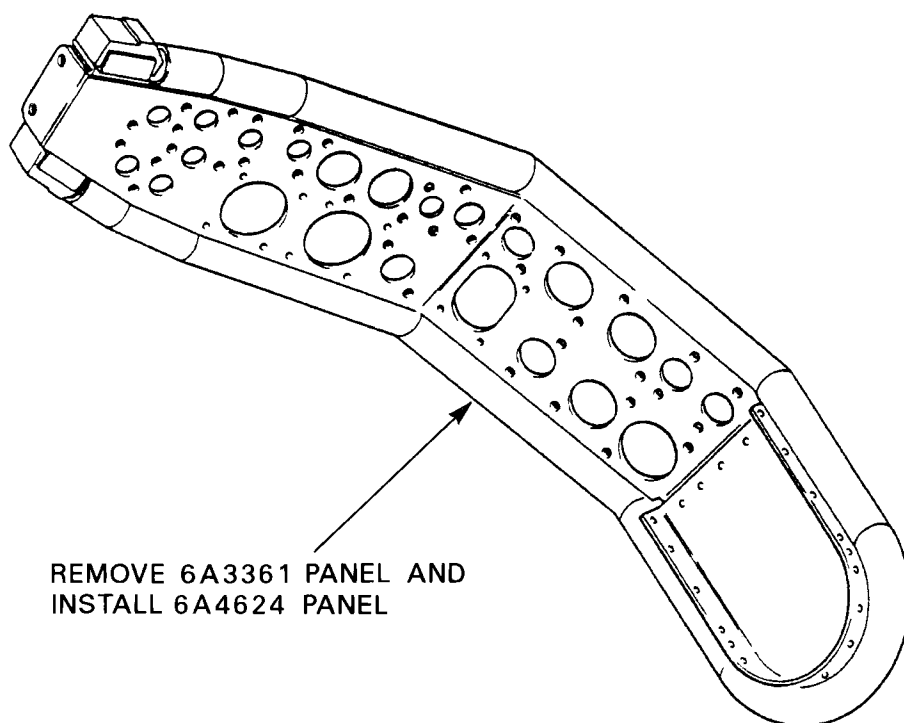
Part 1 Location of bifurcation panel
Fig.1

REMOVE 6A3361 PANEL AND
INSTALL 6A4624 PANEL

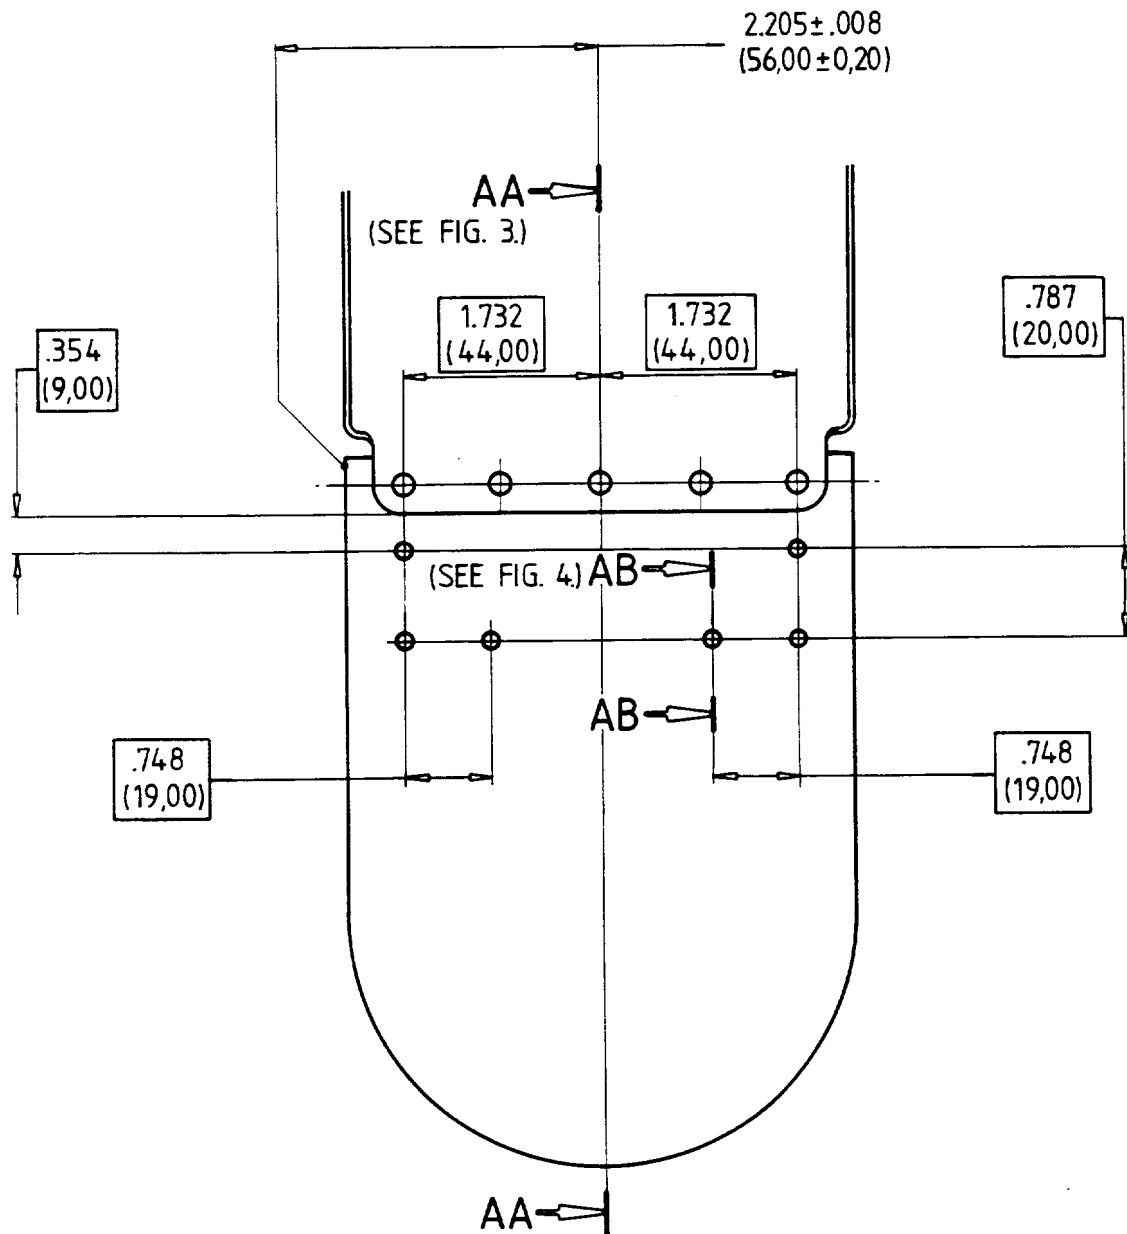
Part 1 Rework of bifurcation panel
 Fig.2

REMOVE THE SHARP EDGES $.012 \pm .008$ (0.30 ± 0.20).
 DIMENSIONS ARE IN INCHES WITH MILLIMETRE CONVERSIONS IN PARENTHESES
 GEOMETRIC SYMBOLS CONFORM TO I.S.O. R1101-1969.
 VIEW SHOWING REWORKING OF EXISTING PANELS.
 STIFFENING BRACKETS REMOVED FOR CLARITY.
 SCALE: SIZE PART 1

Procedure	Supplementary Information
(i) Remove the applicable parts of the sealing retaining strips by removal of rivets	See Figure 3 and Figure 4. Use basic workshop tools
(ii) Remove the applicable section of rubber seal	See Figure 3. Use a sharp knife. Cut along the glue line
(iii) Locate template through the two holes of the panel, 6A3361	See Figure 3. Use locally made template. Use basic workshop tools
(iv) Mark the applicable three holes on each side of the panel, 6A3361	See Figure 3. Use basic workshop tools
(v) Remove template	
(vi) Drill the applicable three pilot holes on each side of the panel, 6A3361	See Figure 3. Use basic workshop tools
(vii) Examine	Make sure holes are correctly drilled
(viii) Clamp the stiffening plates, 6A4657 and 6A4658, onto panel 6A3361 and drill sixteen rivet holes as shown	See Figure 2 and Figure 3. Use basic workshop tools

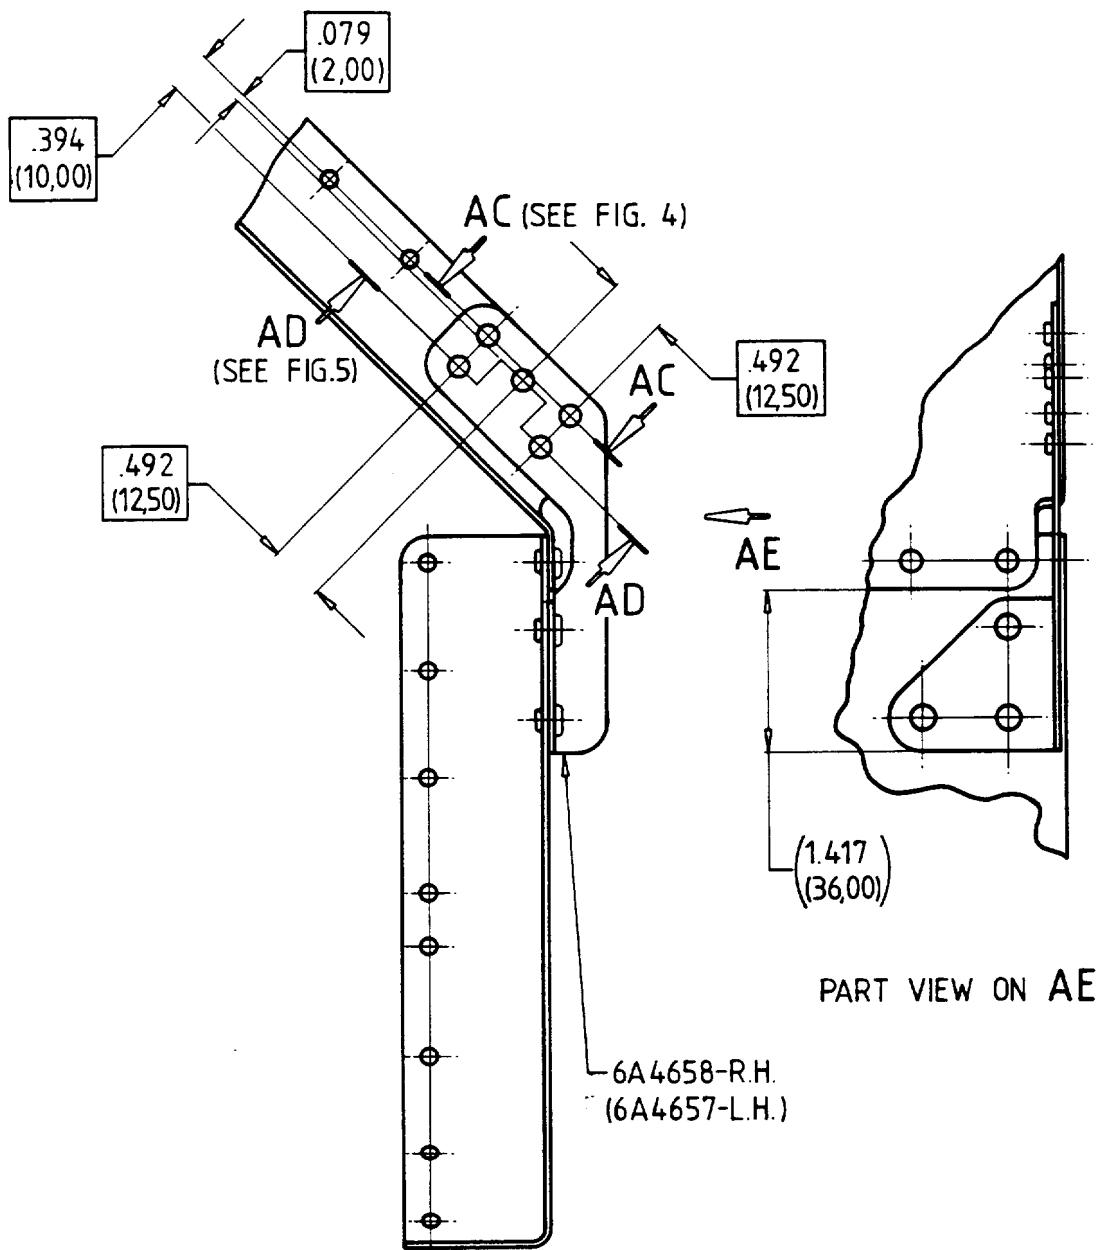
Rework of bifurcation panel
Fig.3

SECTION AA
(SEE FIG. 2)
TYPICAL BOTH SIDES.
PART 1

Special tools are not required, however use of a locally manufactured template will assist in rework operations, refer to Figure 3 and Accomplishment Instructions.

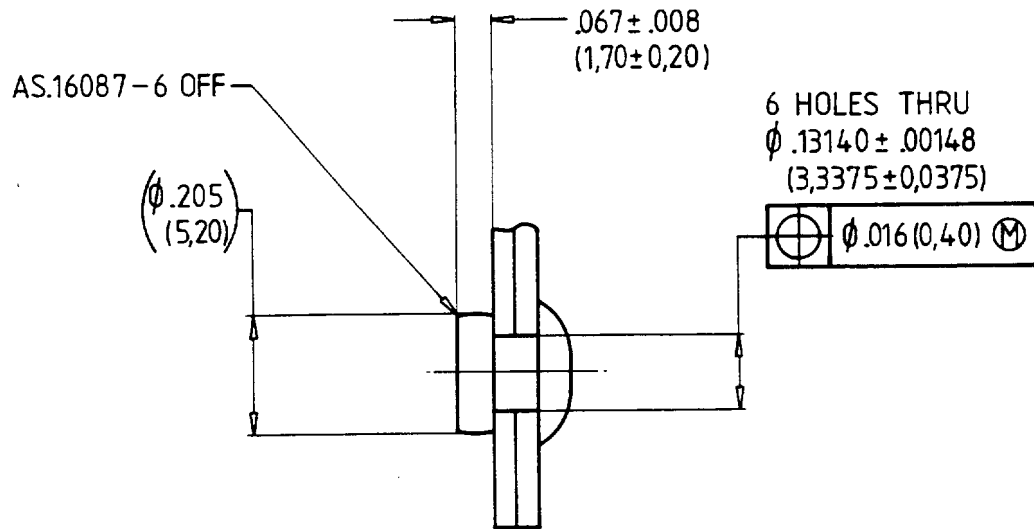
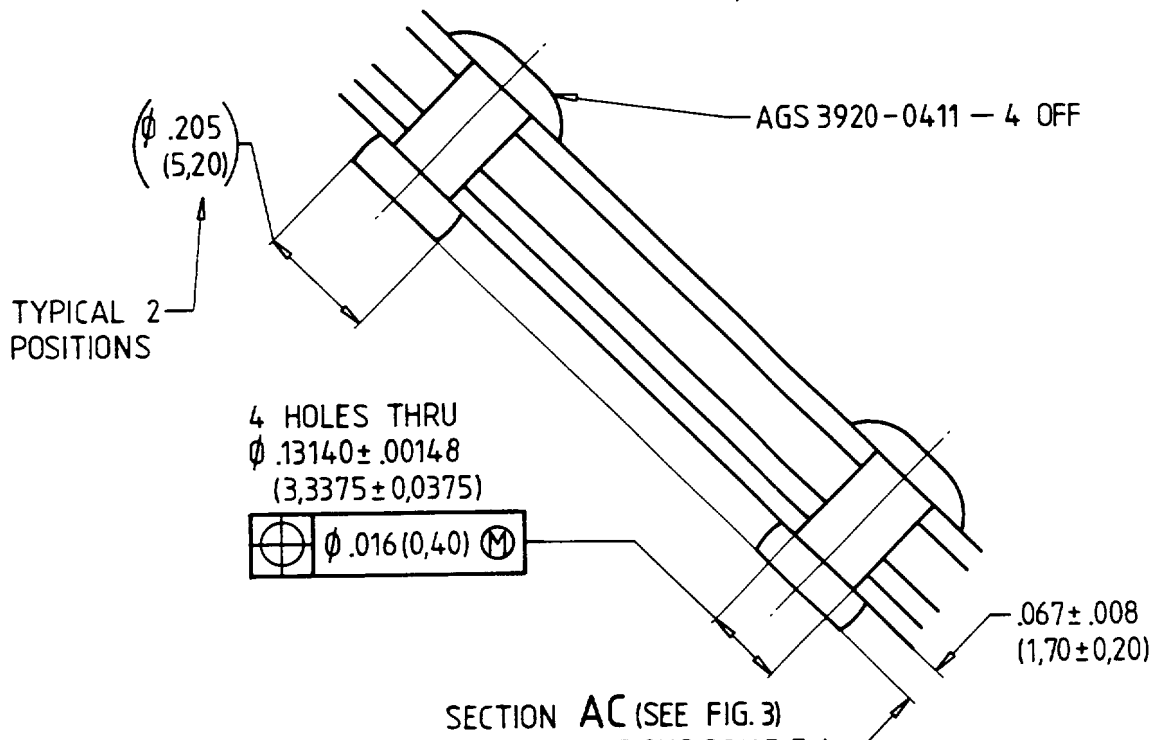
SECTION AC (SEE FIG. 3)
TYPICAL 2 POSITIONS, SCALE 5:1.
PART 1
Part 1Part 1 Rework of bifurcation panel
Fig.4

SECTION AB (SEE FIG. 2)
TYPICAL 6 POSITIONS, SCALE 5:1.

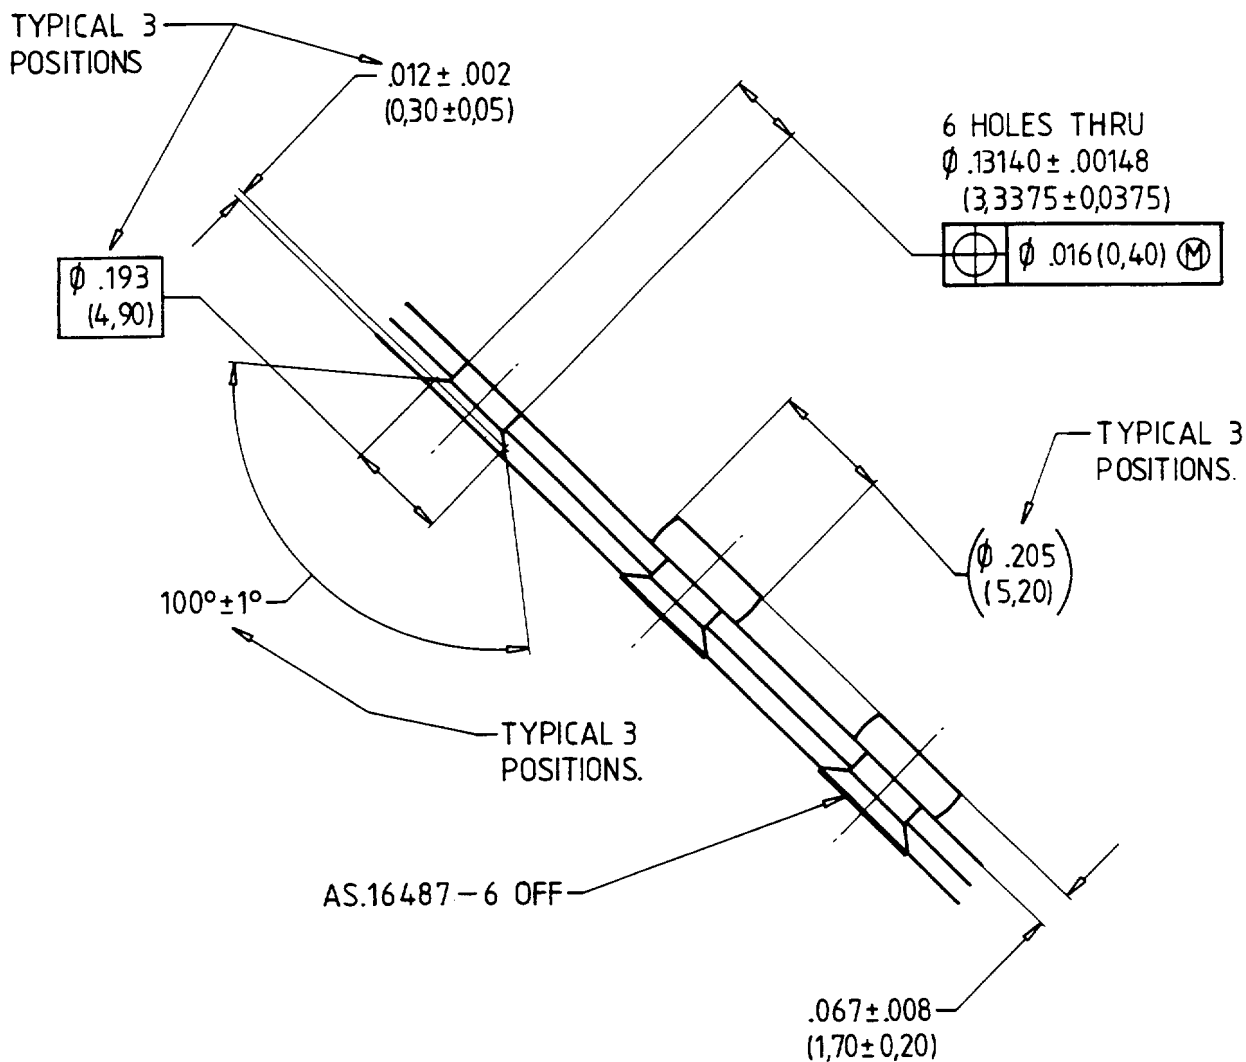
Part 1 Rework of bifurcation panel
Fig.5

SECTION AD (SEE FIG. 3)
TYPICAL 2 POSITIONS, SCALE 5:1.
RIVET & P-SEAL REMOVED FOR CLARITY.
PART 1

- | | | | | | |
|--|---|---|---|---|---|
| (xi) Countersink the six holes where shown | See Figure 5.
Use basic workshop tools | | | | |
| (x) Remove all sharp edges from new holes | Use basic workshop tools | | | | |
| (xi) Assemble stiffening plates, 6A4657 and 6A4658, to panel 6A3361. Fit rivets into countersunk holes | See Figure 3 and Figure 5.
Use AS16487 rivets, solid countersunk head, six off.
Use basic workshop tools | | | | |
| (xii) Fit rivets into holes at foot location | See Figure 2, Figure 3 and Figure 4. Use AS16087 rivets, solid universal head, six off.
Use basic workshop tools | | | | |
| (xiii) Replace rubber seal sections and bond in place | See Figure 3. Refer to Standard Practices/Processes Manual TASK 70-36-02-360-501, SUBTASK 70-36-02-360-020.
Use CoMat 08-013 Silcoset 152.
Use basic workshop tools | | | | |
| (xiv) Replace seal retaining strips and secure with rivets | See Figure 3 and Figure 4.
Use AGS3920-0411 rivets, blind snaphead, sixteen off.
Use basic workshop tools | | | | |
| (xv) Examine | Make sure rivets are tight | | | | |
| (xvi) Cancel the old part number and identify with the new part number | <table border="0"> <tbody> <tr> <td>Old Part No.</td> <td>New Part No.</td> </tr> <tr> <td>6A3361</td> <td>6A4624</td> </tr> </tbody> </table> <p>Refer to Standard Practices/Processes Manual TASK 70-09-00-400-501, SUBTASK 70-09-00-400-001.
Use vibro-engraving equipment</p> | Old Part No. | New Part No. | 6A3361 | 6A4624 |
| Old Part No. | New Part No. | | | | |
| 6A3361 | 6A4624 | | | | |

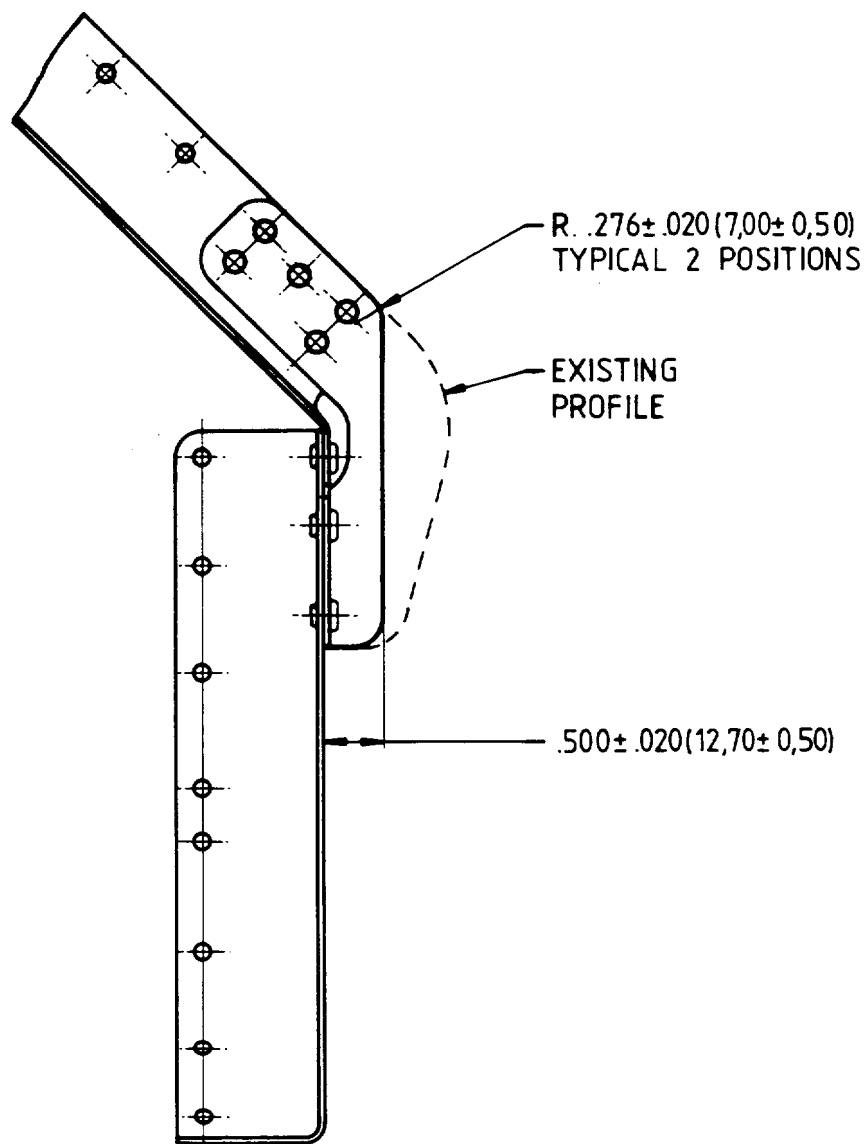
Part 2 Rework of bifurcation panel
Fig.6

VIEW SHOWING REWORKING OF EXISTING PANELS
TYPICAL FOR RIGHT & LEFT HAND STIFFENER PLATES
SCALE: SIZE
PART 2

(i) Mark off area for removal

(iii) De-burr and remove sharp edges

See Figure 6
Measure the dimension and ensure that the edges are smooth
