# SERVICE BULLETIN

ENGINE - LP TURBINE - REMOVE THE CORRELATION MARKING ON THE STAGE 6 INNER AIRSEAL -  
CATEGORY CODE 6 - MOD.ENG-72-0089

V2500-ENG-72-0089

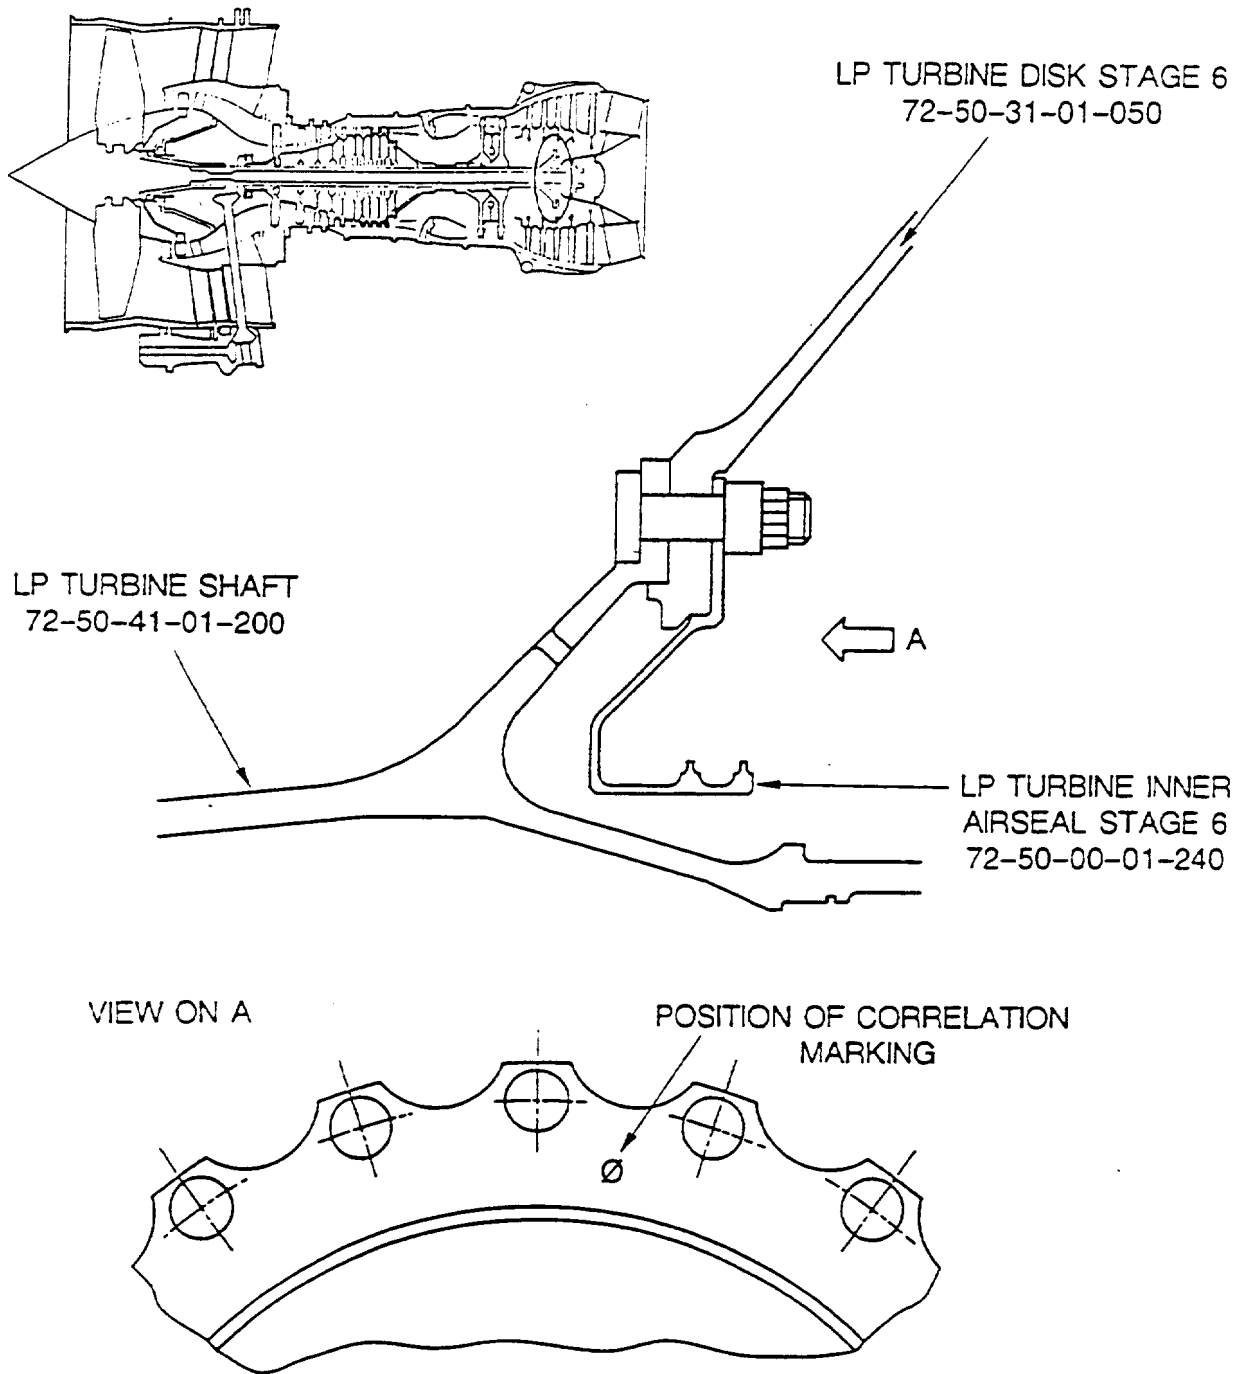
Stage 6 turbine inner airseal, position of correlation marking  
Fig.1

The engine Serial numbers listed above have a vibroengraved correlation marking on the stage 6 Turbine inner airseal that is not required for use at engine assembly.

- (1) Identify the correlation marking on the stage 6 turbine inner airseal. Refer to Figure 1.

NOTE: The correlation marking is located on the rear side of the airseal flange.

- (2) Remove the correlation marking.
