V2500 Propulsion System — Engine

ENGINE - LP COMPRESSOR - REWORK THE NO.3 BEARING HOUSING ASSEMBLY  
TO INCORPORATE REVISED MATERIAL PINS

V2500-A1

V2500-ENG-72-0093

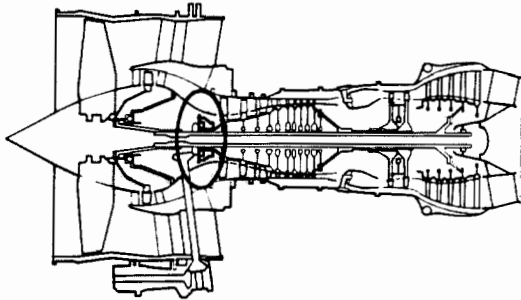
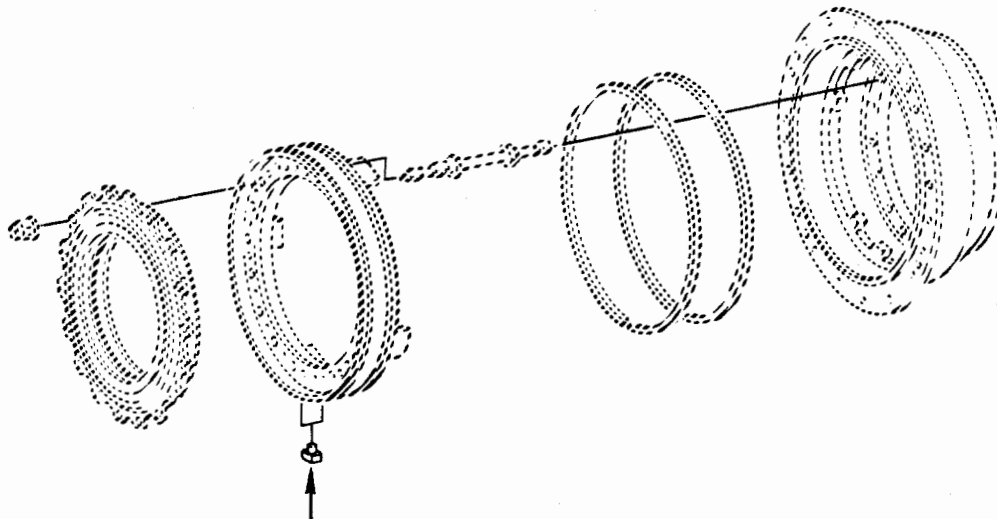
Location of No.3 bearing housing assembly  
Figure 1

Wear has been experienced on the Anti-rotation Pins located in the No.3 Bearing Housing.

It has been determined that the Anti-rotation Pin material may not be hard enough and permits the Anti-rotation Pin to wear when the Seal Rings are seated in the No. 3 Bearing Housing Assembly.

- (a) Remove the two 1A9666 Slab Pin from the No.3 Bearing Housing Assembly.
- (b) Install the new 2A2205 Slab Pin (2 off) in the No.3 Bearing Housing Assembly.

REPLACE PN 1A9666 SLAB PIN (2 Off)  
WITH PN 2A2205 SLAB PIN (2 Off)
