Subject: Transmittal of Revision 1 to Service Bulletin No. V2500-ENG-72-0094

V2500 Propulsion System — Engine

ENGINE - LP COMPRESSOR - REPLACE THE FAN EXIT GUIDE VANE
ASSEMBLY PLATFORM BOLTS

V2500-ENG-72-0094
Page 1 of 9

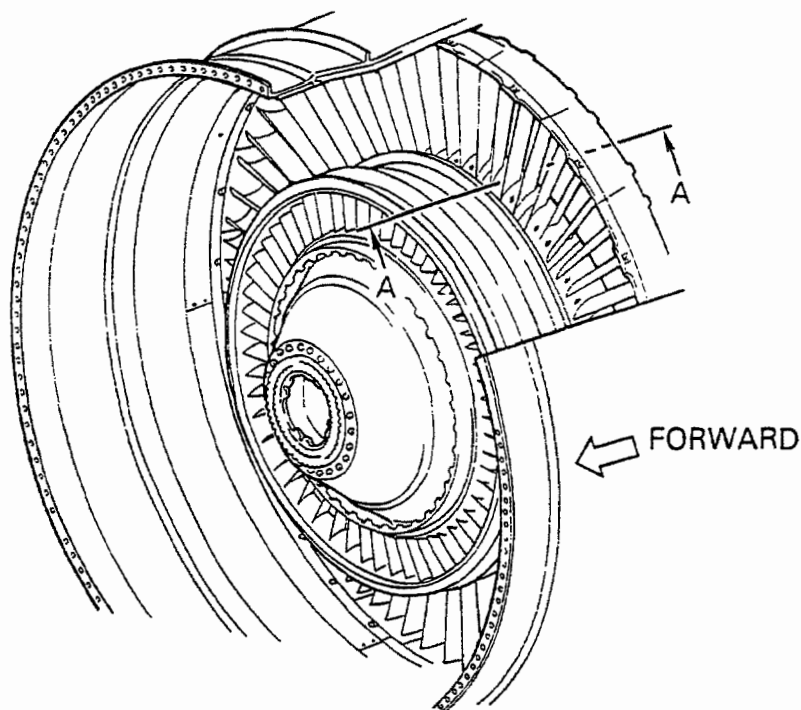
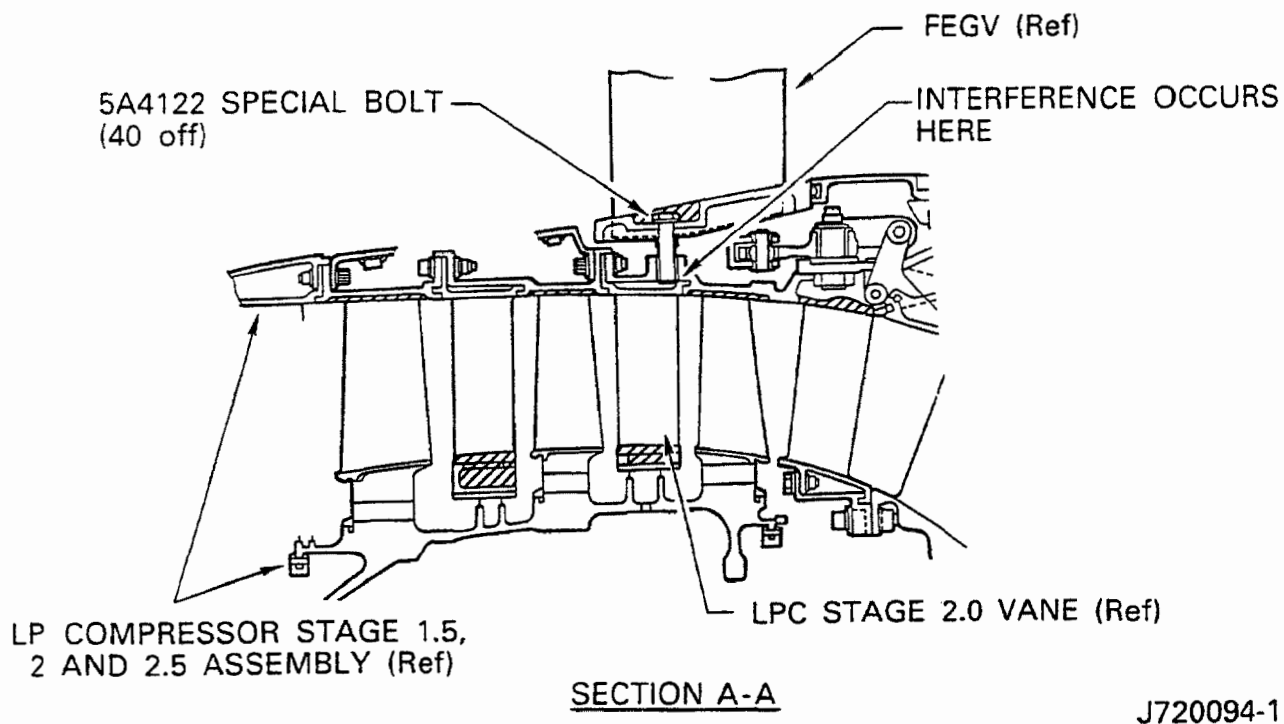
Location of the FEGV's Platform Special Bolts
Figure 1

It was determined that some Special Bolts used to secure the Fan Exit Guide Vane (FEGV) Platform may have to be shortened in length to enable the LP Compressor Stage 1.5, 2 and 2.5 Assembly to disassemble and assemble without removal of the Special Bolts.

With the existing configuration of longer Special Bolts which have a change letter "A" for the 5A4122, it is possible for an interference between the bolt ends and the Stage 2.0 Vane Assembly if the LP Compressor Stage 1.5, 2 and 2.5 Assembly is disassembled and assembled without removal of Bolts, though no obstruction exists with that of shorter Special Bolts which have a change letter "B" for the 5A4122.

- (a) The existing Special Bolts 5A4122 with change letter "A" have been changed in length from 1.290 - 1.309in. (32,75 - 33,25 mm) to 1.211 - 1.230in. (30,75 - 31,25 mm) and reidentified to a new part number 5A0849. (See Figures 1 and 2).
- (b) The existing 1.211 - 1.230in. (30,75 - 31,25 mm) long Special Bolts 5A4122 with change letter "B" have been reidentified to a new part number 5A0849. (See Figures 1 and 2).

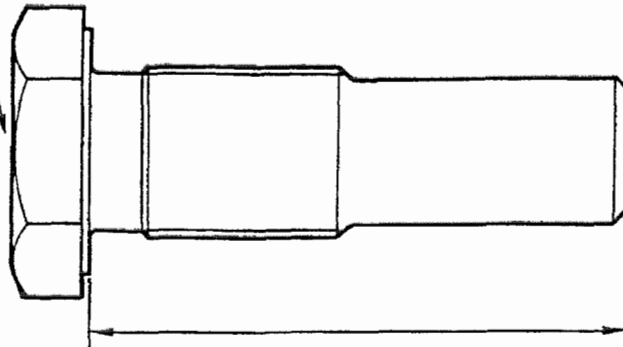
Rework of the FEGV's Platform Special Bolts
Figure 2

BEFORE ALTERATION 1.290 (32,75)
1.309 (33,25)

- (1) Collect the longer Special Bolts which have the identification number 5A4122A on the bolt head to rework and renumber.
- (2) Collect the shorter Special Bolts which have the identification number 5A4122B on the bolt head to renumber.
- (3) Rework the identification number 5A4122A, longer Special Bolts, with the identification No. RM007, Standard Precision Lathe, to decrease the length of Bolts. (Refer to Figure 2 and 1.K. (3)).

The length of Bolt	Before rework	After rework
	1. 309 (33, 25)	1. 230 (31, 25)
	1. 290 (32, 75)	1. 211 (30, 75)

MARK NEW PN 5A0849 WITH VIBRO-PEEN ADJACENT TO EXISTING PN 5A4122A IDENTIFIED HERE. MARK TWO LINES (≡) ON EXISTING PN WITH VIBRO-PEEN TO ERASE IT.

AFTER ALTERATION 1.211 (30,75)
1.230 (31,25)

CHAMFER
0.031 (0,8) x 45 DEG

MACHINE WHERE MARKED ✓ TO DECREASE THE LENGTH OF PN 5A4122A BOLT.
SURFACE TEXTURE TO BE 248 MICROINCHES (6,3 MICROMETERS).
BREAK SHARP EDGES 0.003-0.015 (0,08-0,38).
