ENGINE - LP COMPRESSOR - INCORPORATE ANTI-FRET COATING ON THE ANNULUS FILLER ASSEMBLY
FRONT FACE - CATEGORY CODE 6 - MOD.ENG-72-0096

V2500-ENG-72-0096

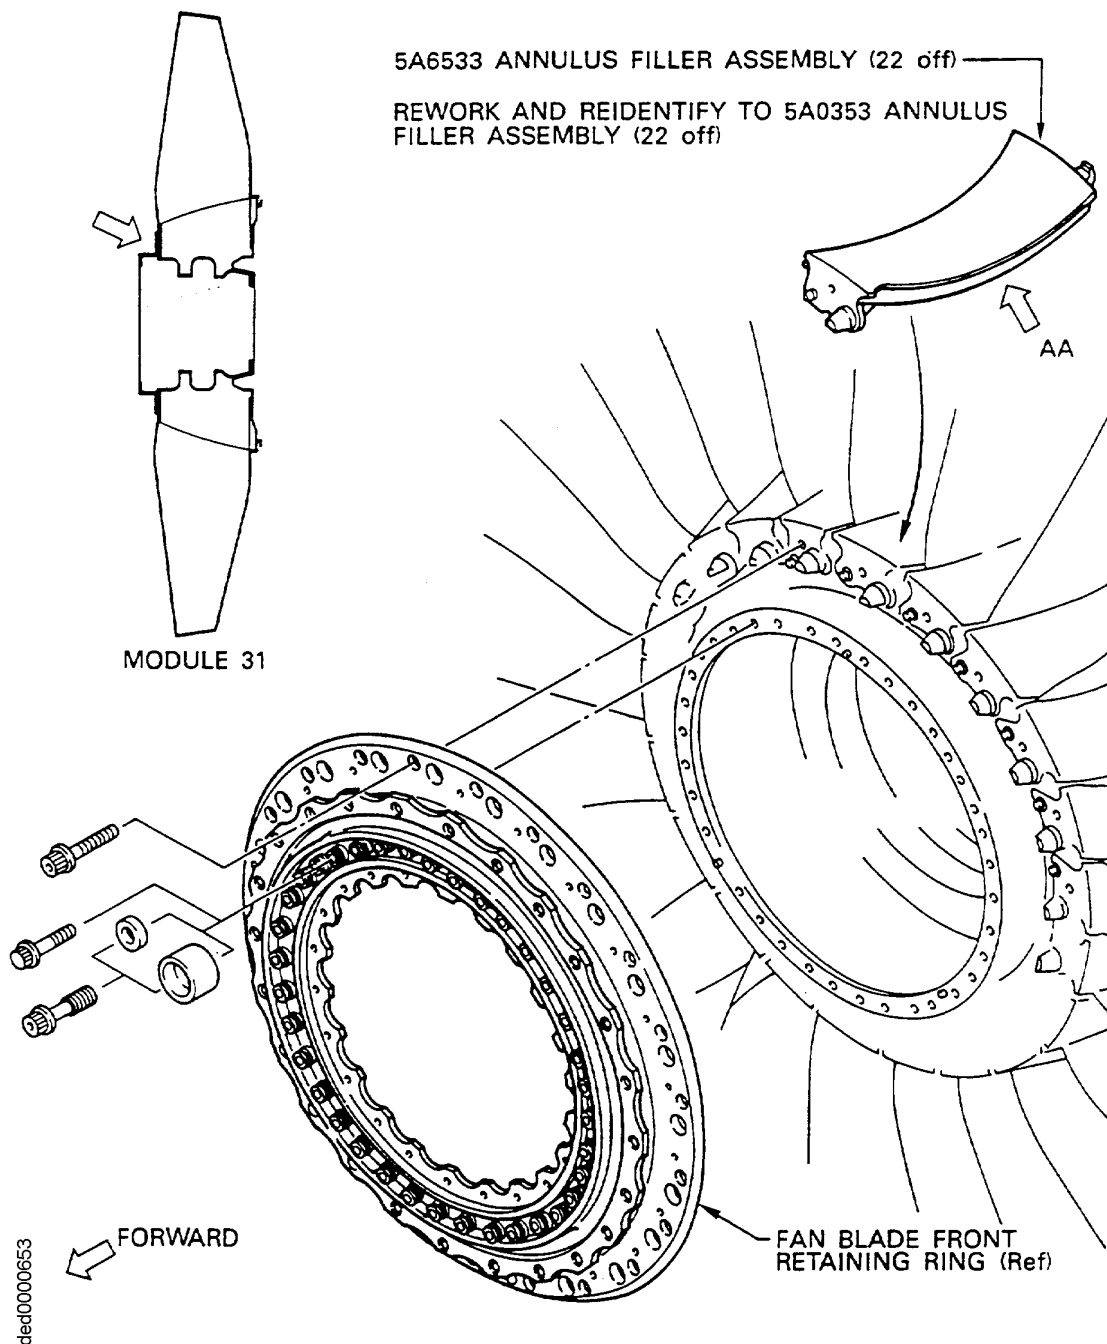
Modification of the Annulus Filler Assembly
Fig.1, Sheet 1 of 2

Fretage may occur between the front face of Annulus Filler Assembly and the LP Compressor Fan Blade Front Retaining Ring.

- (1) The changes introduced by this Service Bulletin are as follows:
- (a) One coat of the dry film lubricant is applied to the front face of Annulus Filler Assembly to prevent fretting between the Annulus Filler Assembly and the LP Compressor Fan Blade Front Retaining Ring. (See Figure 1).
 - (b) Existing Part Number of the Annulus Filler Assembly has been changed to a new Part Number.
- (2) Existing Annulus Filler Assembly can be reworked to a new configuration. (See Figure 1).

Procedures	Supplementary Information	
(1) Apply one coat of CoMat 10-004, Dry Film Lubricant PL.237, to each front face of the 22 PN 5A6533, Annulus Filler Assemblies, by the approved procedures in the Standard Practices /Processes Manual, 70-38-03.	Refer to Figure 1, 1.K. (3) and 1.K. (4). Coating thickness must be 0.00012 to 0.00059 in. (0,003 to 0,015 mm).	
(2) Renumber with Vibro-peen adjacent to the old part number marked on each rear face of Annulus Filler Assemblies by the approved procedures in the Standard Practices /Processes Manual, 70-09-00.	Refer to Figure 1, and 1.K. (3) Existing Renumber 5A6533 5A0353

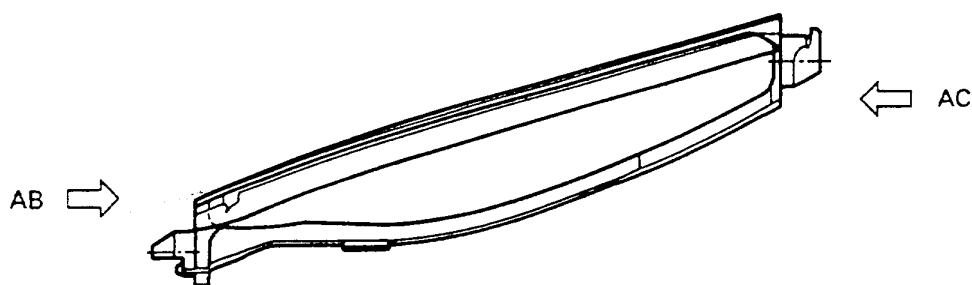
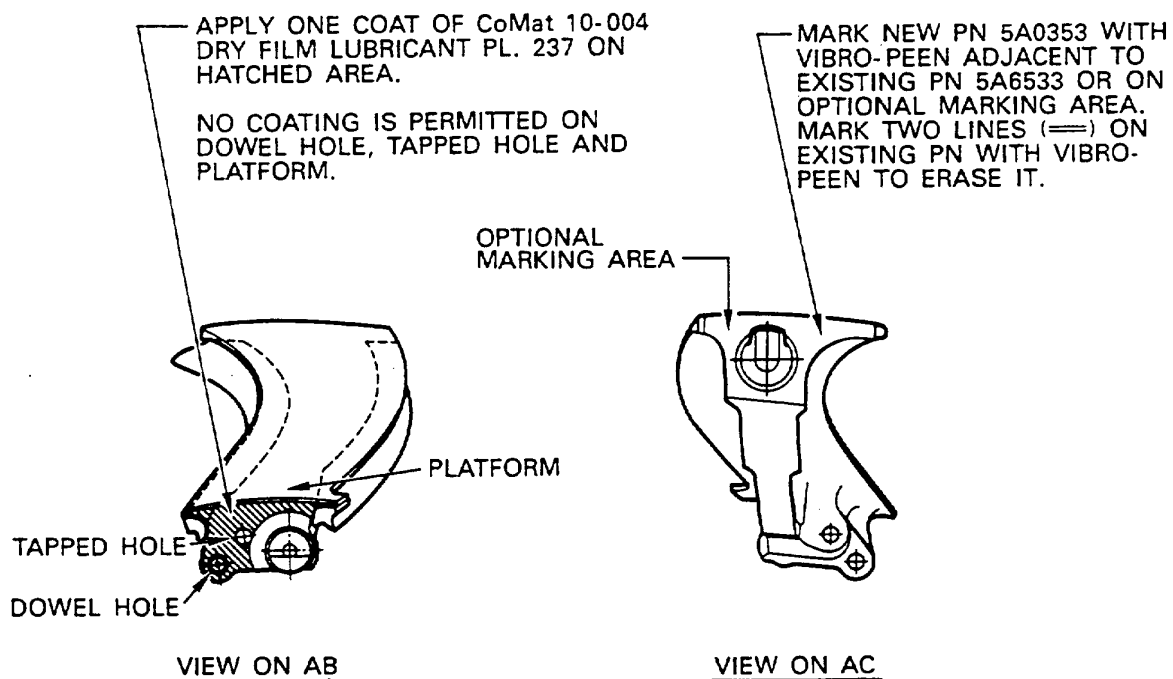
Modification of the Annulus Filler Assembly
Fig.1, Sheet 2 of 2

VIEW AT AA
