ENGINE - H.P. COMPRESSOR CASE - INTRODUCTION OF STRENGTHENED BORESCOPE BLANKING PLUG ASSEMBLIES AND GASKET SEALS AT STAGES 8, 9 AND 11 AND GASKET SEAL AT STAGE 7 - CATEGORY CODE 6 - MOD.ENG-72-0100

V2500-ENG-72-0100

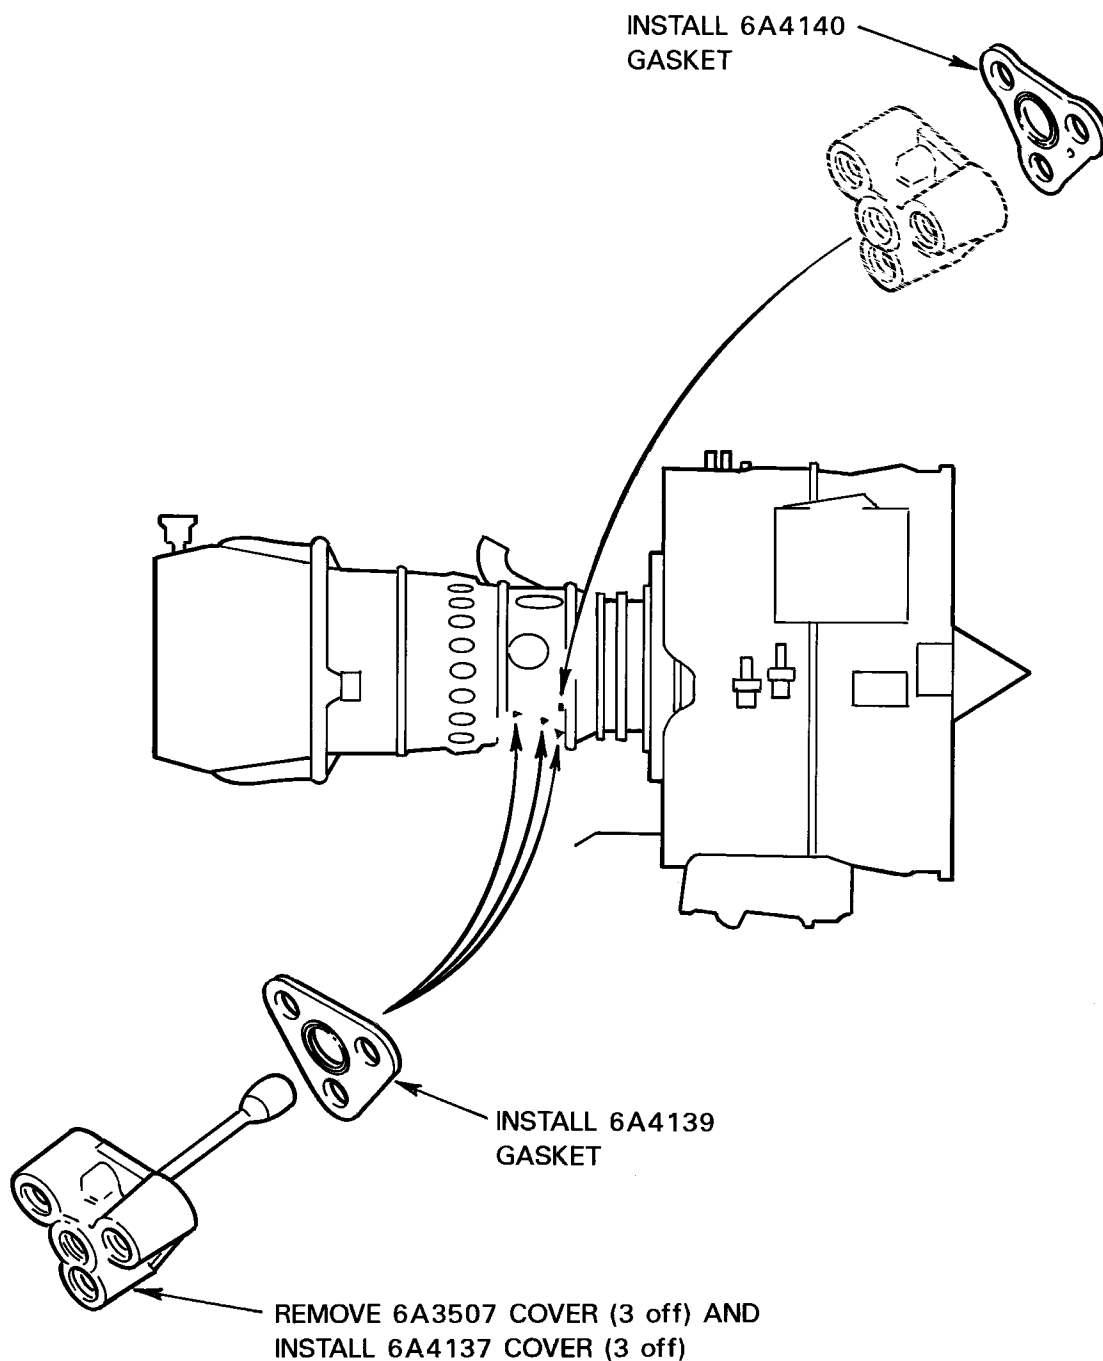
Location of borescope blanks  
Fig.1

Difficulty could occur during removal of existing stage 8, 9 and 11 borescope blanking plug assemblies.

Breakage of the stem on the blanking plug assemblies during extraction has been reported. Breakage was at the weld beads at either end of the stem.

- (a) New borescope blanks are introduced at stages 8, 9 and 11 featuring a stem which has been strengthened by increasing its diameter from 1.5 (0.059in.) to 8,0 mm. (0.315in.). the stem welds have been eliminated by making the inner bulb integral with the stem and enlarging the stem at its outer end to form a spigot. The weld is not between the spigot and flange. The new flange incorporates 2 tapped holes. The assembly retaining bolts can be screwed into these holes to assist removal.
- (b) Corrujoints are introduced in place of jointing compound at stages 8, 9 and 11. This change is also applied at the stage 7 borescope location at which a flat blanking plate is fitted.

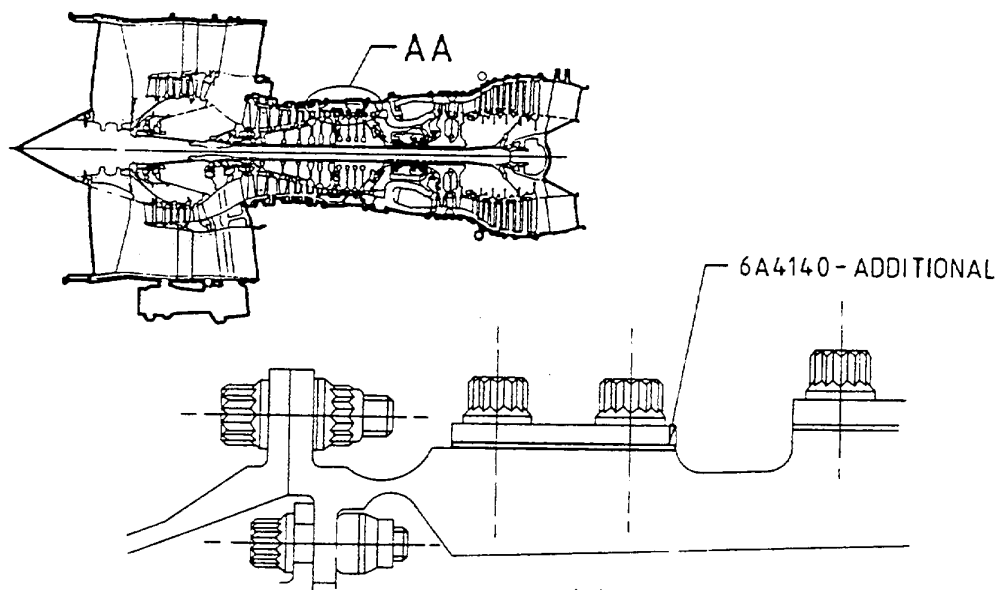
VIEW AT AA  
SHOWING THE STAGE 7 BLANK.

In addition, the use of SQ2 sealing compound between the plug flange and compressor case could result in a 'cement' seal. Consequently, excessive force may be required to break the seal before the assembly can be removed.
