# SERVICE BULLETIN

ENGINE - HP TURBINE - PROVIDE A NEW STAGE 2 HP TURBINE HUB ASSEMBLY WITH REVISED  
METERING PLUGS - CATEGORY CODE 6 - MOD.ENG-72-0101

V2500-ENG-72-0101

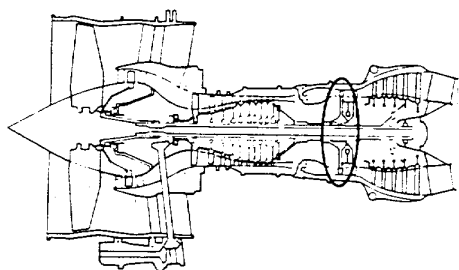
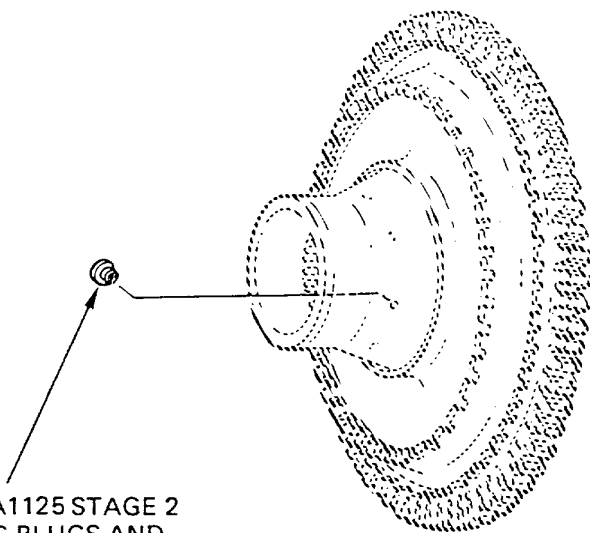
Location of Stage 2 HPT Metering Plug  
Fig.1

The original metering plugs may not retain the Heatshield sufficiently. If the Heatshield is permitted to shift, it can liberate the plugs, which can cause damage to the shaft.

REMOVE PN 2A1125 STAGE 2  
HPT METERING PLUGS AND  
INSTALL PN 2A2403 STAGE 2  
HPT METERING PLUG (4 off)

- (a) Assemble the Stage 2 Turbine Rotor Assembly by the approved procedure in Reference (3), Chapter/Section 72-45-30, Assembly. See Figure 1.

- (i) Use the 2A2403 Stage 2 HPT Metering Plug (4 off).
