<u>ENGINE - LP COMPRESSOR - PROVIDE A NEW WEIGHT REDUCED FAN CASE ASSEMBLY - CATEGORY</u> CODE 7 - MOD.ENG-72-0103

- (1) Aircraft:
 - (a) Airbus A320
- (2) Engine:
 - (a) V2500-A1 Engines prior to Serial Number V0204.

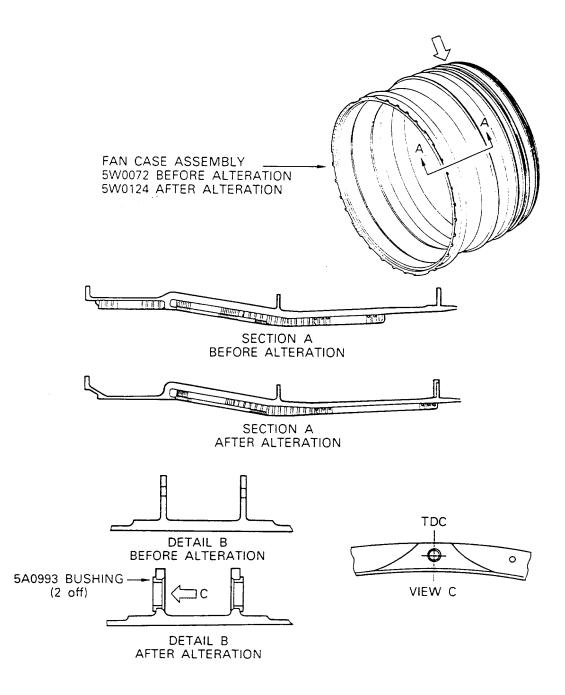
Fan Case Assembly - Before and After Alteration Fig.1

- (a) The carcase thickness of the Fan Case Assembly has been reduced accompanying with improved linings and panels. And the transition panels are applied for this new configuration (See Figures 1 and 2).

- (b) The lifting holes with bushings are provided at TDC of the Flange FD and the Flange FE on the Fan Case to improve the Fan Case maintainability (See Figure 1).

- (1) Assemble the new 5W0124, Fan Case Assembly to the LP Compressor/ Intermediate Case Module by the approved procedures in the Engine Manual, 72-32-00 Assembly (Refer to 1.K. (3)).

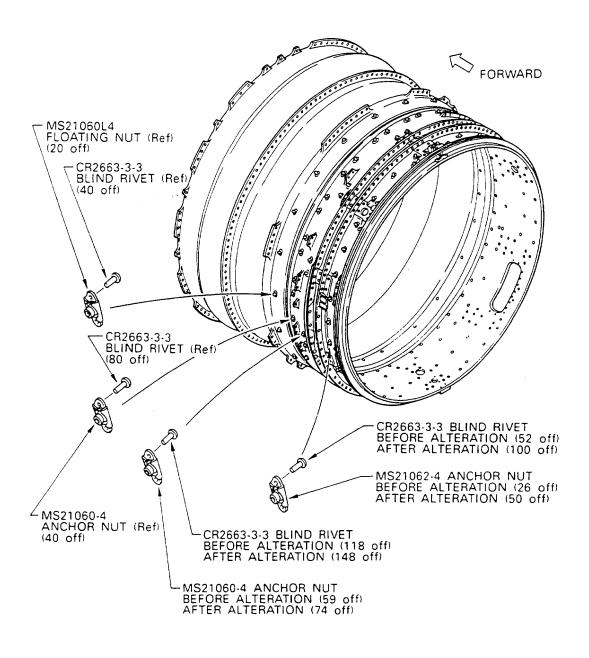
Fan Case Fitting Parts - Before and After Alteration Fig. 3

- (d) New Rubber Seals have been introduced (See Figure 5).
 - (e) With changes described in 1.D. (1) (c) and (d), quantity and location of the fastening features of the Rubber Seals and the Fan Case Liner Panels to the Fan Case Assembly have been changed (See Figures 3, 6 and 7).

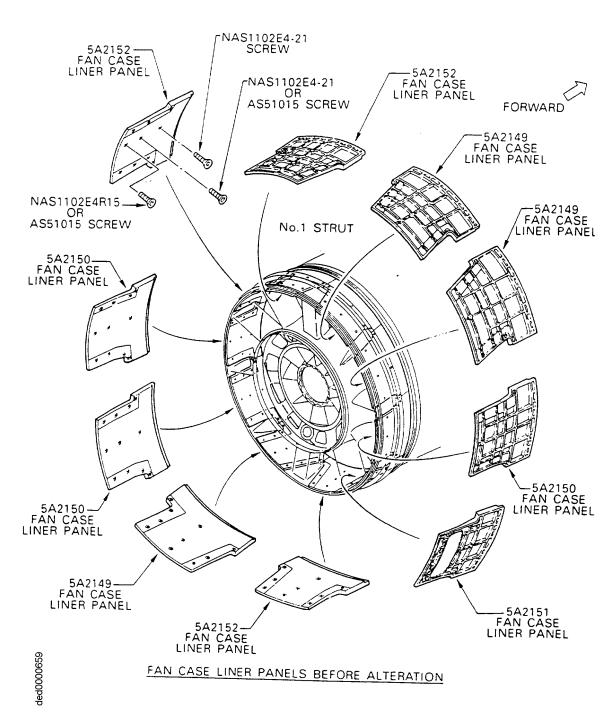
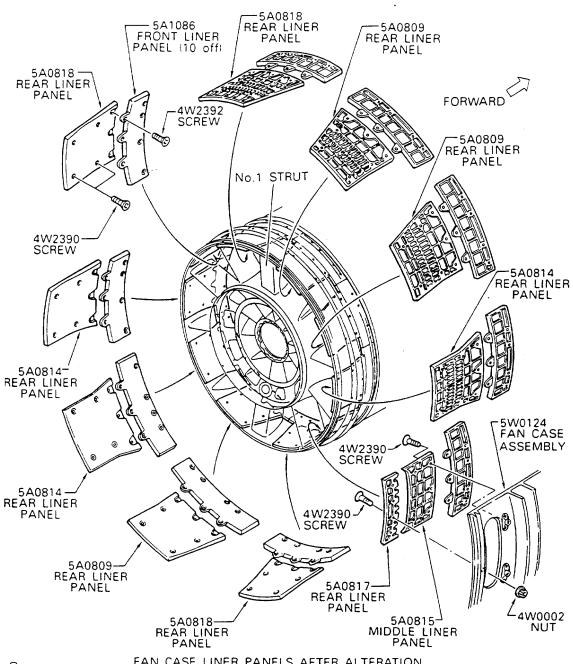
Fan Case Liner Panels - Before and After Alteration Fig.4, Sheet 1 of 2

- (c) Each of Fan Case Panel Liners has been divided into two pieces (i.e. Front and Rear) to improve the maintainability and also the material of liners has been changed to increase the impact strength against Foreign Objective Damage (FOD) (See Figure 4).

- (2) Assemble the ten 5A1086, Front Liner Panels, the three 5A0809, Rear Liner Panels, the three 5A0814, Rear Liner Panels, 5A0815, Middle Liner Panel, 5A0817, Rear Liner Panel, the three 5A0818, Rear Liner Panels to the LP Compressor/Intermediate Case Module with the 30, 4W2392, Screws, the 42, 4W2390, Screws, and the four 4W0002, Nuts by use of approved procedures in the Engine Manual 72-32-00, Assembly (Refer to Figure 3, Figure 4, Sheet 2, Figure 6, Sheet 2 and 1.K. (3)).

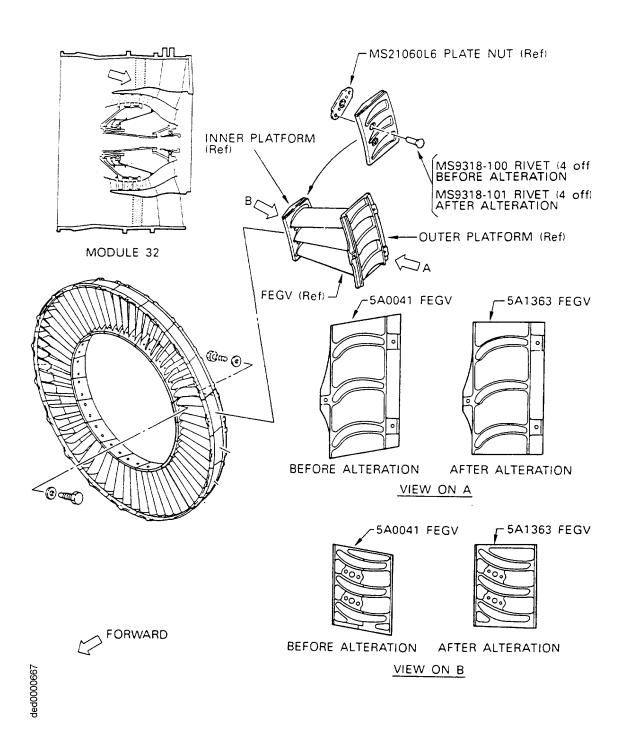
, Fan Exit Guide Vane (FEGV) A/O - Before and After Alteration Fig.8

- (g) The profile of the Fan Exit Guide Vane inner and outer platforms has been changed from the parallelogram to the rectangle to enable the removal and installation of the FEGV's with the new configuration of Fan Case Assembly (See Figure 8).

- (4) Assemble the 20, 5A1364, FEGV's to the LP Compressor/Intermediate Case Module by use of approved procedures in the Engine Manual, 72-32-00, Assembly (Refer to Figure 8 and 1.K. (3)).

- NOTE: The new FEGV's are not accessible if the Rear Fairing A/O's introduced by SB. No. V2500-ENG-72-0105 are installed. make sure that the Rear Fairing A/O's are not installed before the installation of FEGV's.

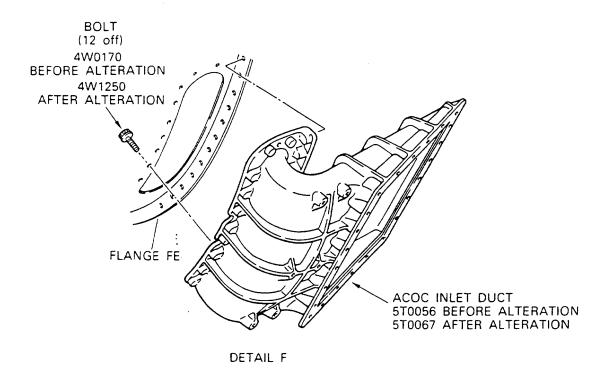
ACOC Inlet Duct - Before and After Alteration Fig.9

- (h) The new Air Cooled Oil Cooler (ACOC) inlet duct has been introduced for this new configuration (See Figure 9).
- (2) The Module Assembly Number (Module Identification Number) marked on the LP Compressor/Intermediate Module has been changed.
- (3) This Service Bulletin must be incorporated after or concurrently with the IAE Service Bulletin No. V2500-ENG-72-0105.

- (6) Install the 5T0067, ACOC Inlet Duct and ACOC to the 5W0124, Fan Case Assembly by the approved procedures in the Engine Manual, 72-00-32, Installation (Refer to Figure 9 and 1.K. (3)).
