International Aero Engines SERVICE BULLETIN

Subject: Transmittal of Revision 2 to Service Bulletin
No.V2500-ENG-72-0105

**ENGINE - LP COMPRESSOR - INTRODUCE A SEGMENTED
REAR FAIRING ASSEMBLY**

V2500-ENG-72-0105

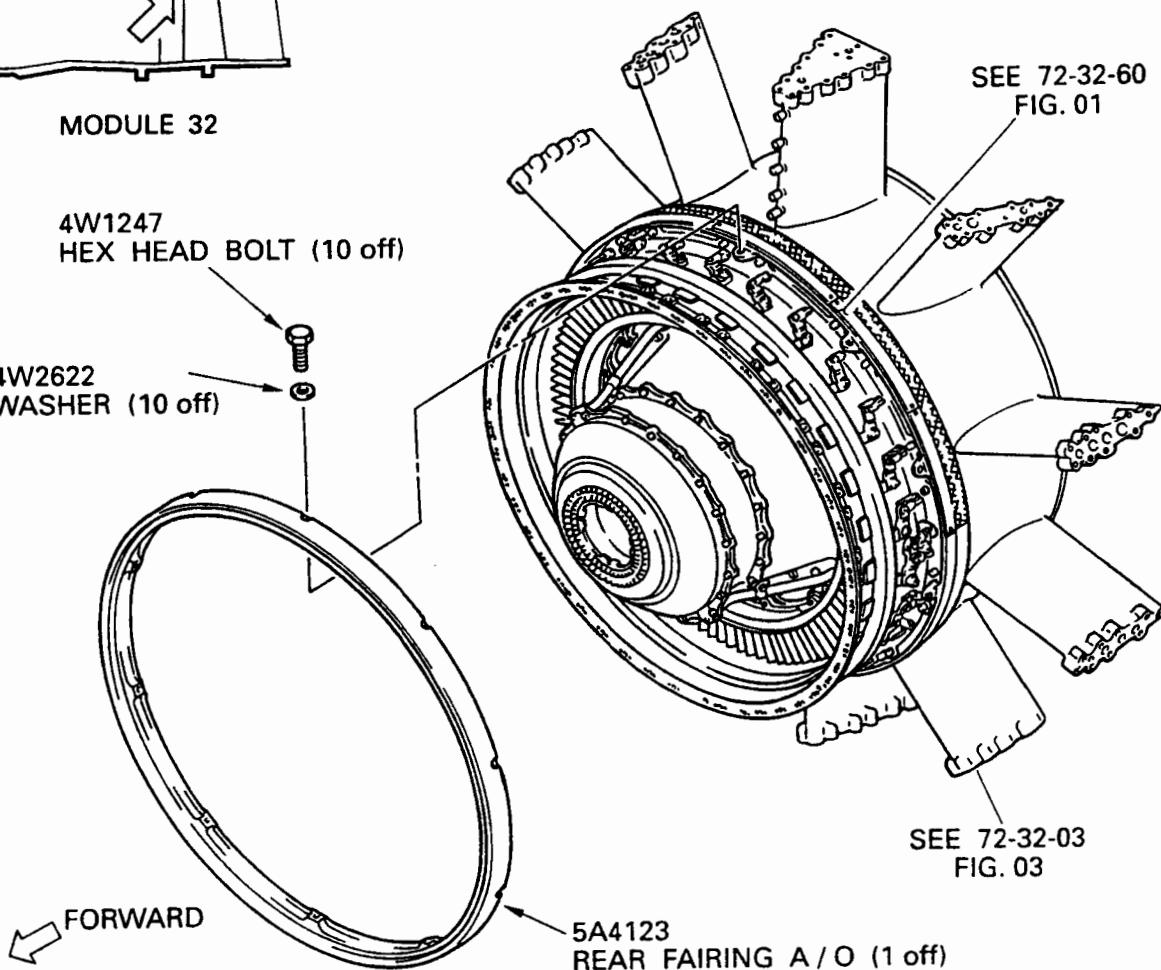
Rear Fairing Assembly - Before Alteration
Figure 1

The existing Rear Fairing Assembly can not be replaced when the engine is installed on the aircraft.
