SERVICE BULLETIN

ENGINE - LP TURBINE - PROVIDE AN OUTER DIFFUSER SUPPORT ASSEMBLY WITH SILVER PLATED CLINCH NUTS - CATEGORY CODE 6 - MOD.ENG-72-0110

V2500-ENG-72-0110

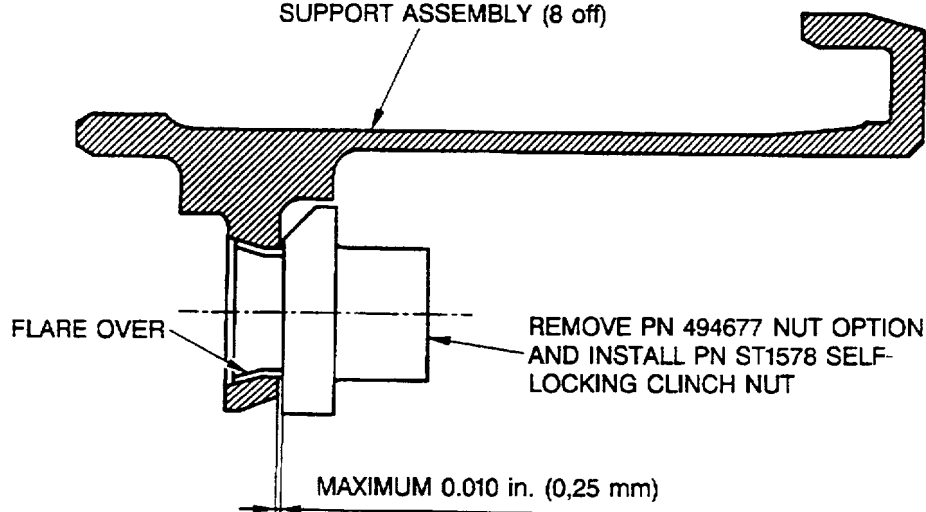
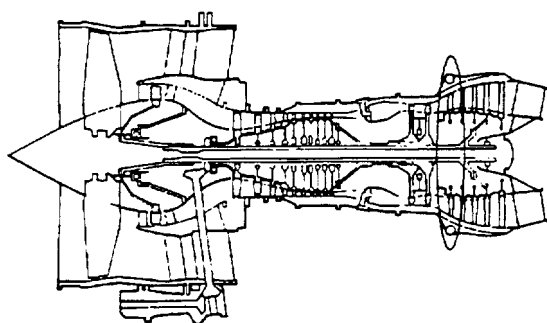
Modification of the LP Turbine Outer Diffuser Support Assembly
Fig.1

In the present configuration the Outer Diffuser Support Assemblies have fully silver plated Clinch Nuts. The silver plate can contribute to a chemical reaction which may result in sulfidation/corrosion of the support in hot gas environment.

- (1) The Self-Locking Clinch Nuts of the Outer Diffuser Support Assemblies are silver plated in the thread area only.
- (2) Existing Outer Diffuser Support Assemblies can be reworked, See Figure 1.
- (3) New Self-Locking Clinch Nuts will be available for replacement purposes.

Procedure	Supplementary Information	
(a) Machine off flared portion of clinch nut.	Refer to Figure 1. Make sure that the chamfer, bore and faces of the Support do not become damaged.

(d) Install P/N ST1578 (2 off) Self-Locking Clinch Nut onto the Support.	Refer to Figure 1. The nut shoulder must be located so that the Nut can not rotate.

(e) Flare over location diameter of Clinch Nut.	Use hydraulic portable yoke riveter. Axial movement up to 0.010in. (0.25 mm) is permitted. Refer to Figure 1.

(f) Inspect visually the assembled Clinch Nuts for cracks.	No cracks are permitted.	
(g) Inspect the Support for correct assembly	The flared area of the Nut should be continuous with no broken or rough edges.

REMOVE PN 3A0084 OUTER
DIFFUSER SUPPORT ASSEMBLY
(8 off), DO A MODIFICATION,
RE-NUMBER AND INSTALL
PN 3A1907 OUTER DIFFUSER
SUPPORT ASSEMBLY (8 off)
