ENGINE - DIFFUSER AND COMBUSTOR GROUP - PROVIDE A NEW NO.4 BEARING SUPPORT ASSEMBLY
WITH INCREASED DURABILITY - CATEGORY CODE 5 - MOD.ENG-72-0112

V2500-ENG-72-0112

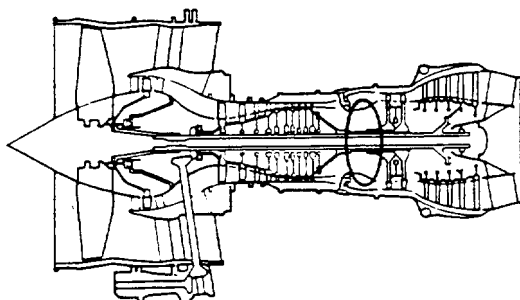
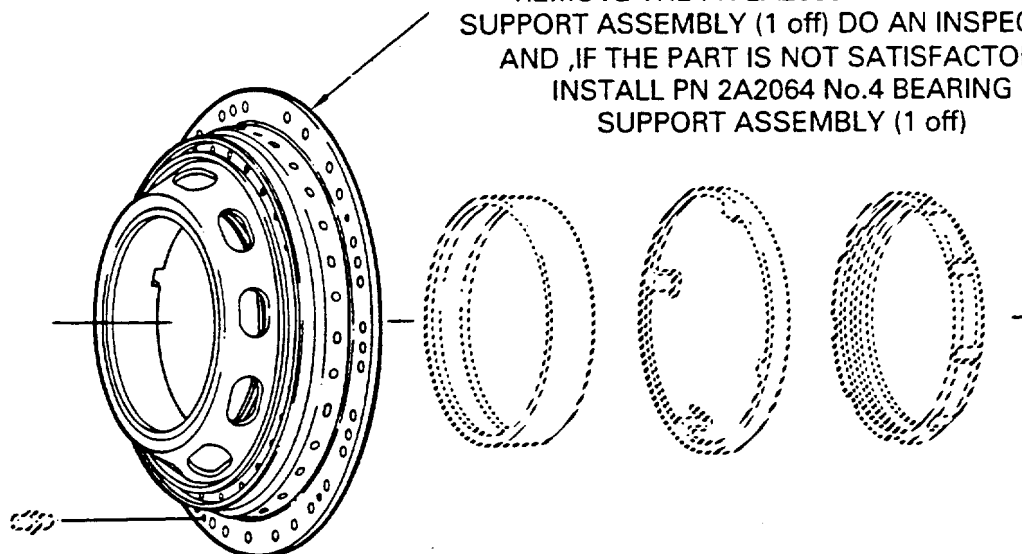
Location of No.4 bearing support assembly
Fig.1

REMOVE THE PN 2A2038 No.4 BEARING
SUPPORT ASSEMBLY (1 off) DO AN
INSPECTION AND IF ACCEPTABLE,IDENTIFY
AND INSTALL AS PN 2A2461 No.4 BEARING
SUPPORT ASSEMBLY (1 off)

REMOVE THE PN 2A2038 NO.4 BEARING
SUPPORT ASSEMBLY (1 off) DO AN INSPECTION
AND ,IF THE PART IS NOT SATISFACTORY,
INSTALL PN 2A2064 No.4 BEARING
SUPPORT ASSEMBLY (1 off)

- (c) If the hardness is less than 40 HRC, replace the 2A2038 No.4 Bearing Support Assembly with a 2A2064 No.4 Bearing Support Assembly. Refer to Figure 1. See paragraph D. Post-requisite Instructions.

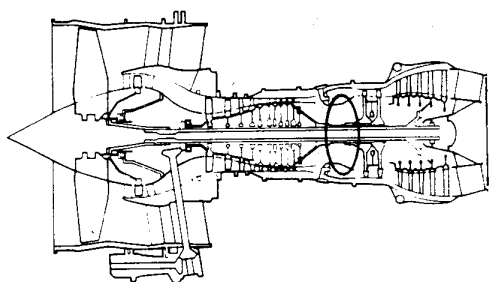
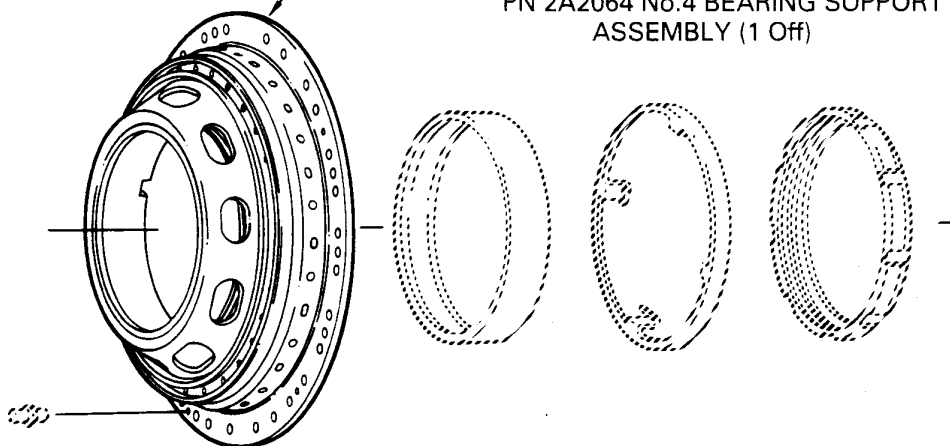
Location of No.4 bearing support assembly
Fig.2

REMOVE THE PN 2A0846 No.4 BEARING
SUPPORT ASSEMBLY (1 Off) DO A
MODIFICATION, IDENTIFY, AND INSTALL
AS PN 2A2461 No. 4 BEARING SUPPORT
ASSEMBLY (1 Off)

REMOVE THE PN 2A0846 No.4 BEARING
SUPPORT ASSEMBLY (1 Off) AND INSTALL
PN 2A2064 No.4 BEARING SUPPORT
ASSEMBLY (1 Off)

(c) Mark the New part Number adjacent to the Old Part Number. Use the vibration peen method.	OLD PART NO.	NEW PART NO.
	2A0846	2A2461
	Refer to Figure 2 and Figure 3, Sheet 2 requirements Refer to Reference (3) Control No./Task No. 70-09-00-400-501.	
Replace the 2A0846 No.4 Bearing Support Assemblies (Reference (1) Fig/Item No. 01-010) with more than 2800 engine cycles. Use a 2A2064 No.4 Bearing Support Assembly. Refer to Figure 2.

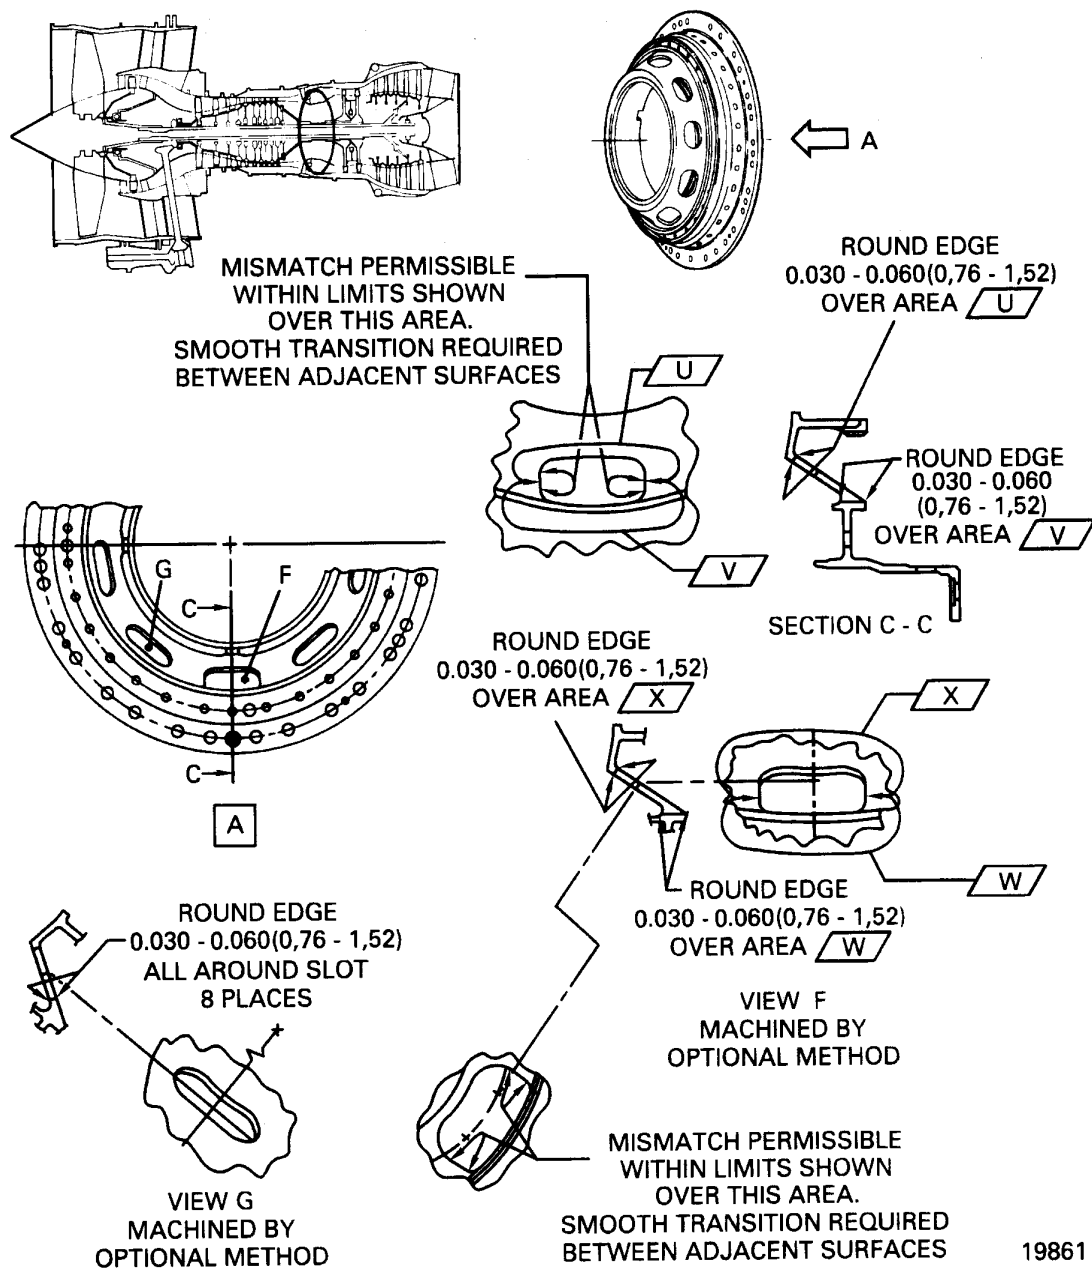
Modification of No.4 bearing support assembly
Fig.4

(b) The No.4 Bearing support has eight slots based on nine equally spaced slots and one rectangular oil drain slot at the six o'clock position. A higher than anticipated stress concentration has been found in the corners of the rectangular slot.

(b) A analytical review has determined that the rectangular oil drain slot corners have an increase in stress concentration. This could reduce the durability of the No.4 Bearing support.

Procedure	Supplementary Information	
(a) Round the edges of all slots in the No. 4 Bearing Support Assembly.	Refer to Figures 2 and 4 requirements.	
(b) Shotpeen the No. 4 Bearing Support Assembly to an intensity of 6A using SAE 170 maximum cast steel shot (Hardness 45-55 HRC or equivalent by TASK 70-38-13-380-501 (AMS 2430)).	Refer to Figures 2 and 5 requirements. Refer to the approved procedure in Reference (3), Chapter/Section 70-38-13 Surface Treating.	
NOTE: Overspray is permitted on all other surfaces if not differently specified.
