SERVICE BULLETIN

ENGINE - NO. 4 BEARING COMPARTMENT - PROVIDE A NEW NO. 4 BEARING PRESSURE TUBE ASSEMBLY
- CATEGORY CODE 6 - MOD.ENG-72-0115

V2500-ENG-72-0115

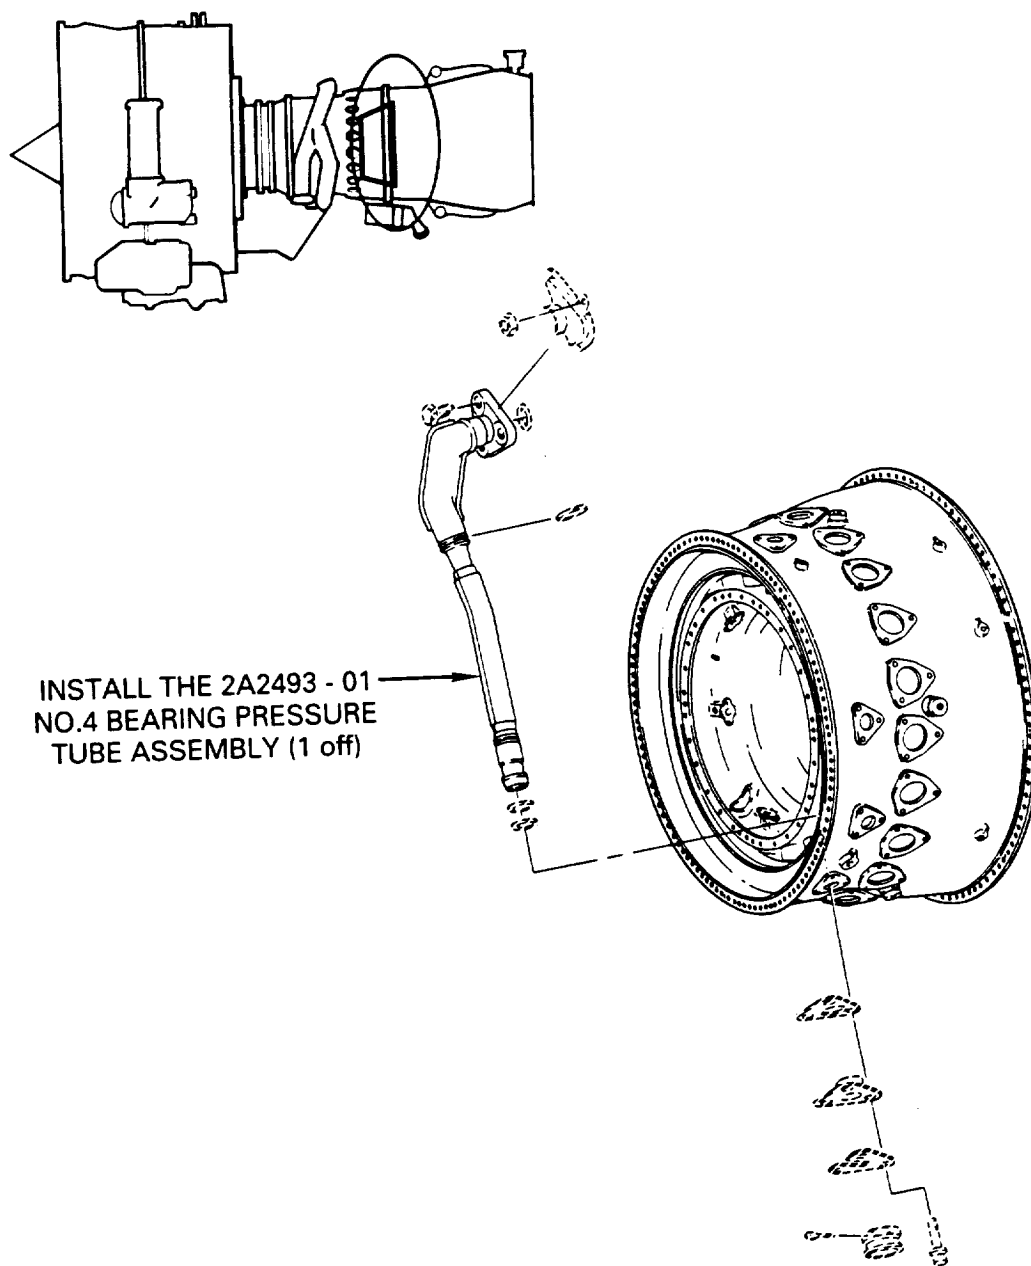
Location of the No.4 Bearing Pressure Tube Assembly
Fig.1

Internal oil coking has been found near the holes in the No. 4 Bearing Pressure Tube Heat Shield.

Borescope inspection of the No. 4 Bearing Oil Tube Assemblies on two test engines showed internal oil coking. It was found that the coking was caused by the two gaps, formed by the two cut-outs which are at each corner of the two Oil Tube Heat Shield Halves.

- (1) A new No. 4 Bearing Pressure Tube Assembly with new heat shields that do not have the gaps at each end of the heat shield halves.

- (1) Install the 2A2493-01 No.4 Bearing Pressure Tube Assembly (1 off). Use the approved procedure in Reference (1), Chapter/Section 72-42-10, Assembly.
