# SERVICE BULLETIN

ENGINE - LP TURBINE - PROVIDE A NEW LP TURBINE SHAFT THAT ELIMINATES NITRIDING ON THE SPLINE - CATEGORY CODE 7 - MOD.ENG-72-0117

V2500-ENG-72-0117

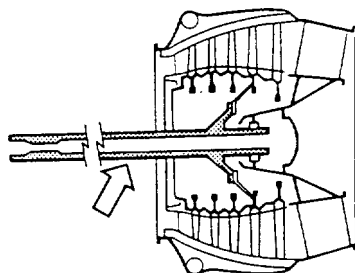
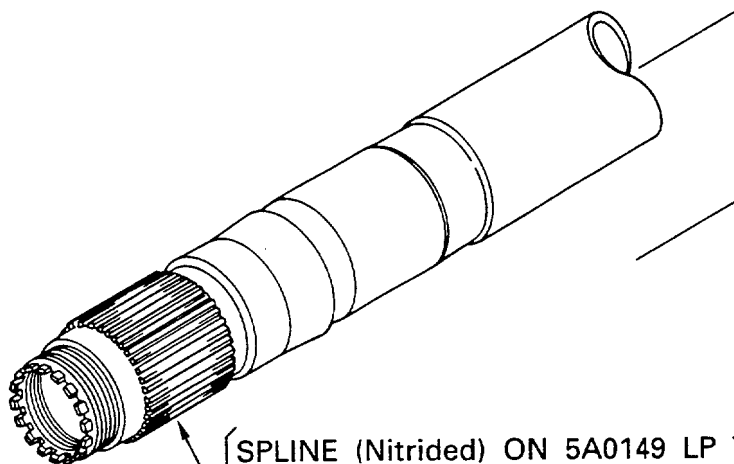
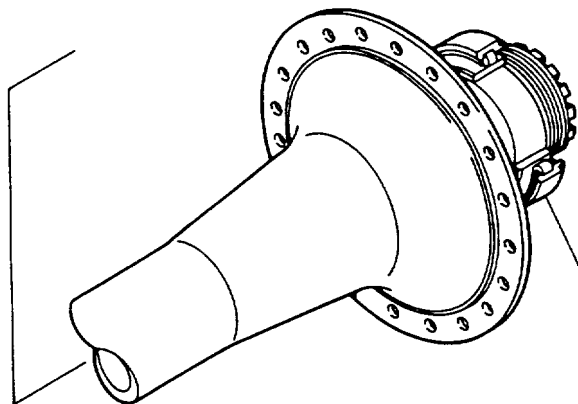
LP Turbine Shaft - Before and After Alteration  
Fig.1

(a) New LP Turbine Shaft which is not nitrided on the spline has been introduced (See Figure 1).

SPLINE (Nitrided) ON 5A0149 LP TURBINE SHAFT  
- BEFORE ALTERATION

SPLINE (Not nitrided) ON 5A0892 LP TURBINE SHAFT  
- AFTER ALTERATION

- (1) Install 5A0892, LP Turbine Shaft, to the LP Turbine Module by the approved procedures in the Engine Manual, 72-50-00, Assembly-01, TASK 72-50-00-430-001 (Refer to 1.K. (2)).
