DATE ~~R~~ Dec. 6/02**V2500-A1 PROPULSION SYSTEMS SERVICE BULLETIN**

This document transmits Revision 5 to Service Bulletin EV2500-72-0120

V2500-ENG-72-0120

ENGINE - NO.4 BEARING COMPARTMENT - PROVIDE A NEW NO.4 BEARING SCAVENGE TUBE ASSEMBLY
AND GASKET

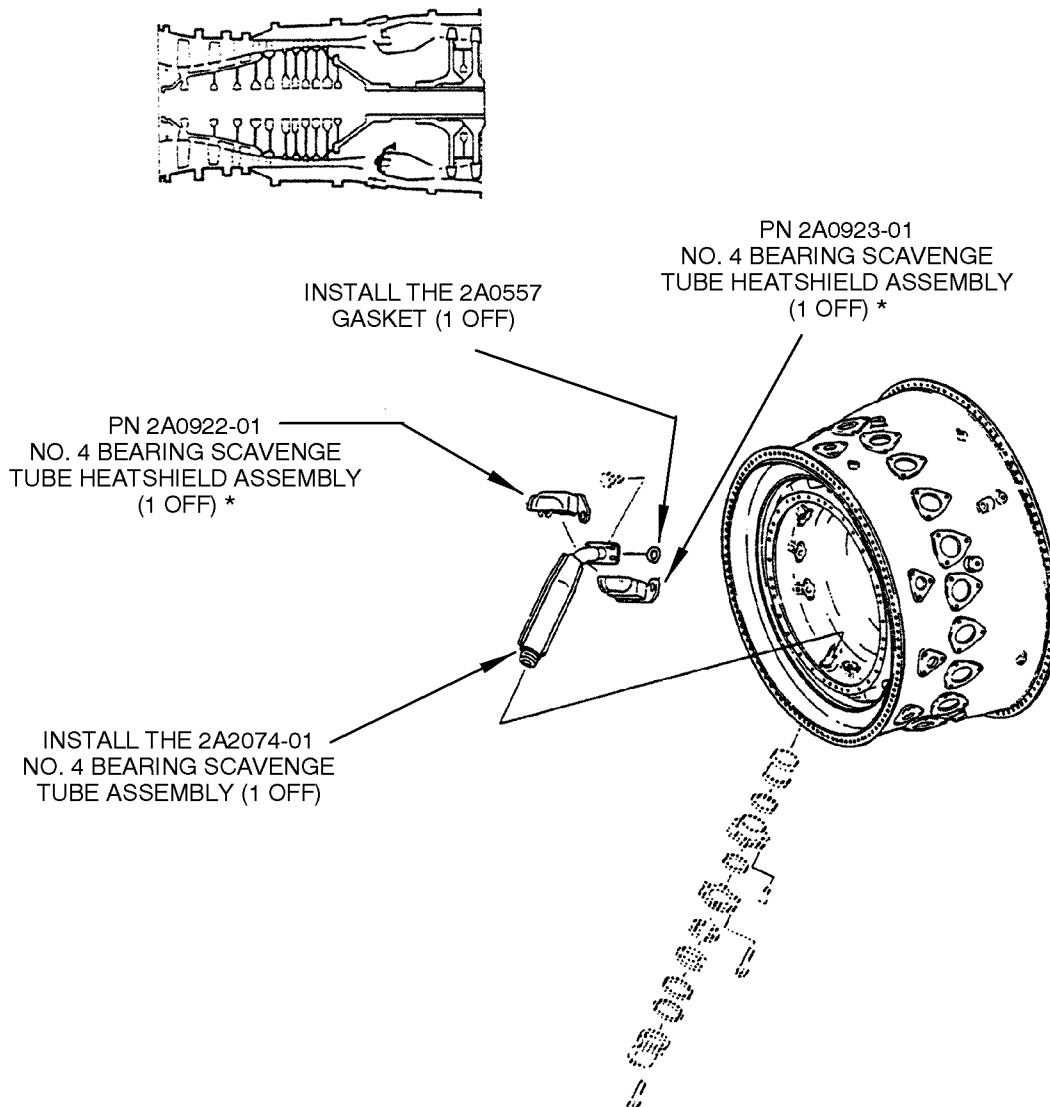
Location of the No.4 Bearing Scavenge Tube Assembly For Engines Which Incorporate
Reference (2), But Do Not Incorporate Reference (3)
Fig.1 (Sheet 1 of 2)

* THESE PARTS ARE REMOVED AND WILL
NOT BE INSTALLED AGAIN WITH THE NEW
CONFIGURATION

- (1) Install the 2A0557 Gasket and the 2A2074-01 No.4 Bearing Scavenge Tube Assembly (1 off). Use the approved procedure in Reference (1), Chapter/Section 72-42-00, Assembly. See Figure 1.
- (2) Do not install the No.4 Bearing Tube Heatshields 2A0922-01 and 2A0923-01 when you do this Service Bulletin, for engines which do not incorporate Reference (2), and for engines which incorporate Reference (3). See Figure 1.
