SERVICE BULLETIN

ENGINE - HP TURBINE ROTOR AND STATOR ASSEMBLY - PROVIDE NEW HPT BAND SEGMENT ASSEMBLIES
AND NEW HPT DUCT SUPPORT ASSEMBLIES - CATEGORY CODE 8 - MOD.ENG-72-0124

V2500-ENG-72-0124

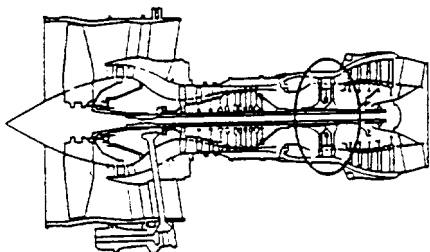
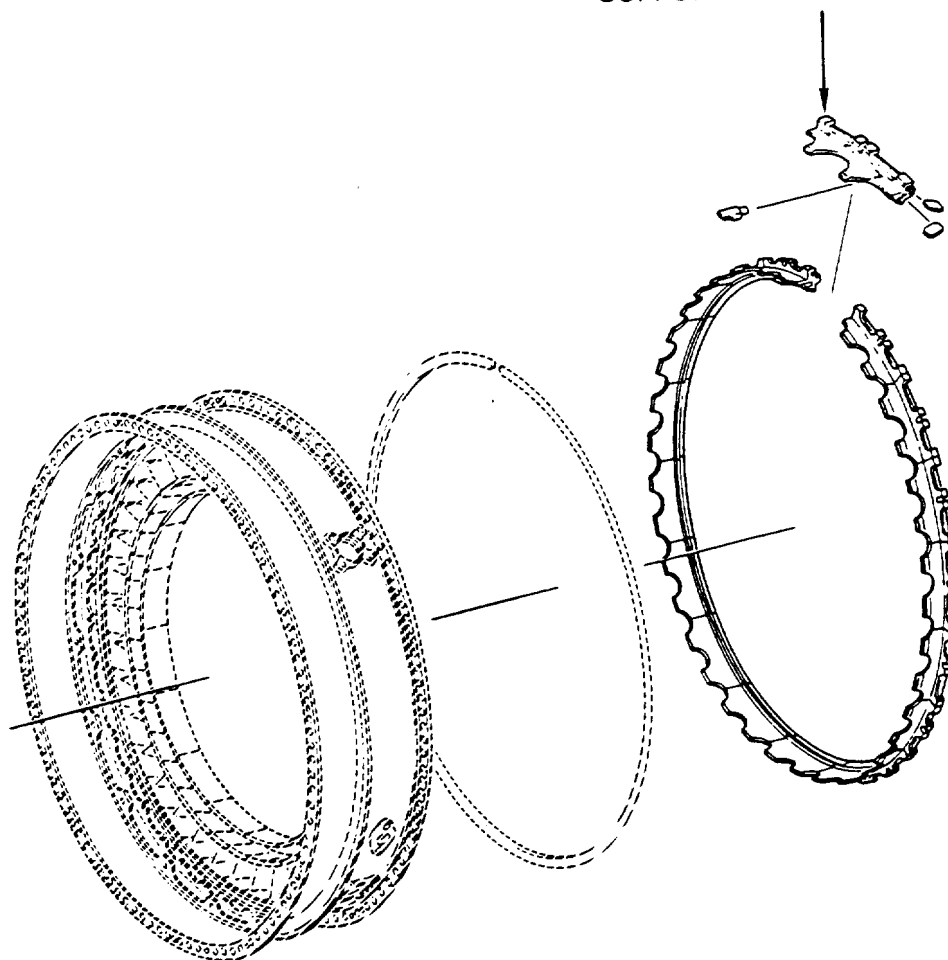
Location of Stage 2 HPT Duct Support Assembly
Fig.1

REPLACE THE 2A0189
STAGE 2 HPT DUCT SUPPORT
ASSEMBLIES WITH THE 2A2270
STAGE 2 HPT DUCT
SUPPORT ASSEMBLIES (19 off)

- (1) Install the 2A2270 Stage 2 HPT Duct Support Assembly (19 off) by the procedure given in Reference (4), Chapter/Section 72-45-20, Assembly-01. Refer to Figure 1.
- (2) Install the 2A2269-01 Stage 2 HPT Band Segment Assemblies (1 off) and the 2A2271-01 Stage 2 HPT Band Segment Assemblies (2 off). Use the procedure given in Reference (4), Chapter/Section 72-45-20, Assembly-01. Refer to Figure 2.

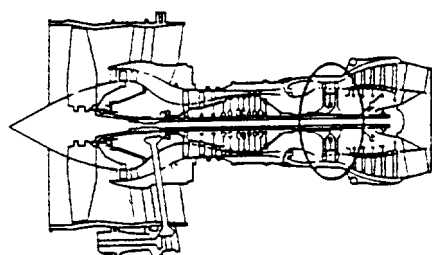
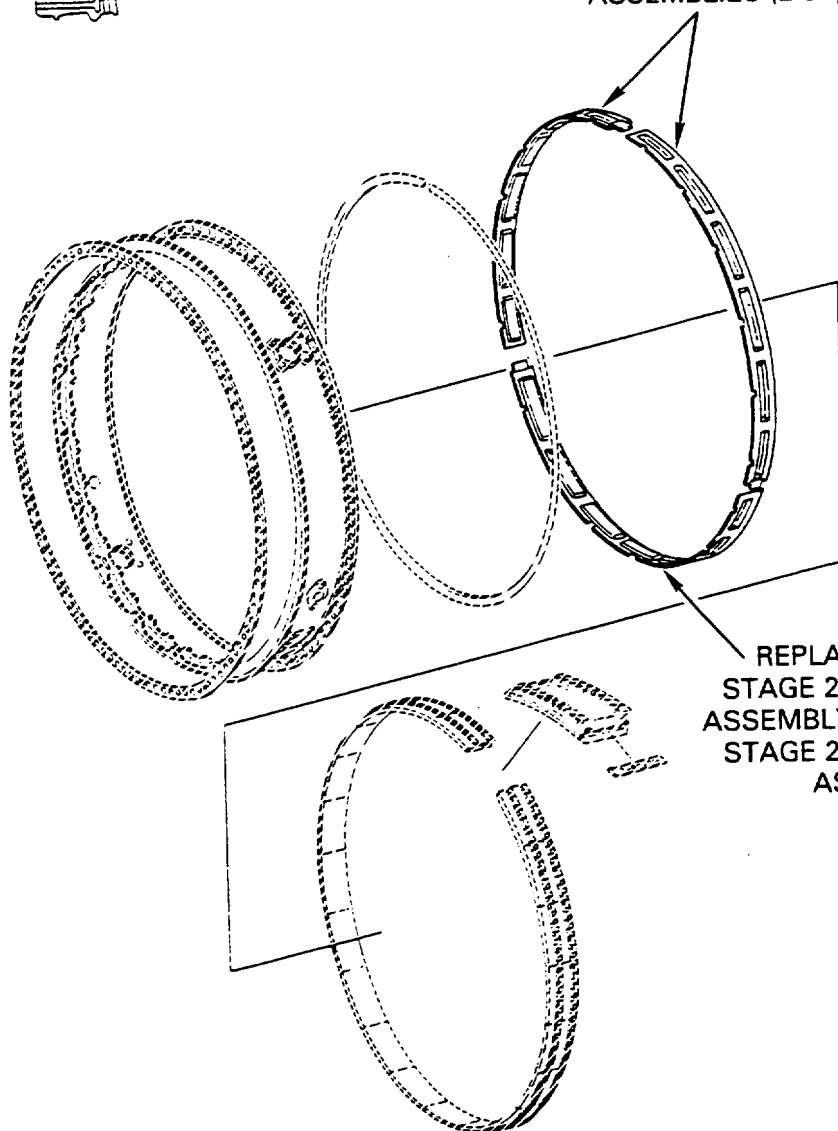
Location of Stage 2 HPT Band Segment Assembly
Fig.2

REPLACE THE 2A0195 - 01
STAGE 2 HPT BAND SEGMENT
ASSEMBLIES WITH THE 2A2271 - 01
STAGE 2 HPT BAND SEGMENT
ASSEMBLIES (2 off)

REPLACE THE 2A0198 - 01
STAGE 2 HPT BAND SEGMENT
ASSEMBLY WITH THE 2A2269 - 01
STAGE 2 HPT BAND SEGMENT
ASSEMBLY (1 off)
