## V2500-A1 SERIES PROPULSION SYSTEMS SERVICE BULLETIN

# V2500-ENG-72-0125

ENGINE – LP TURBINE – INCORPORATE LPT DISK AND DIFFUSER SUPPORT ASSEMBLY NUTS WITH  
REVISED COATING

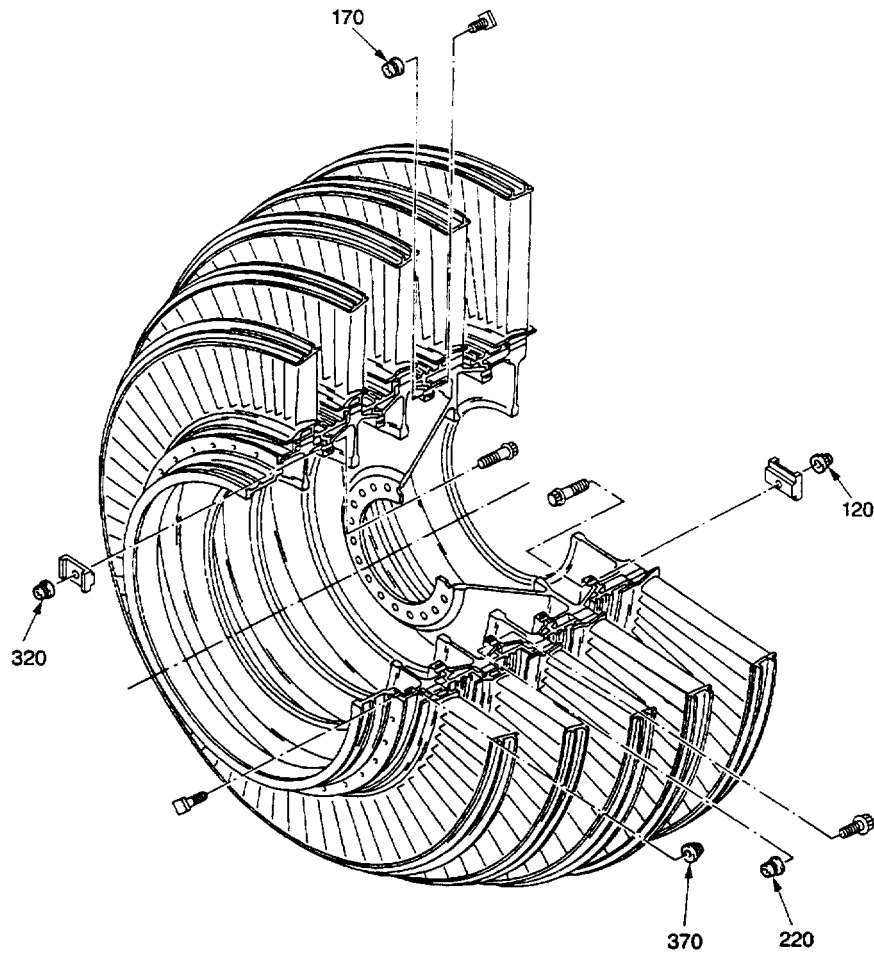
LPT rotor assembly  
Figure 1

R The silver plating causes corrosion on the Low Pressure Turbine (LPT)  
R disks and on the diffuser support ring.

Silver coating as antiseize is necessary and effective in the threaded area only. Liberated silver particles may act as corrosion catalyst.

(1) New nuts for the LP turbine rotor connection with silver plating in the threaded area only are now available.
