ENGINE - LP COMPRESSOR - LPC BLEED VALVE LINKAGE SYSTEM WITH IMPROVED DURABILITY -
CATEGORY CODE 8 - MOD.ENG-72-0133

V2500-ENG-72-0133

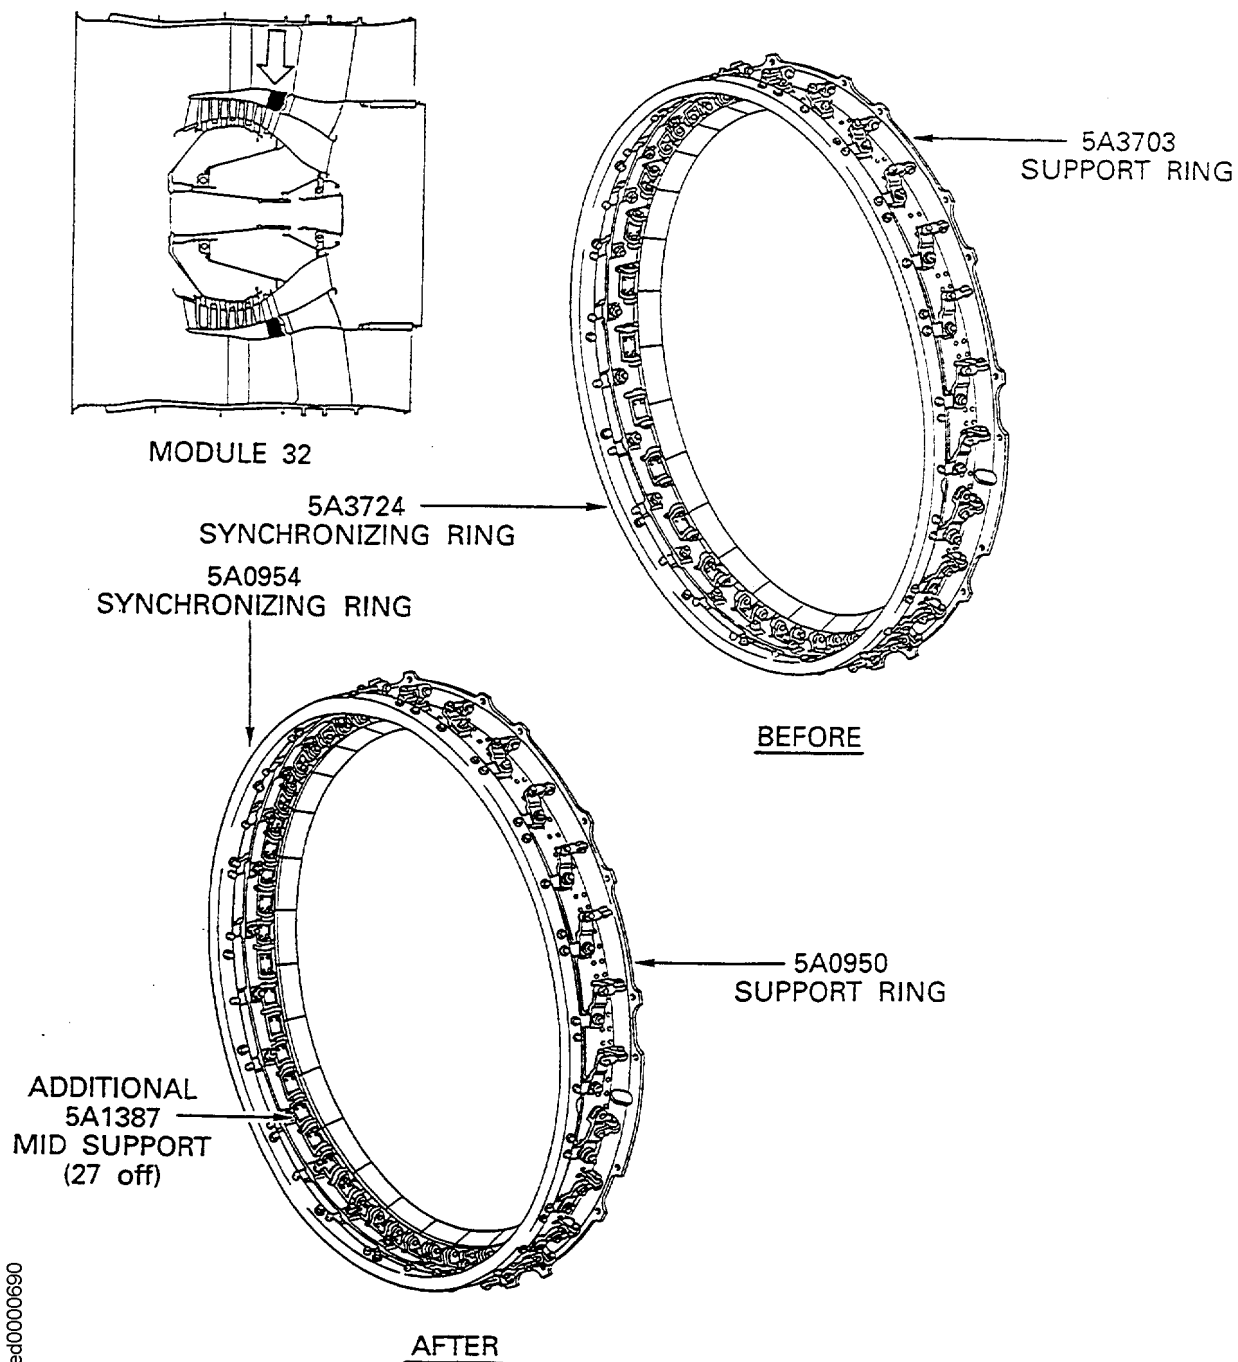
LPC Bleed Valve Linkage System - Before and After Alteration
Fig.1

Wear has been observed on pins and bushes of LPC bleed valve linkages.

This condition has been noted on the development engine during strip inspection. An analysis of bleed valve linkage system has shown the necessity of stiffened linkage connecting parts and the linkage support.

- (1) The changes introduced by this Service Bulletin are as follows;
- (a) Additional mid-supports are fabricated in around the Support Ring A/0 to increase the stiffness of the Bleed Valve Mechanism. (See Figure 1)
 - (b) Pins and Nuts which connect the Bleed Valve to the Link Arm have been changed to improve linkage system durability. (See Figure 4 Sheet 2)
 - (c) Additional bushes are fitted on the Synchronize Ring. (See Figure 4 Sheet 6)
 - (d) The Synchronize Ring Guides and the Guide Pins have been changed to increase the diameter.
 - (e) The procedures for adjusting the Actuating Rods are changed.
- (2) Old Part Number 5A3703, Support Ring A/0 can be reworked to the new configuration. (See Figure 2, Sheet 1, 2, 3 and 4)
- (3) Old part number 5A3724, Synchronizing Ring can be reworked to the new configuration. (See Figure 3, Sheet 1, 2, 3 and 4)
