SERVICE BULLETIN

ENGINE - LP TURBINE ASSEMBLY - REPLACEMENT OF LP TURBINE BLADES STAGE 3 - CATEGORY CODE 6 - MOD.ENG-72-0134

V2500-ENG-72-0134

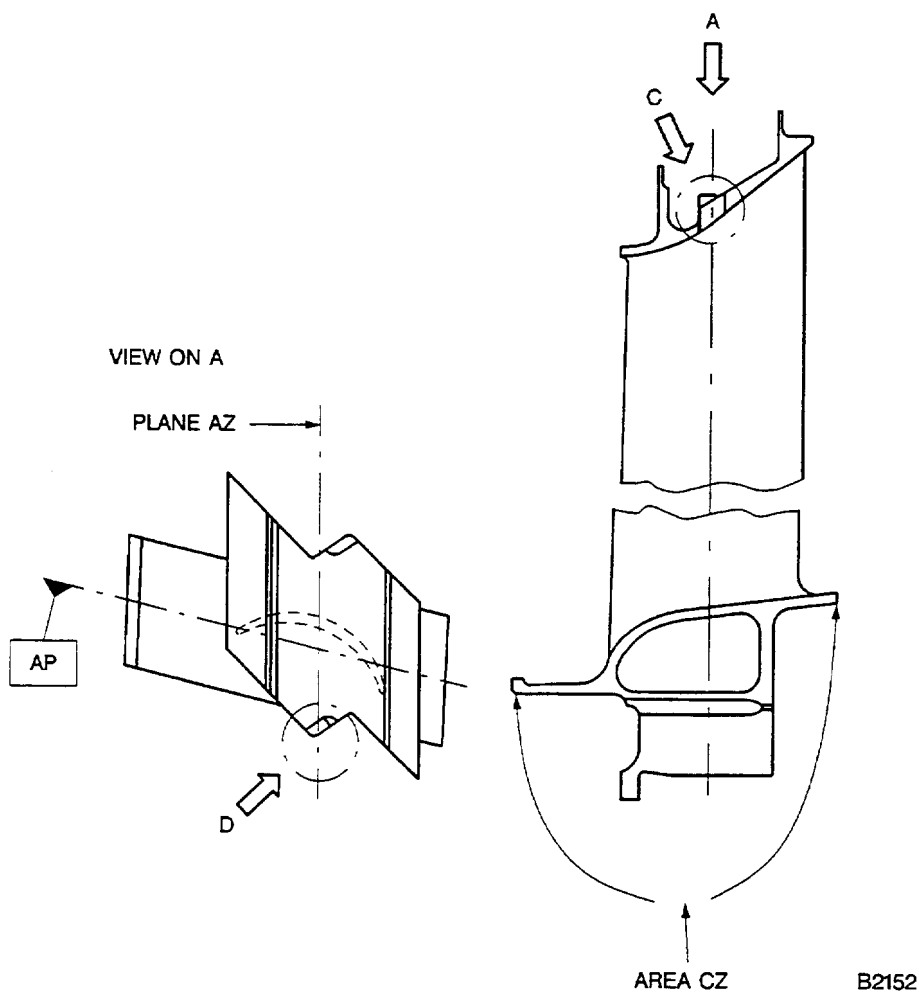
Turbine blade outer shroud overlap (shingling) may occur when handling or reassembling Stage 3 LP turbine rotor assemblies with used turbine blades.

This condition was observed during assembly of development engines. Outer shroud overlap (shingling) has not been reported in service. Undetected shroud overlap (shingling) may cause engine damage during subsequent engine test.

Shingling of LP turbine stage 3 rotor blades – preparation of build up welding
Fig.1

To ensure the correct assembly of Stage 3 LP turbine rotor blades by introducing a blade outer shroud stop on existing blades.

To increase shroud thickness locally.

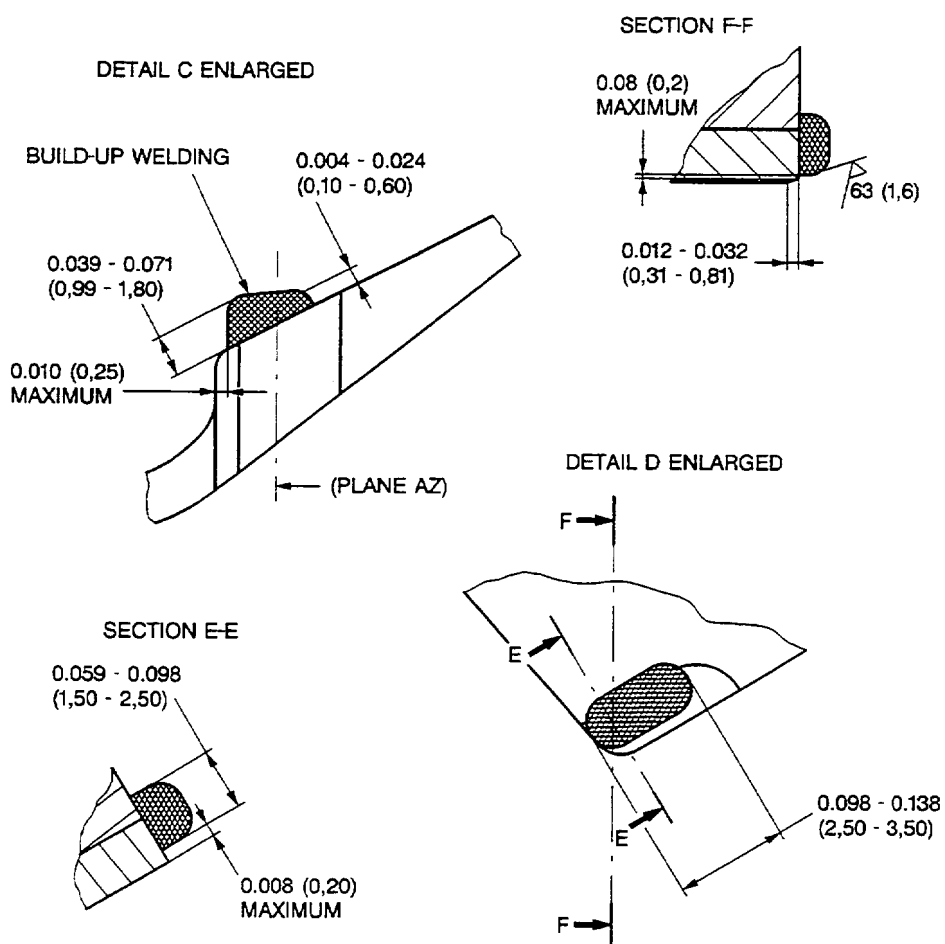
LP turbine stage 3 rotor blades - Build up welding dimensions
Fig.2

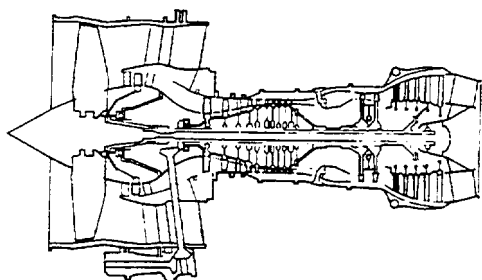
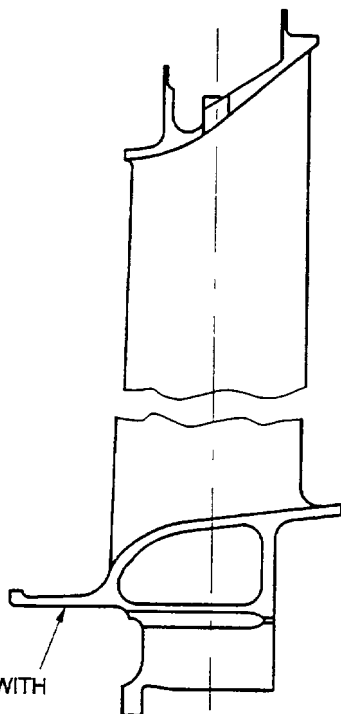
Reidentification of LP turbine stage 3 rotor blades
Fig.3

REIDENTITY WITH
PN3A2053

(1D) Old part can be removed and reidentified to the new part number
