ENGINE - LP COMPRESSOR- DELETION OF POLYRUETHANE COATING ON FRONT FAIRING ASSEMBLY -
CATEGORY CODE 8 - MOD.ENG-72-0136

V2500-ENG-72-0136

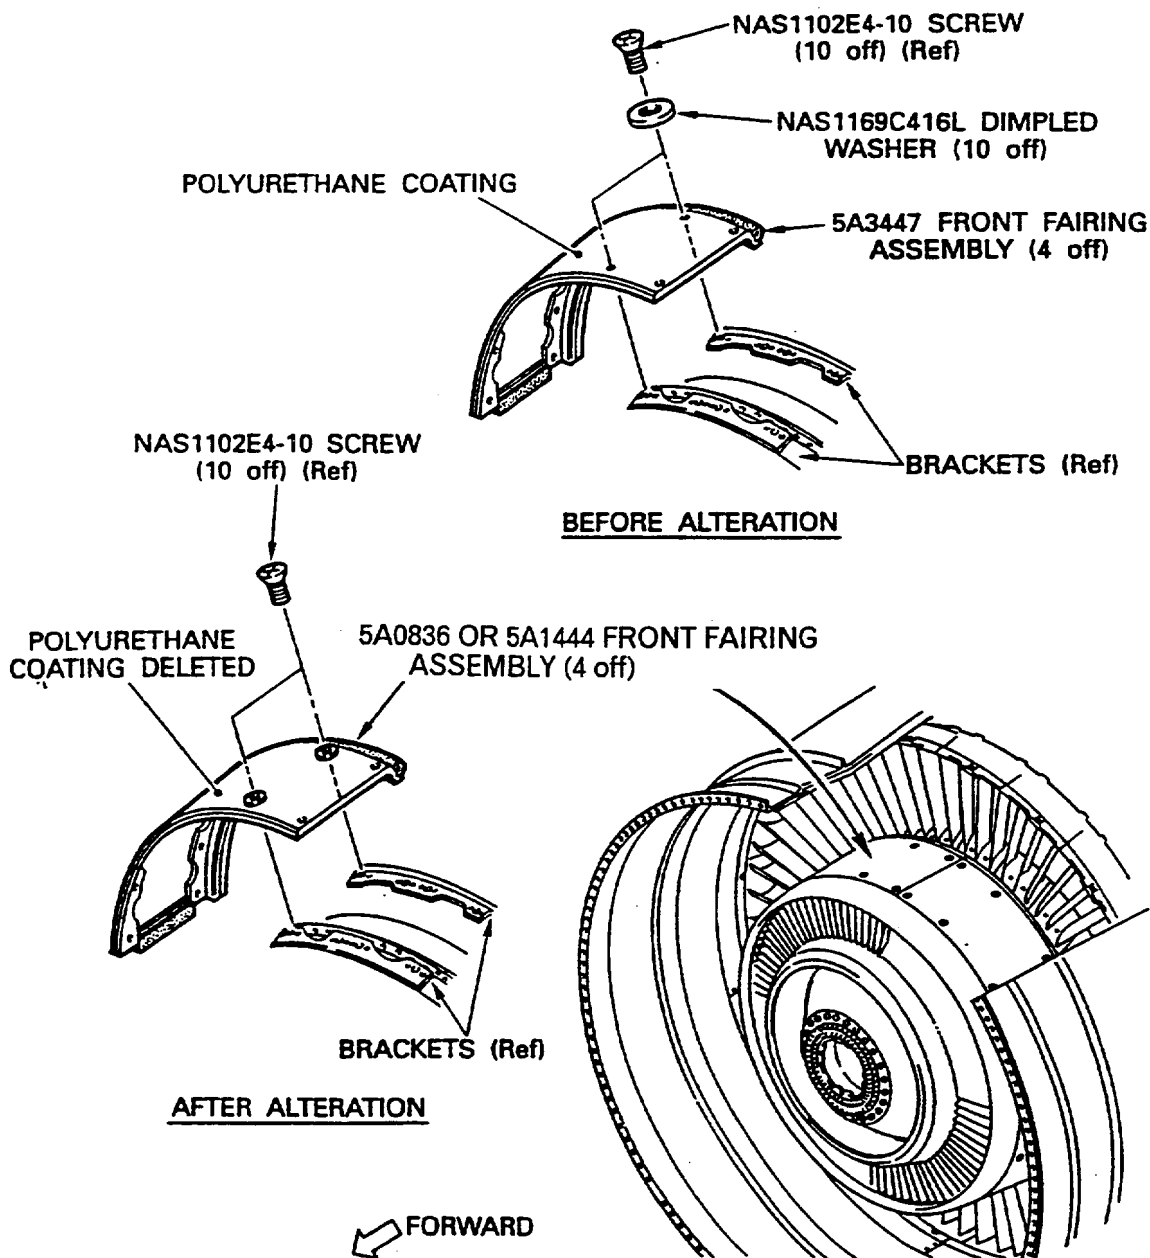
Installation of the Front Fairing Assembly - Before and After Alteration
Fig.1

- (1) The changes introduced by this Service Bulletin are as follows.
 - (a) The polyurethane coating on the outer surface of front fairing assembly has been deleted (See Figure 1).
 - (b) The dimpled washers which attach the front fairing assembly to the bracket are bonded on to the front fairing assembly (See Figure 1.).
- (2) Old part can be reworked and reidentified to the new configuration which is applicable to the service use only by incorporation of bonding of the dimpled washers on to the front fairing assembly (Refer to Figure 2.).
- (3) New front fairing assembly will be available for future replacement purposes.
