# SERVICE BULLETIN

ENGINE – FAN CASE ASSEMBLY – PROVIDE SHORTER FAN EXIT GUIDE VANE BOLT TO ELIMINATE INTERFERENCE BETWEEN BOLT AND EEC MOUNT BRACKET – CATEGORY CODE 4 – MOD.ENG-72-0140

V2500-ENG-72-0140

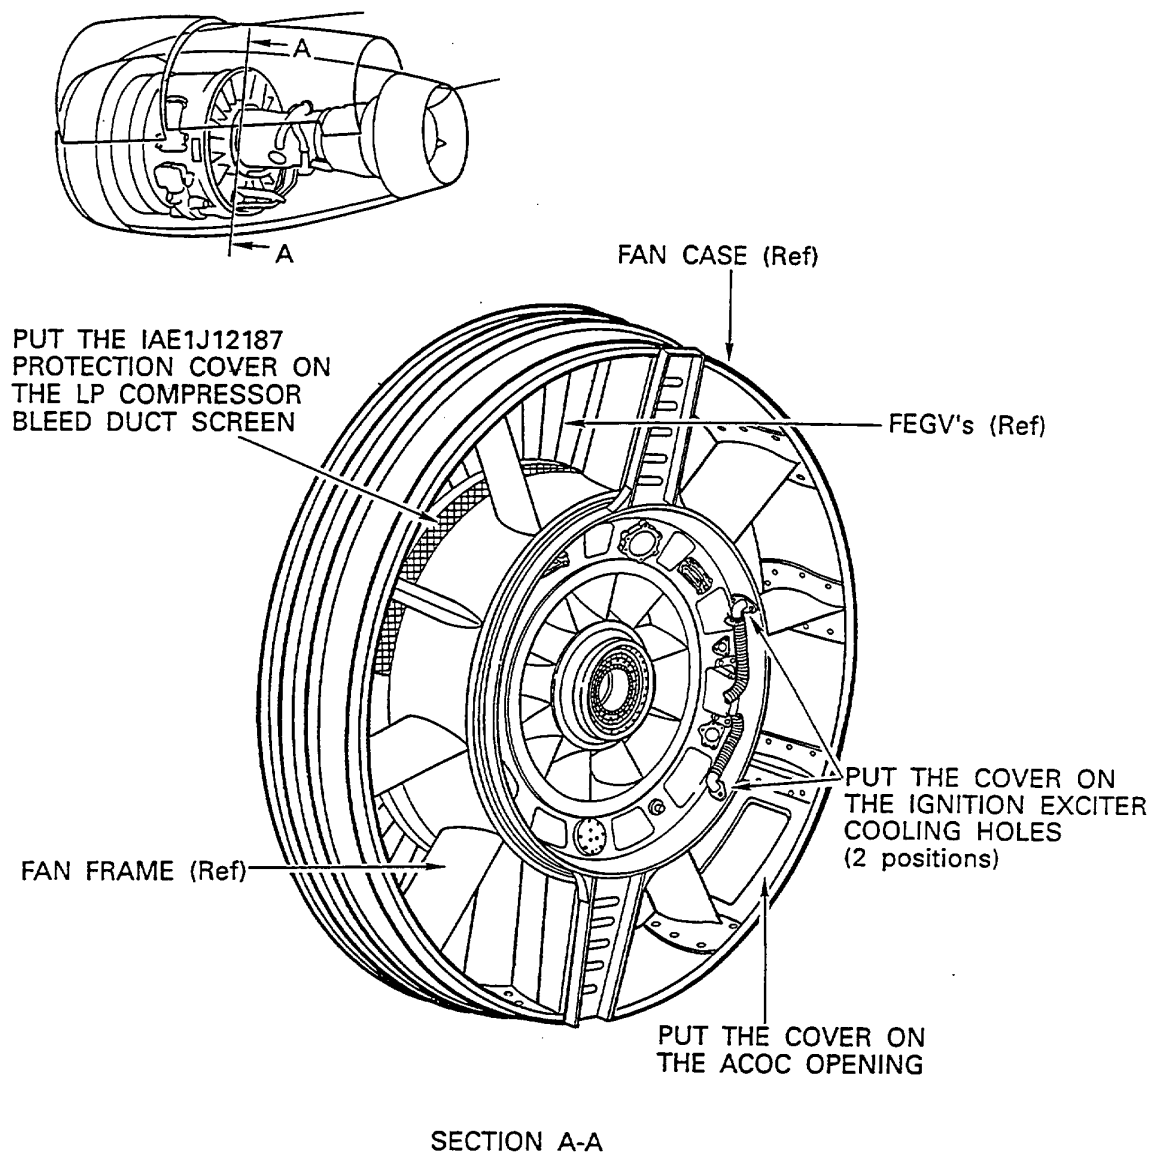
Location of the openings to be protected  
Fig.1

- (5) Remove the inlet cone by the approved procedures in Reference (3), Chapter/Section 72-38-11, Removal.
- (6) Remove the 22 stage 1 fan blades and annulus fillers by the approved procedures in Reference (3), Chapter/Section 72-31-11, Removal.
- (7) Put the IAE1J12187, protection cover on to the LP compressor bleed duct screen and put the covers on all of other openings in the fan case and the fan frame (Refer to Figure 1).

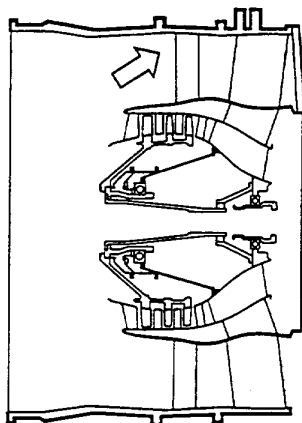
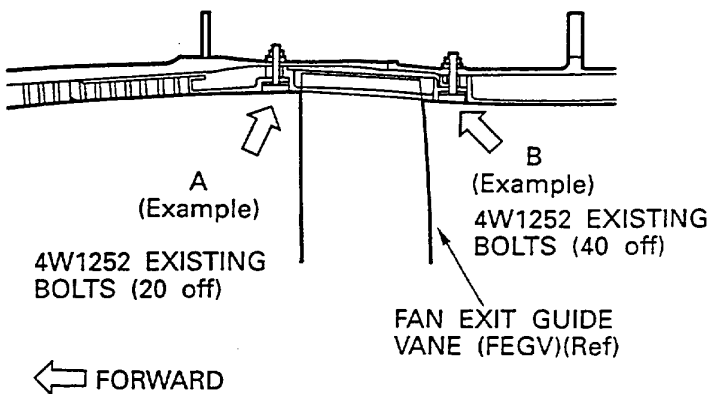
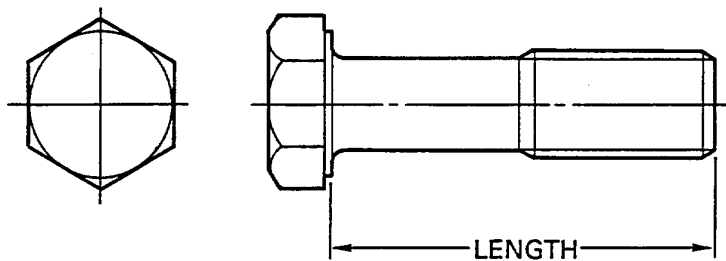
Alteration of the FEGV Bolts  
Fig.2

The potential interference between fan case bolt and EEC mount bracket.

It was determined that the length of bolts which secure the Fan Exit Guide Vanes (FEGV) to the Fan Case Assembly, would be shortened in order to prevent potential interference with the EEC mount bracket.

*EXISTING BOLT LENGTH	1.125(28,6)
NEW BOLT LENGTH	1.000(25,4)

- (1) Find the outer platforms of the FEGV that is installed on the engine.
- (2) Remove the 20 4W1252, Bolts which attach the FEGV to the Fan Case Assembly refer to Reference (3), Chapter/Section 72-32-88, Removal (Refer to Figure 2).
- (3) Install the new 20 4W1250, Bolts refer to Reference (3), Chapter/Section 72-32-88, Installation (Refer to Figure 2).
- (4) Torque the Bolts to 85 to 105 lbfin (10,00 to 12,00 Nm).
- (5) Remove the 40 4W1252, Bolts which attach the FEGV to the Fan Case Assembly refer to Reference (3), Chapter/Section 72-32-88, Removal (Refer to Figure 2).
- (6) Install the new 40 4W1250, Bolts refer to Reference (3), Chapter/Section 72-32-88, Installation (Refer to Figure 2).

- (7) Torque the Bolts to 85 to 105 lbfin (10,00 to 12,00 Nm).

\*REMOVE 4W1252 (60 off) BOLTS FROM A AND B ALL POSITIONS AND INSTALL NEW 4W1250 (60 off) BOLTS TO THE A AND B ALL POSITIONS
