SERVICE BULLETIN

ENGINE – PROVIDE A NEW CARBON SEAL FOR THE NO.5 BEARING COMPARTMENT – CATEGORY CODE 6
– MOD.ENG-72-0142

V2500-ENG-72-0142

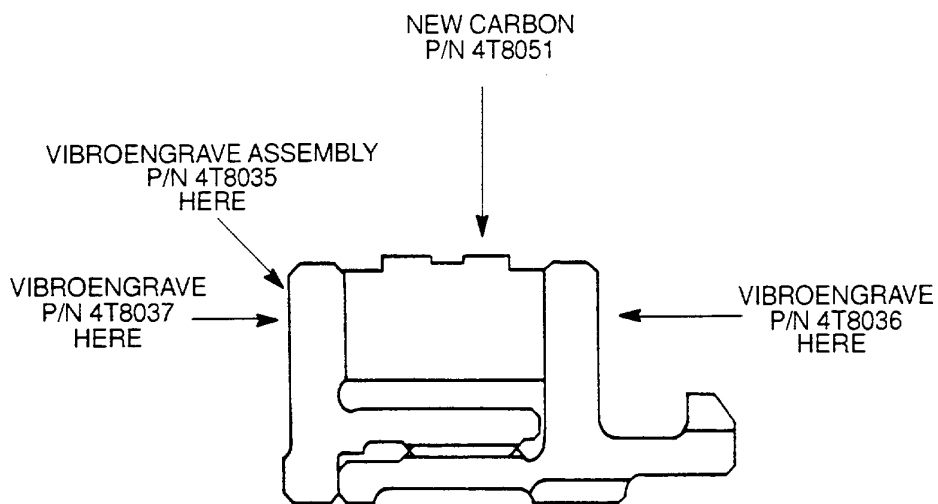
Reidentification of the Seal Components
Fig.1

(a) Wear may occur on existing wave spring and loading rings inside the seal assembly.

- (4) Scrap the carbon rings, the loading rings and the wave spring. Retain the spacers.
- (5) Clean the spacers as specified in the SPM TASK 70-11-22.
- (6) Mark the new part number on the spacers as shown in figure. Use a vibropeen. Remove high metal.

- (10) Fully seat the spacers. Torque to 26 to 95 lbfin (2,94 to 10,79 Nm),
- (11) Renumber the carbon seal assembly
 - (a) Cancel the P/N 4T8002 electrochemical etched. use a vibropeen.

- (b) Vibroengrave the new assembly P/N 4T8035 adjacent to cancelled one.
 - (c) Remove high metal.
