ENGINE - HP COMPRESSOR - DELETION OF THE HEAT SHIELD AT THE OUTLET GUIDE VANE INNER
CASE LOCATION - CATEGORY CODE 6 - MOD.ENG-72-0143

V2500-ENG-72-0143

SERVICE BULLETIN

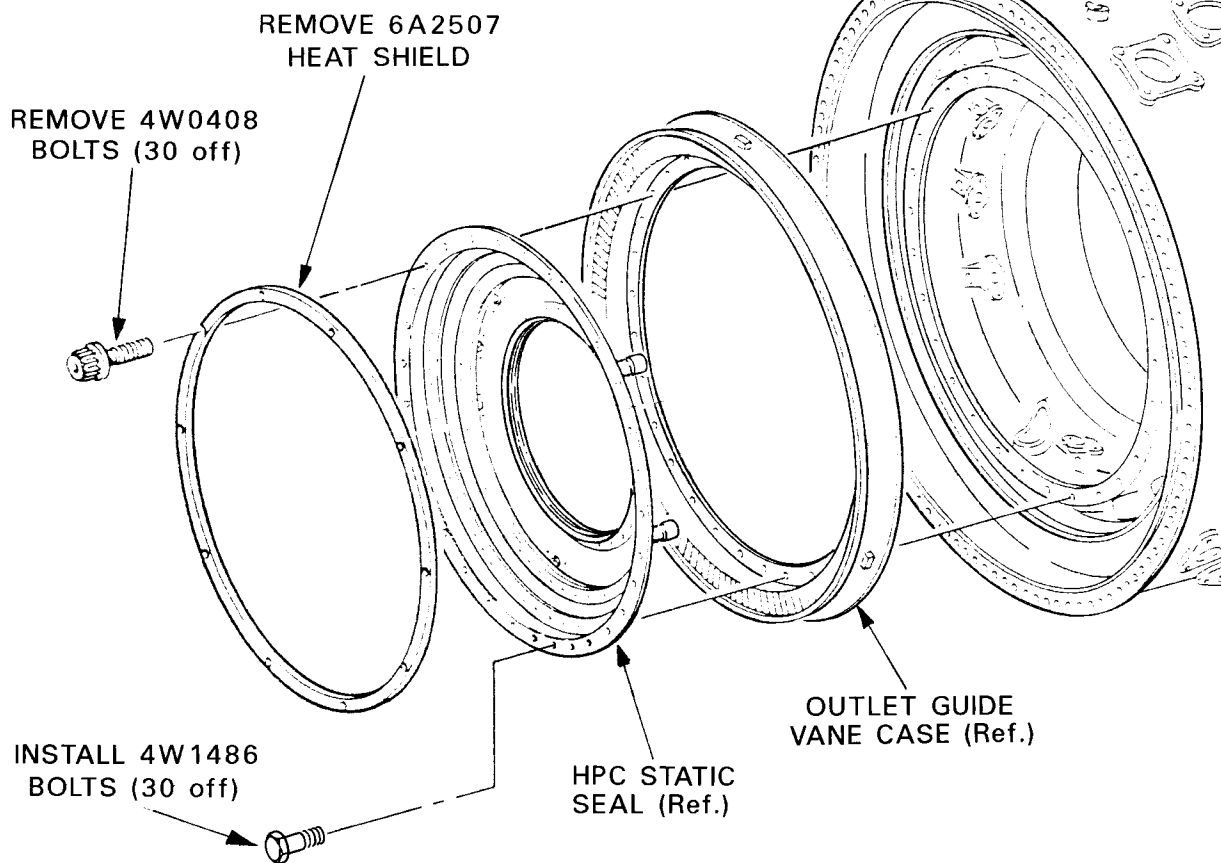
Location of heat shield
Fig.1

The outlet guide vane case on the HP compressor module is secured to the diffuser case by 30 bihex bolts. To minimise possible disturbance of the gas flow caused by the protruding bolt heads a shield is located over the heads. This shield was originally considered to be necessary to ensure that generation of 'windage' heat into the cavity behind the stage 12 rotor disc did not occur.

- (a) The heat shield at the outlet guide vane case inner location is deleted.
- (b) The 30 bihex head bolts securing the shield to the diffuser case are replaced with lower profile plain hex. head bolts whose projection is less than half that of the existing bolts.
