SERVICE BULLETIN

<u>ENGINE - HP TURBINE ROTOR AND STATOR ASSEMBLY - PROVIDE NEW STAGE 2 TURBINE ROTOR HUB</u>
<u>WITH INCREASED FRONT SNAP DIAMETER - CATEGORY CODE 7 - MOD.ENG-72-0145</u>

V2500-ENG-72-0145

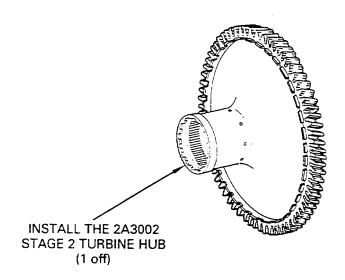
Location of the Stage 2 Turbine Hub Fig.1

The Stage 2 Turbine Hub must have the specified snap diameter to make sure the original cyclic life limit is kept.

The front snap diameter of the stage 2 Turbine Hub must be increased to make sure that the cyclic life of the part is kept.

- (1) Do a modification of the Stage 2 Turbine Hub to increase the front snap diameter.
- (2) For the effect on declared life see Reference (3), 5-10-01, Group A Parts Lives.

- A. Rework Instructions
 - (1) There are no rework instructions necessary to accomplish this Service Bulletin.
- B. Assembly Instructions
 - (1) Install the 2A3002 Stage 2 Turbine Hub by the procedure given in Reference (3), Chapter/Section 72-45-00, Assembly-01. Refer to Figure 2.
 - (2) Identify the new Stage 2 Turbine Rotor Assembly as 2A2822. Use the procedure given in Reference (2), Control No./TASK No. 70-09-00-400-501.
- C. Recording Instructions
 - (1) A record of accomplishment is necessary.
