ENGINE - HP TURBINE ROTOR AND STATOR ASSEMBLY - PROVIDE A NEW STAGE 1 HPT BLADE -
CATEGORY CODE 7 - MOD.ENG-72-0146

V2500–ENG–72–0146

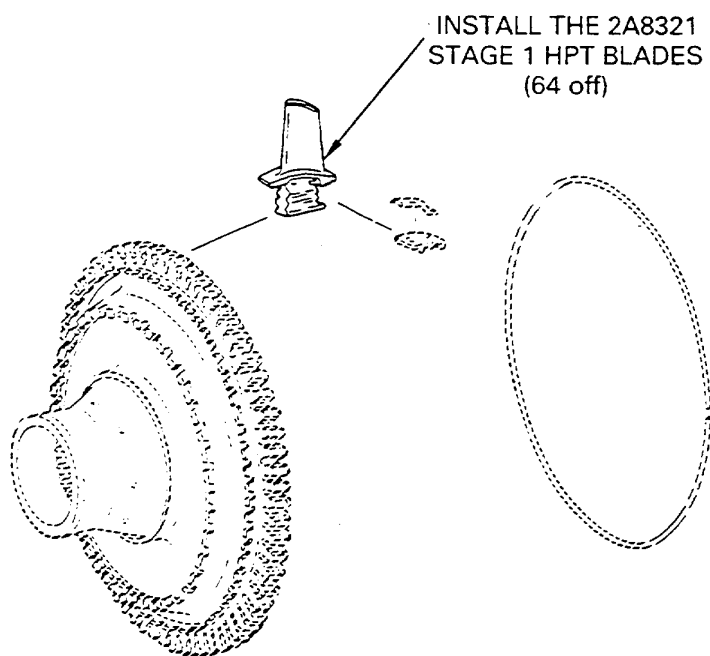
Location of the Stage 1 HPT Blade
Fig.1

The pressures in the leading edge cavities are not equal.

To provide a new Stage 1 HPT Blade with revised crossover slots in the leading edge impingement rib of the casting and a shorter trailing edge platform.

- (1) Install the 2A8321 Stage 1 HPT Blades (64 off) by the approved procedure given in Reference (2), Chapter/Section 72-45-10, Assembly, and Figure 1.

- (2) Install the 2A8321 Stage 1 HPT Blades (64 off) by the approved procedure given in Reference (3), Chapter/Section 72-45-10, Assembly, and Figure 1.
