ENGINE - NO.4 BEARING COMPARTMENT - REPLACE EXISTING TUBE ADAPTERS WITH TUBE ADAPTERS
HAVING A DECREASED INNER DIAMETER - CATEGORY CODE 5 - MOD.ENG-72-0148

V2500-ENG-72-0148

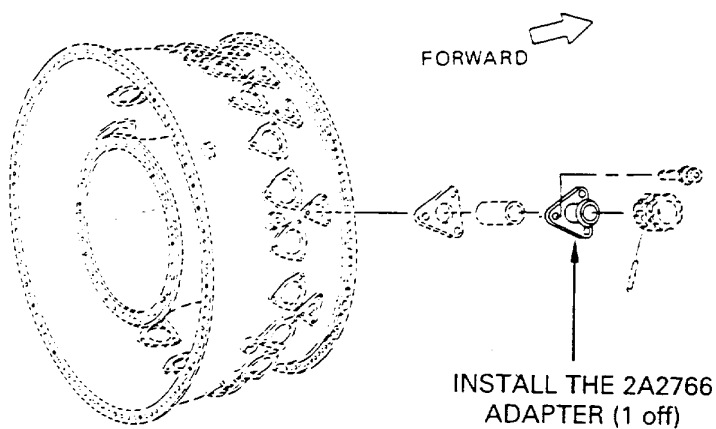
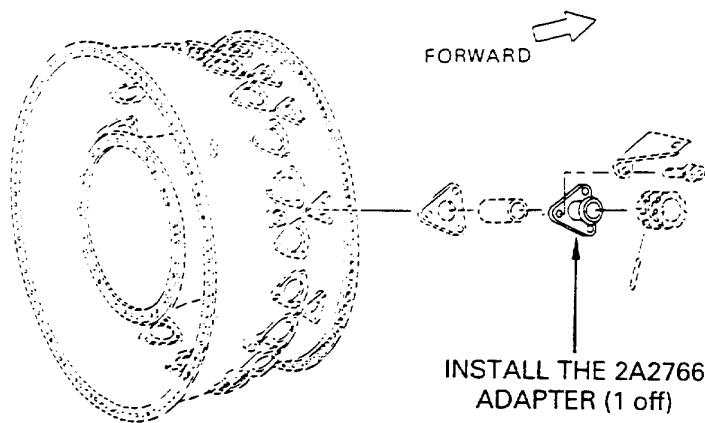
Location of the Adapter (Right Side View V2500-A5 and V2500-D5)
Fig.1 (Sheet 1)

The cool air that flows from Stage 10 of the High Pressure Compressor to the Stage 2 Turbine Blades can be increased.

A change to tube boss adapters with a decreased inner diameter increases the flow of air that cools the Stage 2 Turbine Blades.

- (b) Install the 2A2776 Adapters (2 off) by the approved procedure given in Reference (2), Chapter/Section 72-42-00, Assembly, and Figure 1.

- (b) Install the 2A2776 Adapters (2 off) by the approved procedure given in Reference (3), Chapter/Section 72-42-00, Assembly, and Figure 1.
