V2500-A5 SERIES PROPULSION SYSTEM SERVICE BULLETIN

ENGINE – LP COMPRESSOR – REPLACE THE PTO DRIVE BEARING SUPPORT SHAFT SEALING RING**1. Planning Information****A. Effectivity**

V2500-ENG-72-0152
Page 6

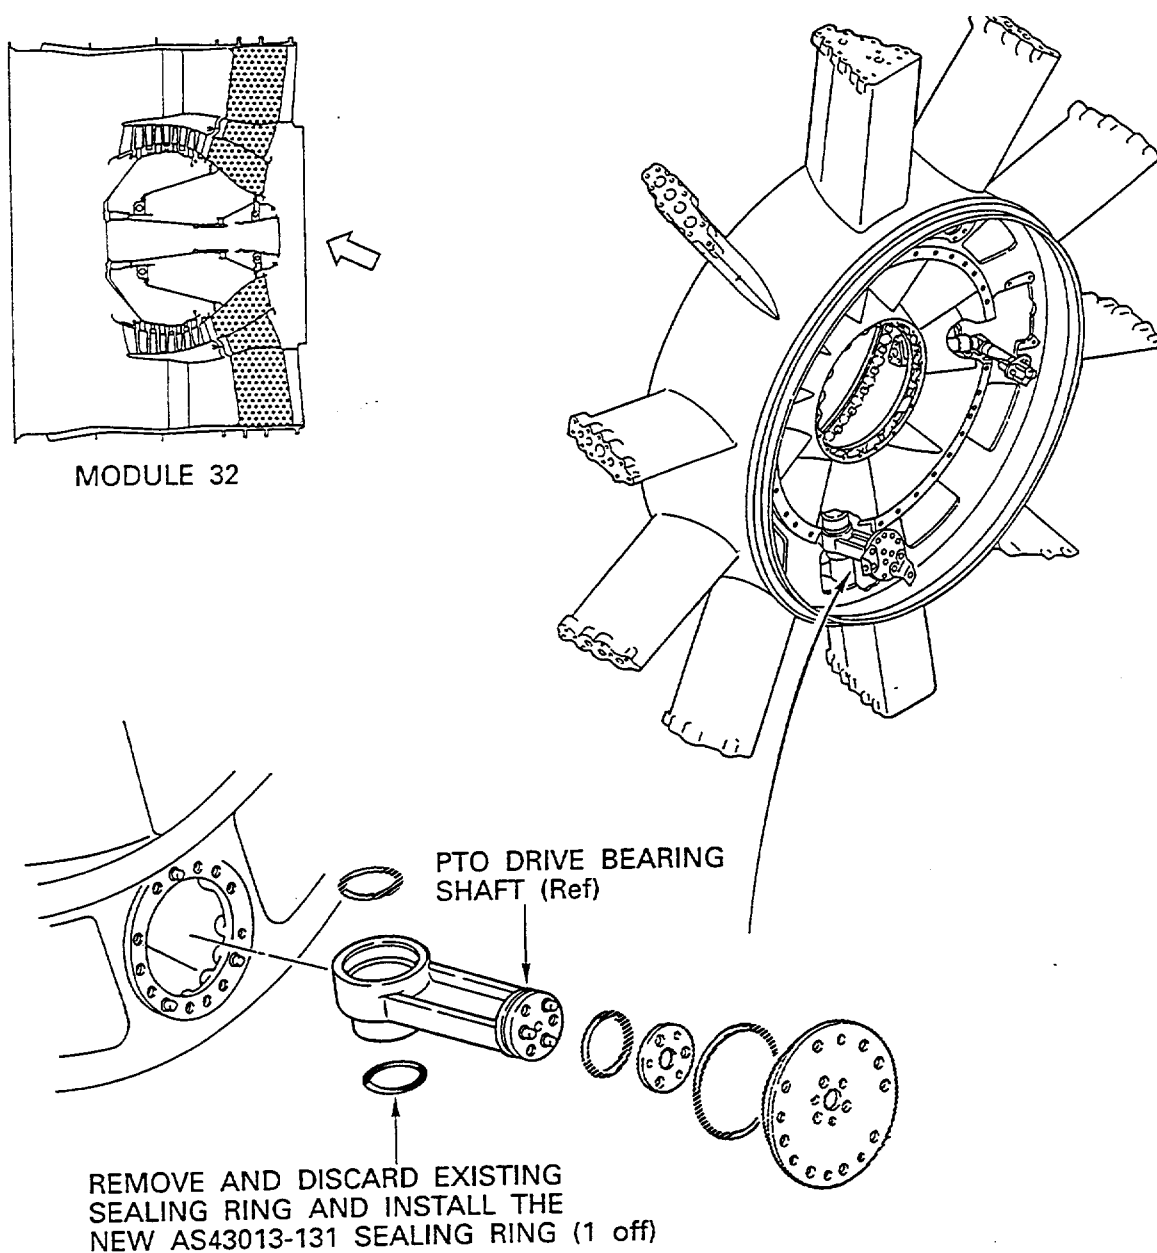
Replacement of the Sealing Ring
Figure 1

When the oil seal tube is installed into Fan Case Assembly, the existing sealing ring may cause twist in the housing A/O centre bearing.

NOTE: The existing sealing ring inside diameter is 1.598 to 1.628in. (40,56 to 41,33 mm) and new sealing ring inside diameter is 1.660 to 1.690in. (42,14 to 42,90 mm).

- (1) Remove and discard the existing sealing ring from the groove in the centre bearing housing assembly by approved procedures in Reference (2), Chapter/Section 72-32-00, Disassembly-14 (Refer to Figure 1).
- (2) Install the new AS43013-131, sealing ring into the groove in the centre bearing housing assembly by approved procedures in Reference (2), Chapter/Section 72-32-00, Assembly-02 (Refer to Figure 1).
