ENGINE - LP COMPRESSOR - REPLACE THE FAN CASE ASSEMBLY NO.1 RUBBER SEAL ASSEMBLY -
CATEGORY CODE 6 - MOD.ENG-72-0156

V2500-ENG-72-0156

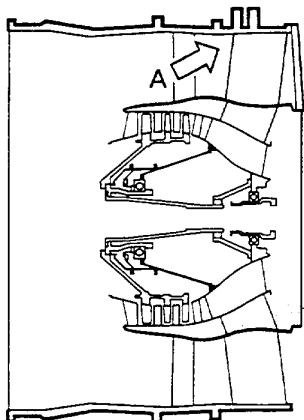
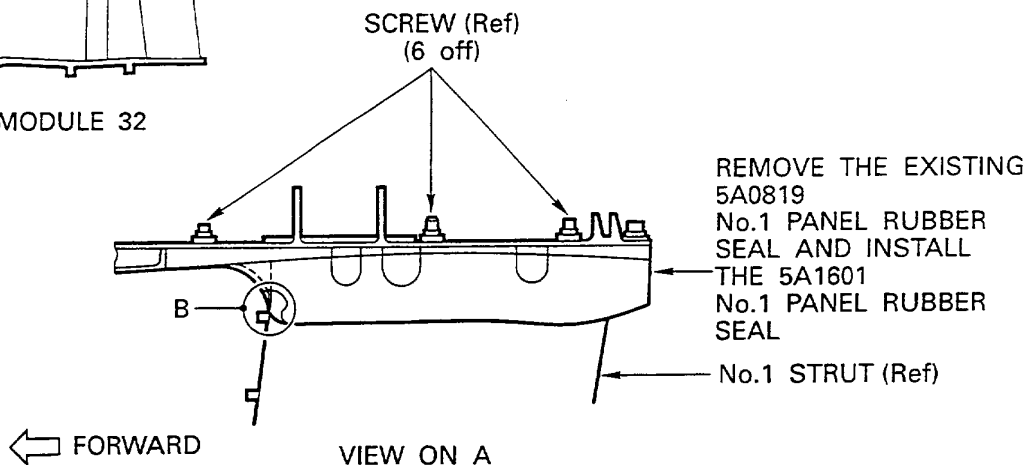
Location of the No.1 Panel Rubber Seal and Sealant Position
Fig.1

Interference may occur between the No.1 panel rubber seal and pressure boss on the No.1 strut. This may result in difficulty removing the rubber seal.

*FILL THE SEALANT IN TO
CLEARANCE AA BETWEEN THE
No.1 STRUT AND FRONT END
OF No.1 PANEL RUBBER SEAL

- (a) The existing 5A0819, No.1 panel rubber seal on No.1 strut with screws of the LP Compressor/Intermediate Case Module is replaced with the 5A1601, No.1 panel rubber seal with sealant in to the clearance AA (See Figure 1).
- (b) Local cut of interference area on the existing No.1 panel rubber seal and put the sealant in to the clearance AA when assembled (See Figure 1 and 2).

(a) Install the 5A1601, No.1 panel rubber seal on to the LP Compressor/Intermediate Case Module in accordance with following procedures (Refer to Figure 1):

- 1 Attach the 5A1601, No.1 panel rubber seal to the fan case and safety the seal with existing six screws (Refer to Figure 1).

(b) Torque the screws to 75 to 85 lbfin (8,50 to 9,60 Nm).

(c) Fill the clearances between the No.1 strut and the rubber seal with silicone rubber compound in accordance with following procedures (Refer to Figure 1):

- 1 Use a clean cloth or a soft brush made moist with CoMat 01-076, Methylethylketone to clean clearance AA between the No.1 strut and the front end of the No.1 rubber seal.
- 2 Apply a thin layer of CoMat 08-014 primer to the areas with a soft brush. Air dry for 30 minutes minimum.

- 3 Fill the CoMat 08-045 silicone rubber compound in to the clearance AA with a sealant dispenser.
- 4 Press the silicone rubber compound in to position and make smooth with a spatula.

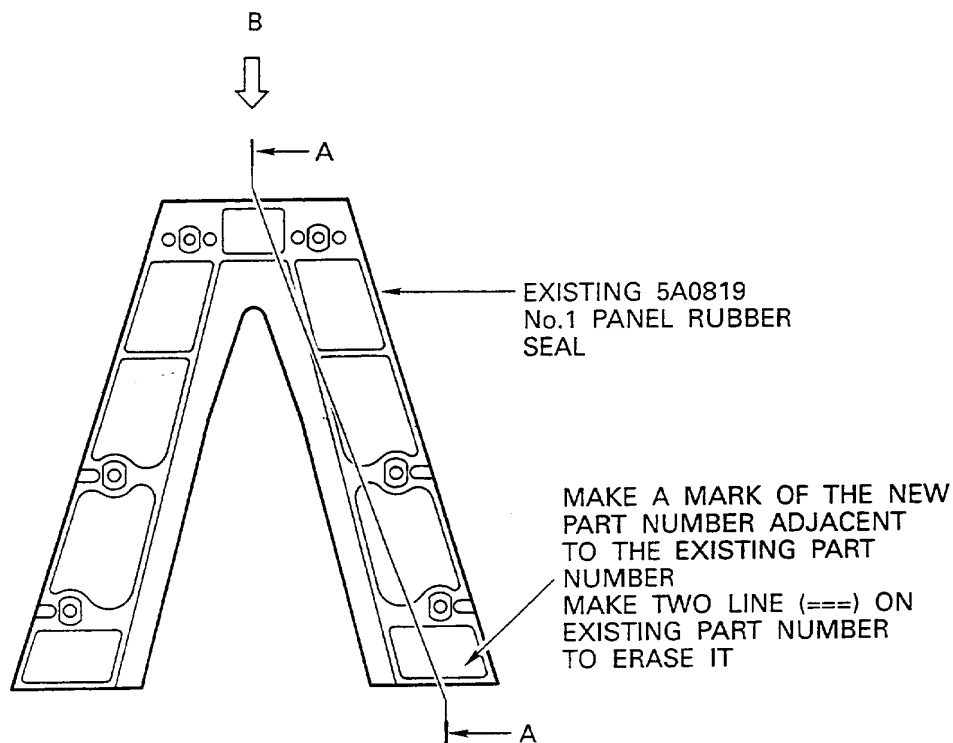
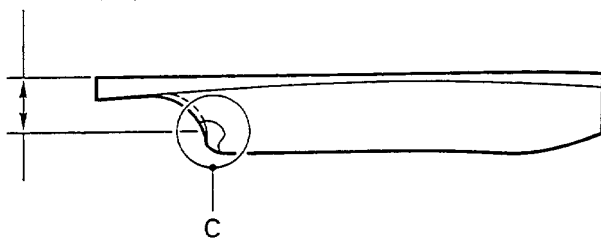
Modification of the No.1 Panel Rubber Seal
Fig.2 (Sheet 1 of 2)

1.319in. (33,5 mm) THRU 1.359in. (34,5 mm)

(2) Existing 5A0819, No.1 panel rubber seal can be reworked to the new configuration (See Figure 2).

- (1) Do a modification to the 5A0819, No.1 panel rubber seal and identify as follows (Refer to Figure 2):

| Procedure | Supplementary Information |
|---|---|
| (c) Remove the unwanted material from marked area (See step (b)) on the No.1 panel rubber seal using Hand Grinder. | Refer to Figure 2. |

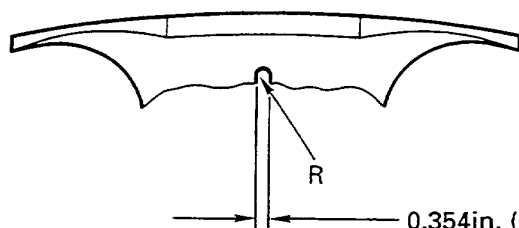
Modification of the No.1 Panel Rubber Seal
Fig.2 (Sheet 2 of 2)

REMOVE THE UNWANTED
MATERIAL AROUND HERE
0.019in. (0,50 mm) TO 0.039in. (1,00 mm)

0.354in. (9,00 mm)
THRU
0.433in. (11,00 mm)
