SERVICE BULLETIN

<u>ENGINE - LP COMPRESSOR - PROVIDE A NEW FAN CASE ASSEMBLY THAT ELIMINATES THE PROVISIONS</u> FOR A TRANSITION RING - CATEGORY CODE 7 - MOD.ENG-72-0160

V2500-ENG-72-0160

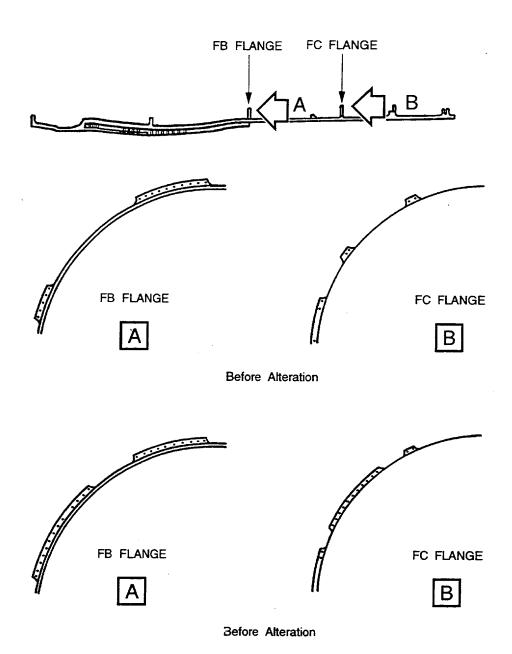
Before and after the alteration of the Fan Case Assembly Fig.1

- (1) The spigot feature at front portion is eliminated. Refer to Figure 1.
- (2) Scallops are changed and holes are added on FB and FC flanges in the Fan Case Assembly. Refer to Figure 2.
- (3) PMA Cooling Air Tubes are rerouted to the new Intermediate Case Module. Refer to Figures 3 and 4.
- (4) The module part number of the Intermediate Case was changed from 5W0130 to 5W0150.
