SERVICE BULLETIN

ENGINE - NO. 4 BEARING COMPARTMENT - PROVIDE A NEW NO. 4 BEARING SEAL ASSEMBLY WITH NUTS SILVER PLATED ON THE THREADS ONLY - CATEGORY CODE 8 - MOD.ENG-72-0163

V2500-ENG-72-0163

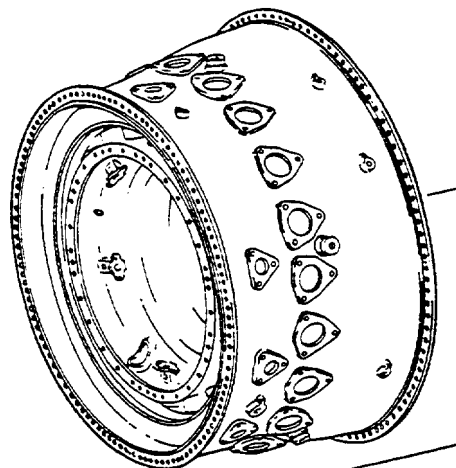
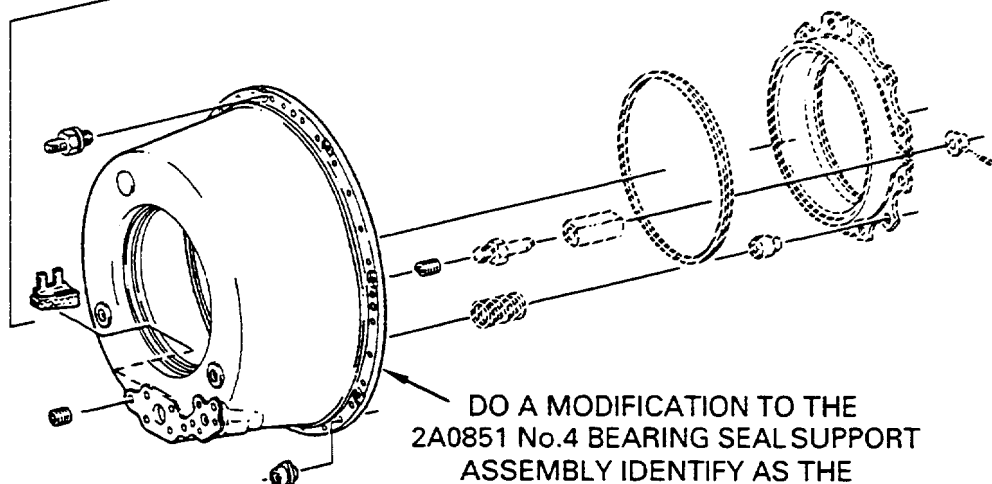
Location of the No. 4 Bearing Seal Support
Fig.1

It is possible for the titanium No. 4 Bearing Seal Support Assembly to develop corrosion when contacted by silver plated nuts.

Stress corrosion develops when the silver plated nuts contact the No. 4 Bearing Seal Support Assembly.

DO A MODIFICATION TO THE
2A0851 No.4 BEARING SEAL SUPPORT
ASSEMBLY IDENTIFY AS THE
2A2833 No.4 BEARING SEAL SUPPORT
ASSEMBLY (1 off) AND INSTALL
