SERVICE BULLETIN

ENGINE - LP TURBINE - REPLACE THE EXISTING NO.5 BEARING SEAL SPACER WITH A SPACER INCORPORATING FOOL-PROOF INSTALLATION FEATURES - CATEGORY CODE 5 - MOD.ENG-72-0165

V2500-ENG-72-0165

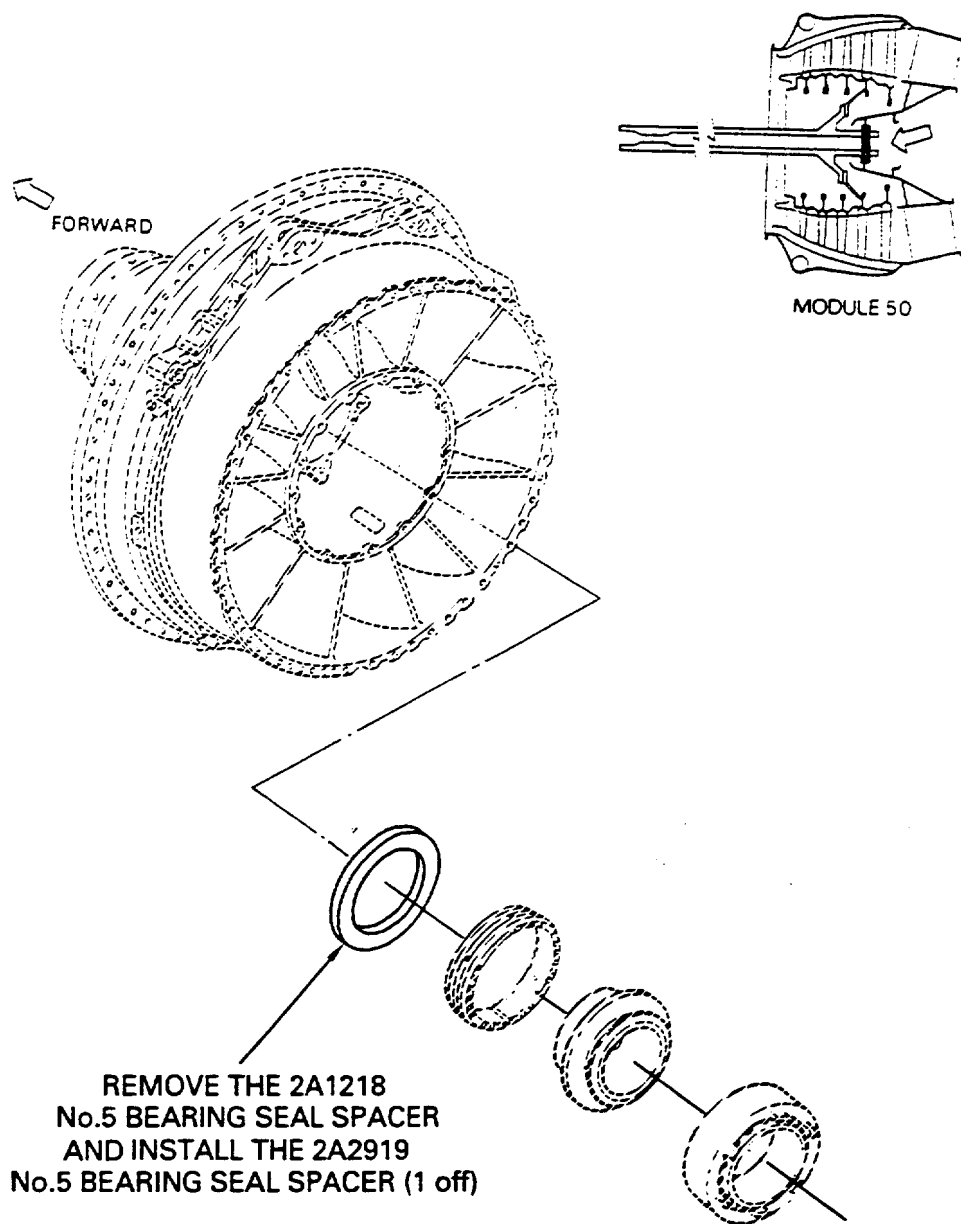
Location of the No.5 Bearing Seal Spacer
Fig.1

It was possible to install the No. 5 bearing Seal Spacer so that it was not correct.

Replace the No. 5 bearing Seal Spacer with one that has features to prevent its installation in a position that is not correct.

- (1) For V2500-A1 and V2500-A5 Engines
 - (a) Remove the 2A1218 No. 5 Bearing Seal Spacer by the approved procedure given in Reference (2), Chapter/Section 72-50-00, Disassembly-01.
 - (b) Install the 2A2919 No. 5 Bearing Seal Spacer (1 off) by the approved procedure given in Reference (2), Chapter/Section 72-50-00, Assembly-02, and Figure 1.
- (2) For V2500-D5 Engines
 - (a) Remove the 2A1218 No. 5 Bearing Seal Spacer by the approved procedure given in Reference (3), Chapter/Section 72-50-00, Disassembly-01.
 - (b) Install the 2A2919 No. 5 Bearing Seal Spacer (1 off) by the approved procedure given in Reference (3), Chapter/Section 72-50-00, Assembly-02, and Figure 1.
