ENGINE - NO. 4 BEARING COMPARTMENT - INTRODUCE A NEW NO. 4 BEARING OIL TUBE ASSEMBLY -
CATEGORY CODE 6 - MOD.ENG-72-0168

V2500-ENG-72-0168

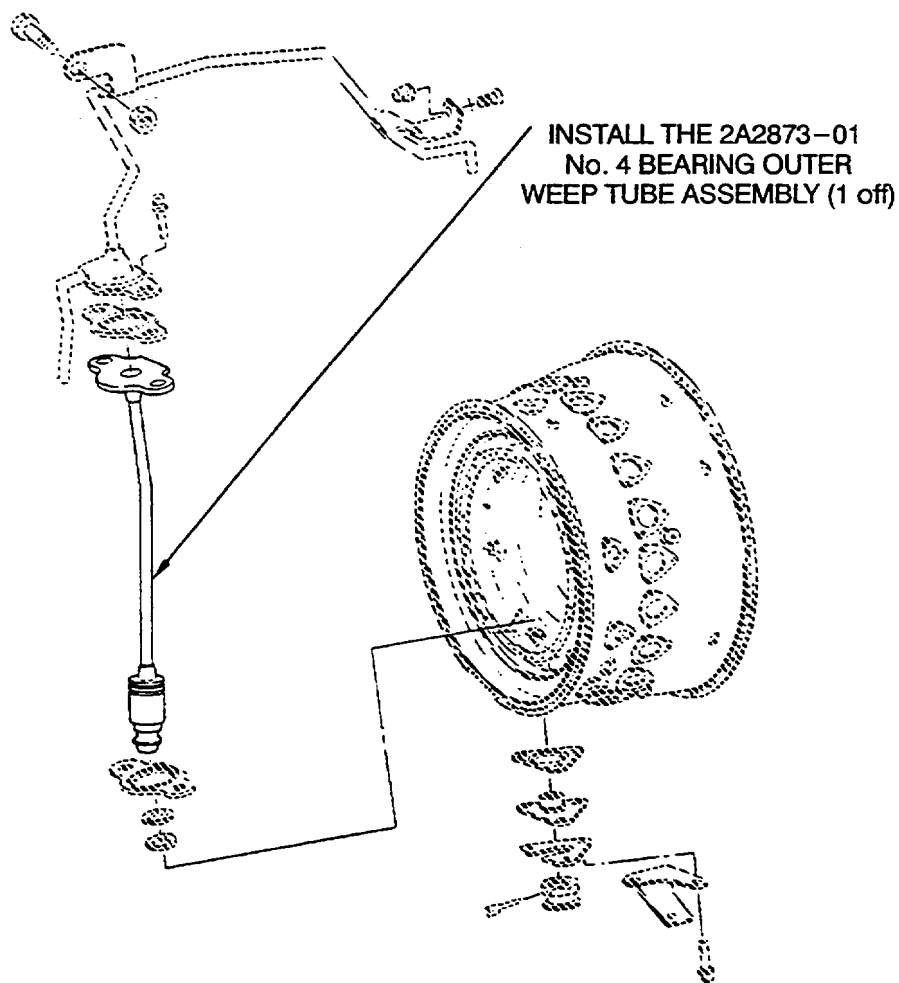
Location of the No. 4 Bearing Outer Tube Assembly
Fig.1

It was possible to have interference between the No. 4 Bearing and Airframe Outer Tube Assembly and the active clearance control linkage. Also, the sealing function did not always operate correctly.

- (1) For V2500-A1 and V2500-A5 Engines
 - (a) Install the 2A2873-01 No. 4 Bearing Outer Weep Tube Assembly (1 off) by the approved procedure given in Reference (2), Chapter/Section 72-42-10, Assembly, and Figure 1.
- (2) For V2500-D5 Engines
 - (a) Install the 2A2873-01 No. 4 Bearing Outer Weep Tube Assembly (1 off) by the approved procedure given in Reference (3), Chapter/Section 72-42-10, Assembly, and Figure 1.
