ENGINE - LP COMPRESSOR - REMOVE UNNECESSARY BLANKING PLATES AND OIL DRAIN TUBE FROM THE FAN FRAME ASSEMBLY - CATEGORY CODE 7 - MOD.ENG-72-0170

V2500-ENG-72-0170

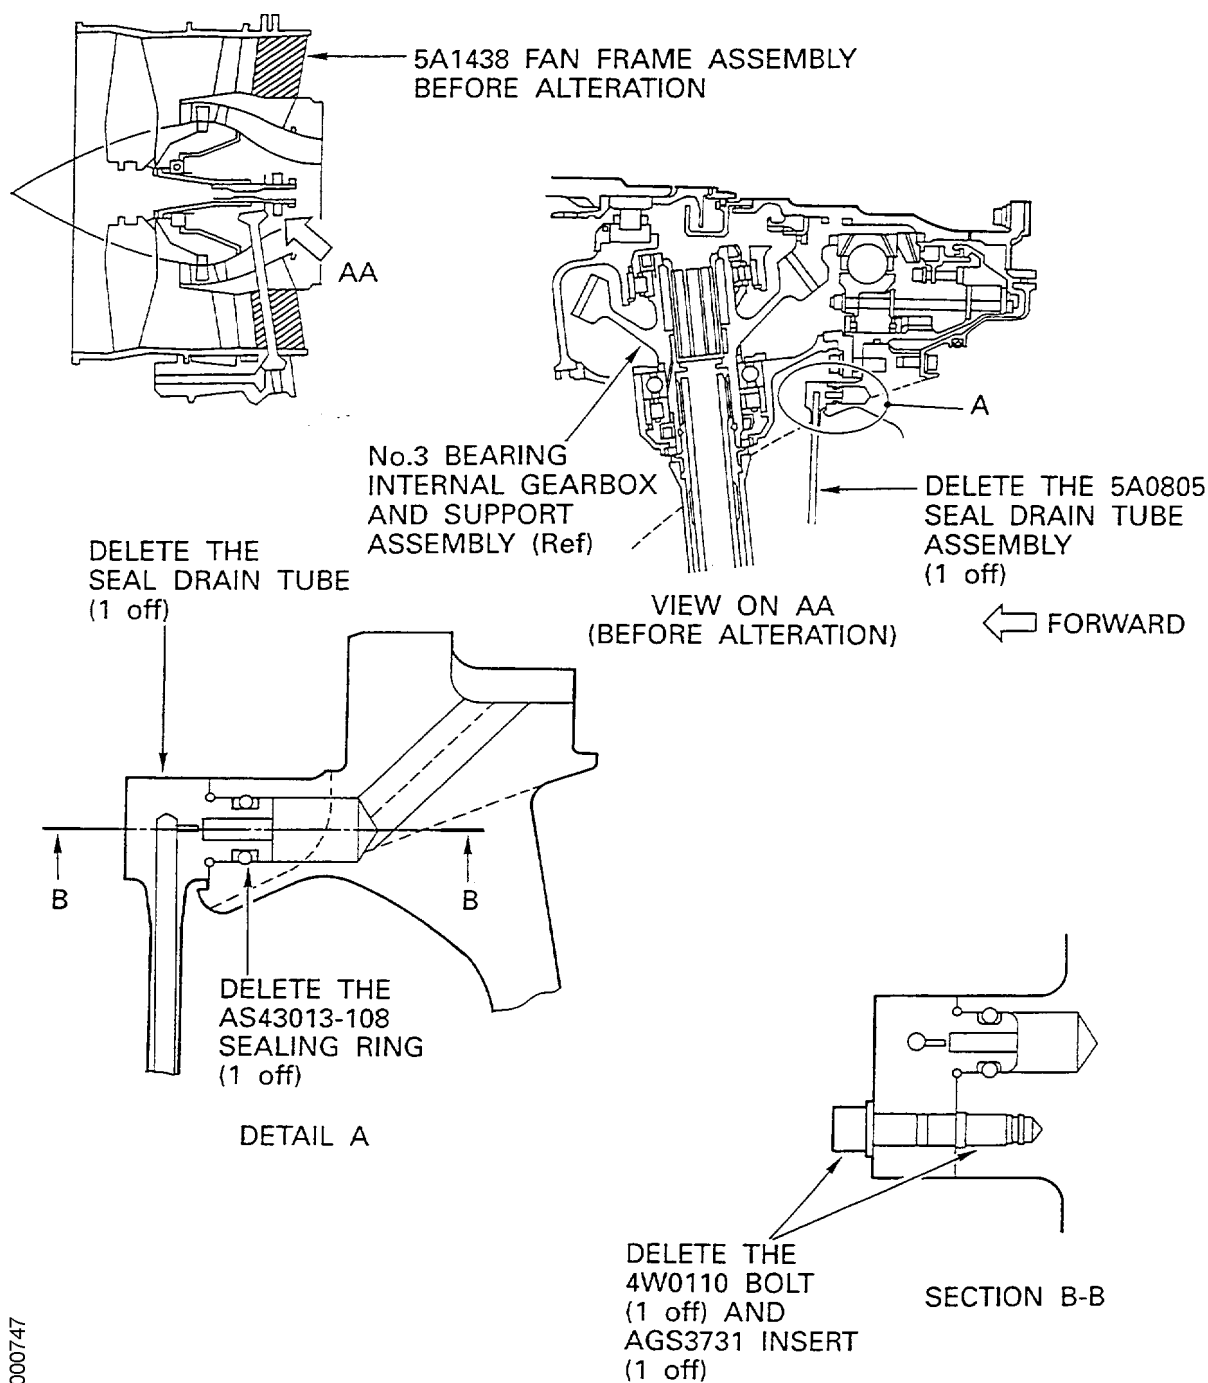
Fan Frame Assembly - Before and After Alteration  
Fig.1 (Sheet 1 of 2)

- (1) This Service Bulletin introduces the new Fan Frame Assembly as follows:
- (a) The blanking plates are deleted from inside of No.1 and No.6 bypass struts on the Fan Frame Assembly.
  - (b) Replace the seal drain tube assembly with flow-restricting pin which is fitted on the Fan Frame Assembly (See Figure 1).
  - (c) The existing bolt and sealing ring of the seal drain tube assembly have been deleted. (See Figure 1).
  - (d) Engine weight will be decreased 0.4 lb. (0,18 kg).

- (1) Install the 5A1609, fan frame assembly by the approved procedures in Reference L. (2), Chapter/Section 72-32-00, Assembly-04.

The 4W0110, bolt, the AS43013-108, sealing ring and the 5A0805, seal drain tube are not necessary to install on the engines.

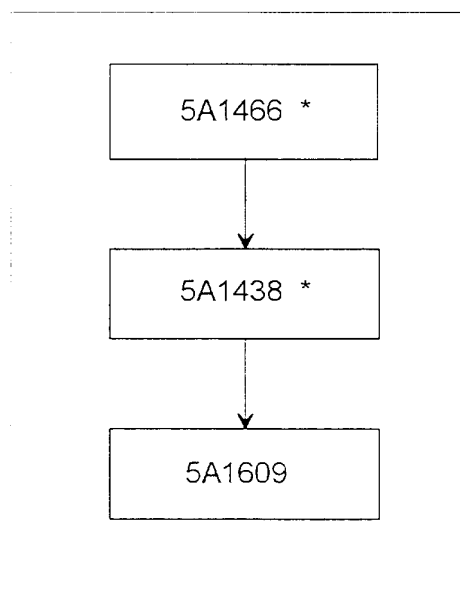
. Family Tree - Fan Frame Assembly Ref. Catalog Sequence No. 72-32-03 Fig. 03, Item 100  
Fig.2

V2500-ENG-72-0170  
REMOVE UNNECESSARY BLANKING  
PLATES AND OIL DRAIN TUBE  
FROM THE FAN FRAME ASSEMBLY

\* NOTE: PART ARE NOT REWORKABLE.
