# International Aero Engines

# SERVICE BULLETIN

# <u>ENGINE - LP COMPRESSOR - PROVIDE LONGER ATTACHING BOLTS FOR THE OPEN LATCH INDICATOR</u> <u>BRACKET - CATEGORY CODE 6 - MOD.ENG-72-0175</u>

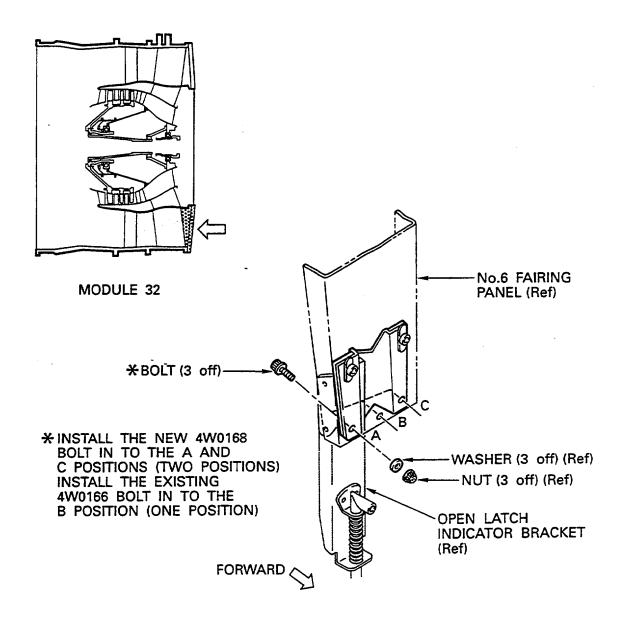
Replacement of the Bolts Fig.1

The length of existing bolts that secure the No.6 fairing panel and the open latch indicator bracket may not be of sufficient length.

Insufficient bolt length may occur as a result of adverse tolerances.

(1) The length of two 4W0168, bolts (At both ends of No.6 fairing panel) in the three relate bolts which attach the open latch indicator bracket to the No.6 fairing panel are changed (See Figure 1).

- A. Assembly Instructions
  - (1) Make sure the existing part number of bolts on both ends for the No.6 fairing panel.
    - (a) If it is not 4W0168, bolts, do a following modification;
      - 1 Replace the existing two bolts with the new two 4W0168, bolts on both ends of the No.6 fairing panel at two positions (Refer to Figure 1).
