V2500-A1/A5 PROPULSION SYSTEM SERVICE BULLETIN

This document transmits Revision 1 to Service Bulletin EV2500-72-0176

V2500-ENG-72-0176

ENGINE - HP COMPRESSOR - INTRODUCTION OF A HP SYSTEM MODULE SERIAL NUMBER
IDENTIFICATION PLATE

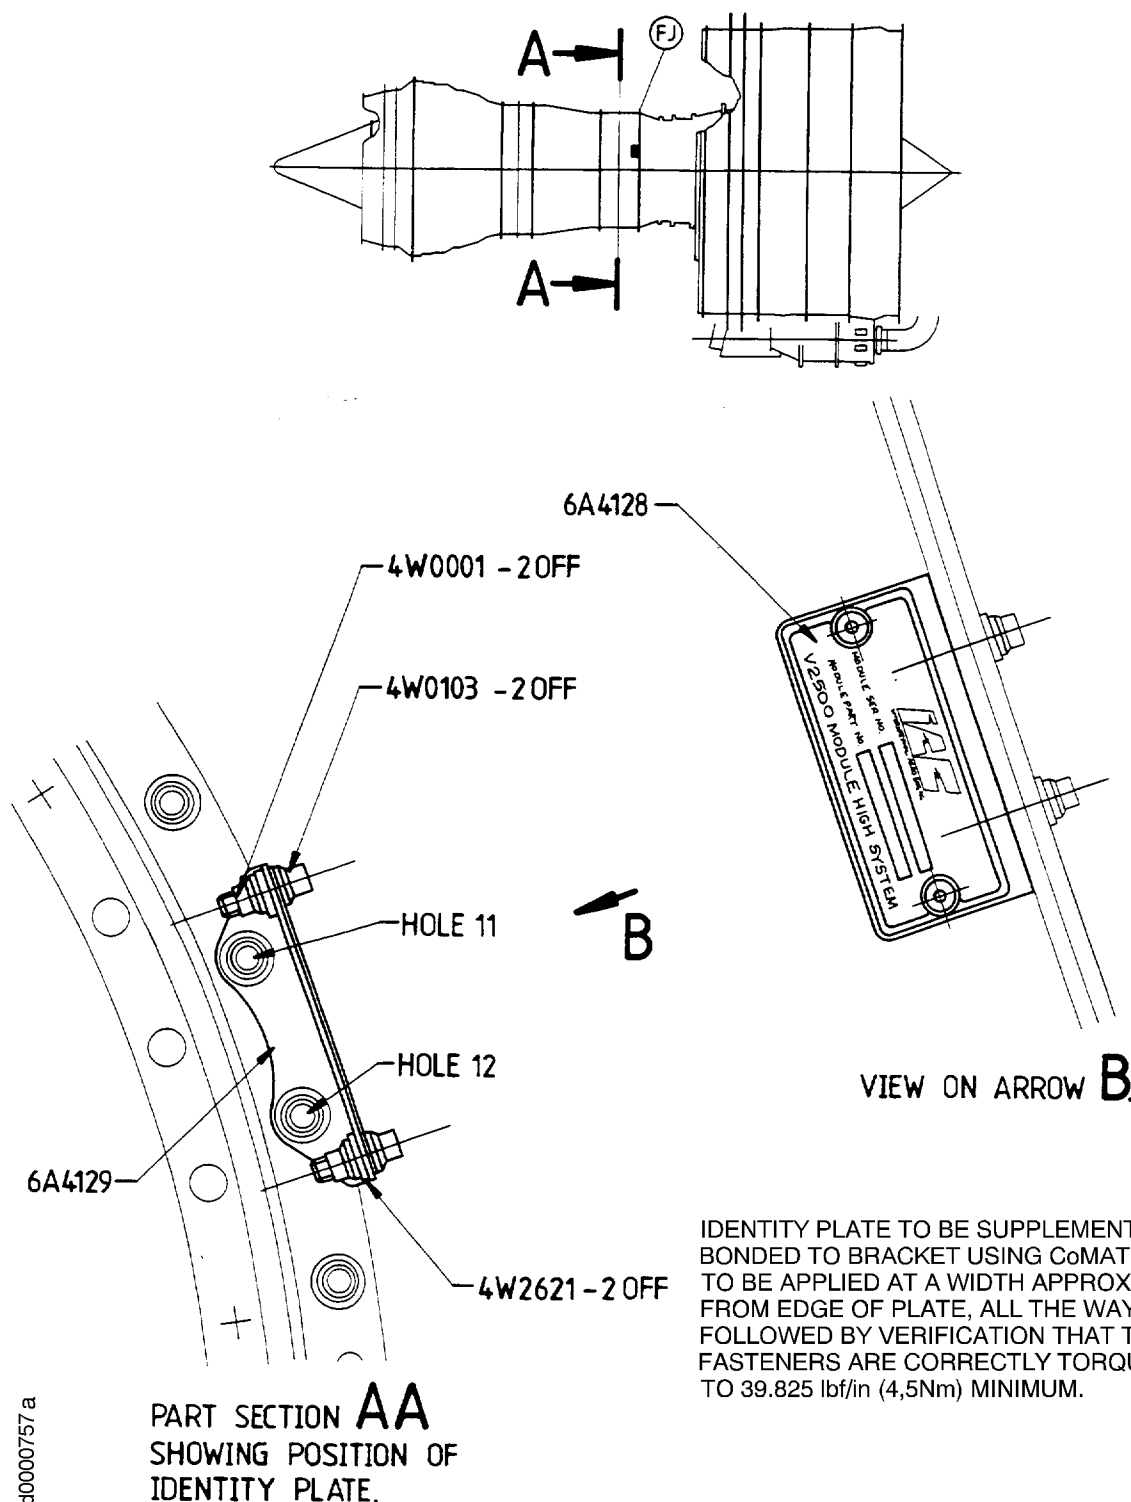
Location of identification plate and bracket
Fig.1

A stainless steel bracket is bolted to the front flange of the HP compressor rear outer case. A module identification plate having spaces for the serial number and module assembly number is bonded to the bracket.

The plate is additionally secured to the bracket by 2 bolts.

- (1) Machine engrave the HP System Module Serial and part numbers on the 6A4128 identification plate in the spaces provided in accordance with References (1), TASK 70-09-00-400-501, SUBTASK 70-09-00-400-001.
- (2) Apply CoMat 08-013, Cold Curing Silicone Compound, to the 6A4128 identification plate and bond the plate to the 6A4129 bracket as shown in Figure 1 and in accordance with Reference(1), TASK 70-36-02-360-501, SUBTASK 70-36-02-360-020.
- (3) Secure the plate with the 4W0103 bolts, 4W2621 washers and 4W0001 nuts. Torque the bolts to 39.8 lbfin (4,5 Nm) minimum.
- (4) Install the plate and bracket onto the rear face of flange FJ at the position shown in Figure 1 using the existing nuts and bolts. Torque the bolts to 180 to 220 lbfin (20 to 25 Nm).

IDENTITY PLATE TO BE SUPPLEMENTARY BONDED TO BRACKET USING CoMAT 08-013, TO BE APPLIED AT A WIDTH APPROX 10mm FROM EDGE OF PLATE, ALL THE WAY AROUND FOLLOWED BY VERIFICATION THAT THE FASTENERS ARE CORRECTLY TORQUED TO 39.825 lbf/in (4.5Nm) MINIMUM.
