ENGINE - LP TURBINE ASSEMBLY - PROVIDE IAE PARTNUMBER IDENTIFICATION FOR LPT ROTORNUTS
- CATEGORY CODE 6 - MOD.ENG-72-0179

V2500-ENG-72-0179

SERVICE BULLETIN

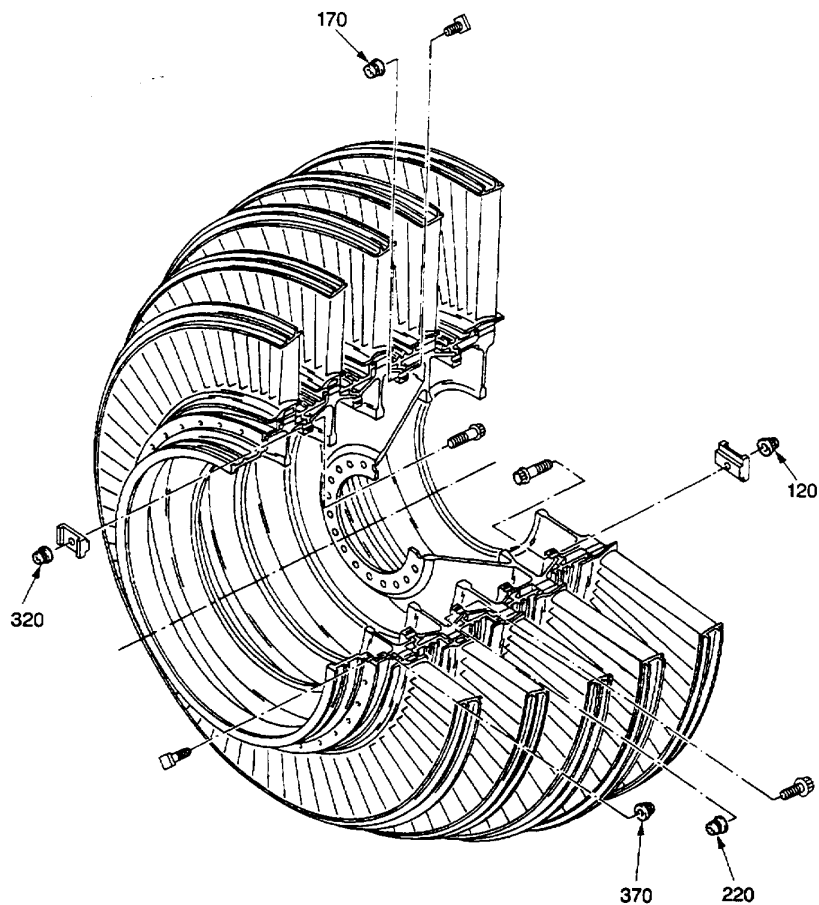
LPT rotor assembly
Fig.1

The existing nuts used at the LP-turbine disk connection are not individually marked with a part number.

During engine shop visit the correct part might be confused with similar parts with inferior material properties, since removed parts can be used again.

Mark the nuts with the respective partnumber in accordance with the approved procedure as per section 1.K. (4).

V2500 Standard Practises Manual, TASK 70-09-00, use vibro peen method or roller stamp method.

The location where the mark must be applied is shown in figure 1.
