ENGINE - HP TURBINE ROTOR AND STATOR ASSEMBLY - INTRODUCE A NEW FIRST STAGE TURBINE AIR SEAL - CATEGORY CODE 6 - MOD.ENG-72-0180

SERVICE BULLETIN

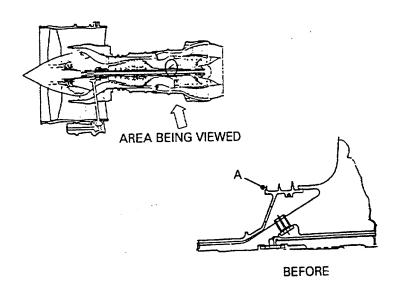
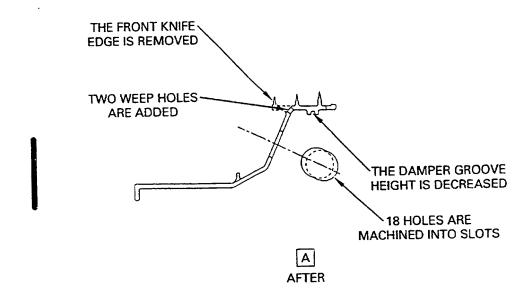
E2022A

It is possible that unwanted oil can collect in the area between the Stage 1 HPT Air Seal and the Stage 1 HOT Turbine Hub.

It was found that the unwanted oil will not drain from the area unless there was a modification to the Stage 1 HPT Air Seal.

Before and After view of configuration changes that affect the High Pressure Turbine Rotor and Stator Assembly Fig.1

To provide a Stage 1 HPT Air Seal with features that let the unwanted oil drain more quickly. These features include: Removal of the front knife-edge, additional drain holes, an elongated cooling air hole and a damper groove with a decreased wall height.

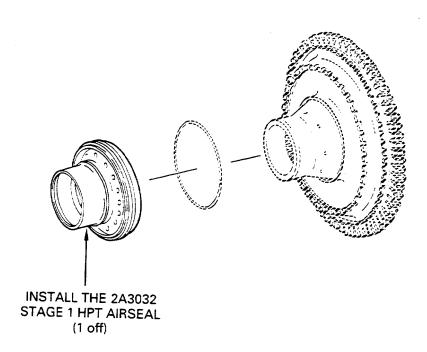
E2023

Location of the Stage 1 HPT Air Seal Fig.2

(1) Install the 2A3032 Stage 1 HPT Air Seal (1 off) by the approved procedure given in References (2) or (3), Chapter/Section 72-45-10 Assembly. See Figure 2.

- (a) Cool the Stage 1 HPT Air Seal in dry ice before you install it.
- (b) Use the IAE 1P16029 Drift to install the Air Seal.
- (c) Install the new Air Seal with the balance mark at the same location as the removed Stage 1 HPT Air Seal.
- (2) Identify the new rotor assembly as 2A8721 by the procedure specified in Reference (4), Chapter/Section 70-09-00, Marking of Parts.

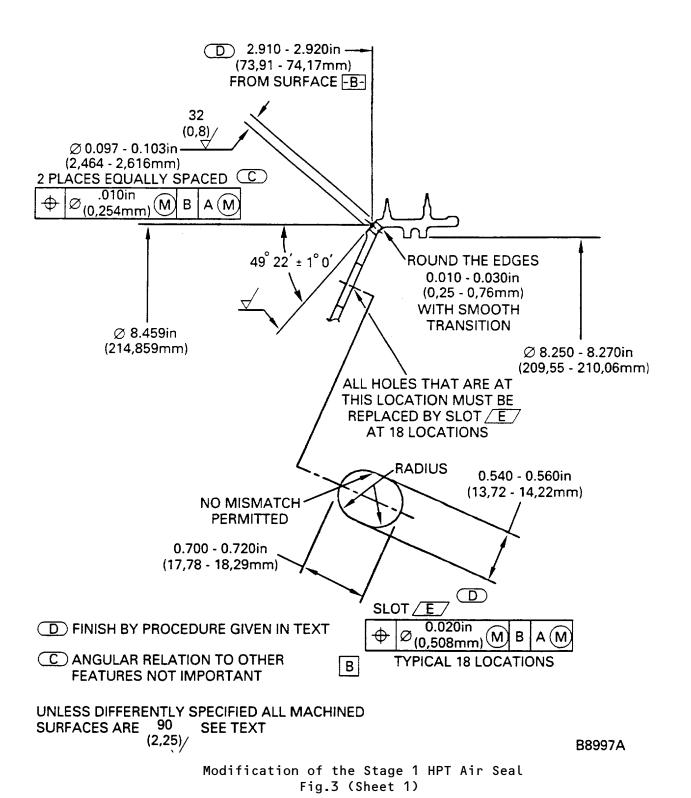
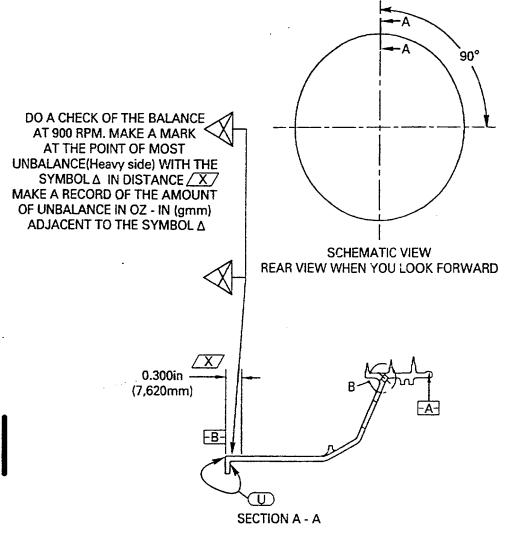
E2024A

Modification of the Stage 1 HPT Air Seal Fig.3 (Sheet 2)

- (a) Set-up and machine to the dimensions specified and as follows:
- Refer to Figures 1 and 2.
- 1 Machine to remove the front knife edge seal.
- 2 Machine two holes at the locations and to the dimensions specified.
- 3 Machine 18 slots E at the hole locations specified.
- 4 Machine the damper groove height to the dimensions specified.
- (b) Do a check of the static unbalance at 900 RPM with the part held on

(c) Mark the new number adjacent to the old part number. Use the vibration peen method. Old Part No. New Part No. 2A1352 2A3032

U ELECTRICAL CONTACT IS PERMITTED ONLY IN THIS AREA NO BURNS PITS OR SELECTIVE ATTACK PERMITTED

MAKE A MARK TO SHOW THE PART NUMBER SEE TEXT

90 UNLESS DIFFERENTLY SPECIFIED ALL MACHINED SURFACES ARE (2,25)/ SEE TEXT
